## **EXAMINATION OF FAILED COMPONENTS OF A CONSTRUCTION HOIST**

TALL CRANE EQUIPMENT LTD.  
22652 FRASER HWY  
LANGLEY TWP, BC V2Z 2T8

File Number: 60515067  
Date: September 11, 2019

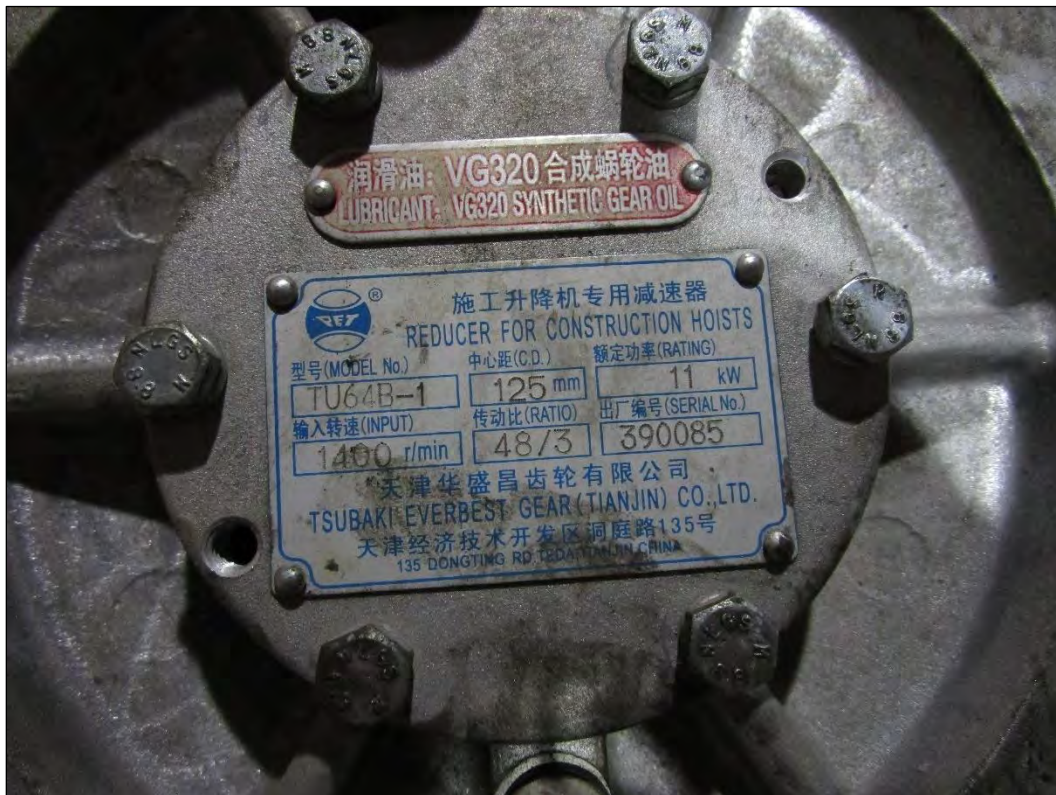
The name plate on the reduction gear box (see **Figure 2**) showed that it was made for construction hoists.

**Figure 2** Name plate on gear box.

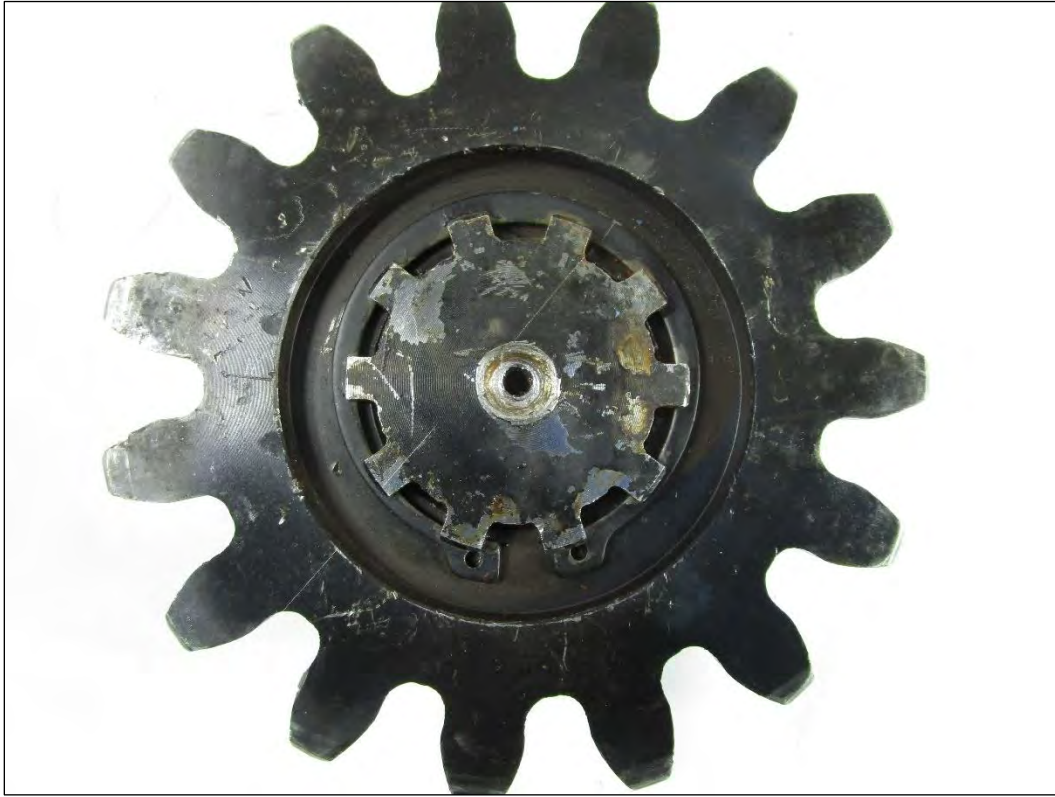
The bottom gear splined shaft broke between the gear box and the gear (see **Figure 3**). The outboard end of the shaft was intact (see **Figure 4**).

**Figure 4** The outboard end of splined shaft inside bottom gear.

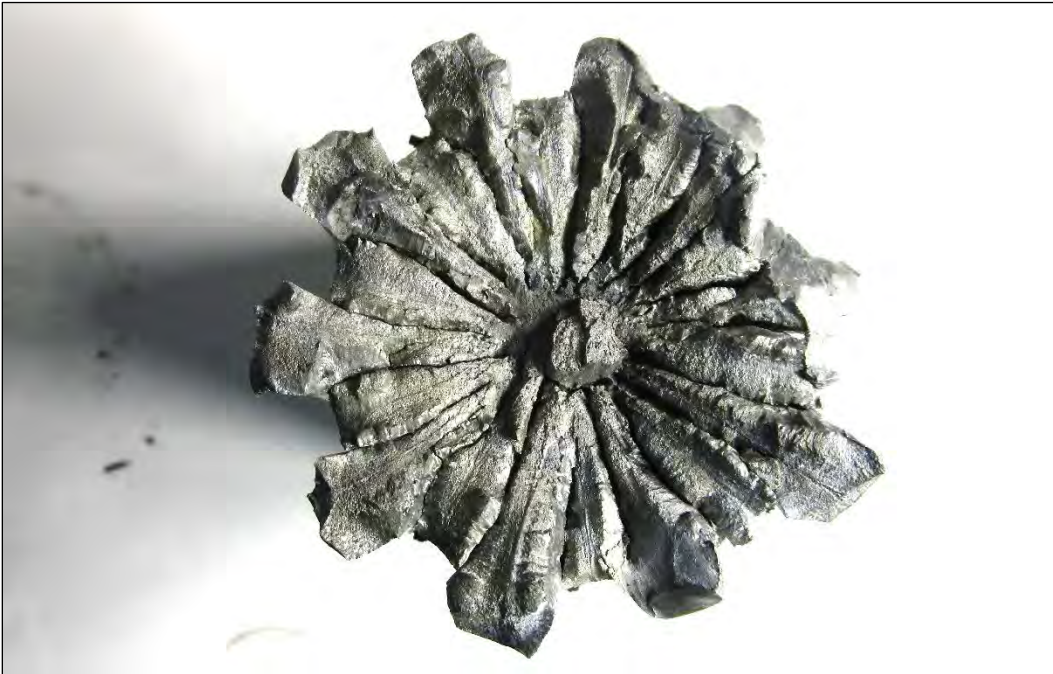
The fracture exhibited a fairly new appearance (see **Figure 3a** for clean fracture on the gear box side and **Figure 3b** for recently formed rust on the gear side). The light rust on the gear side fracture was readily removable by inhibited acid cleaning (see **Figure 6**). These fracture features indicated that the fatigue cracking on the splined shaft was fairly recent, perhaps within a couple of months.

**Figure 6** General appearance of shaft fracture after cleaning.

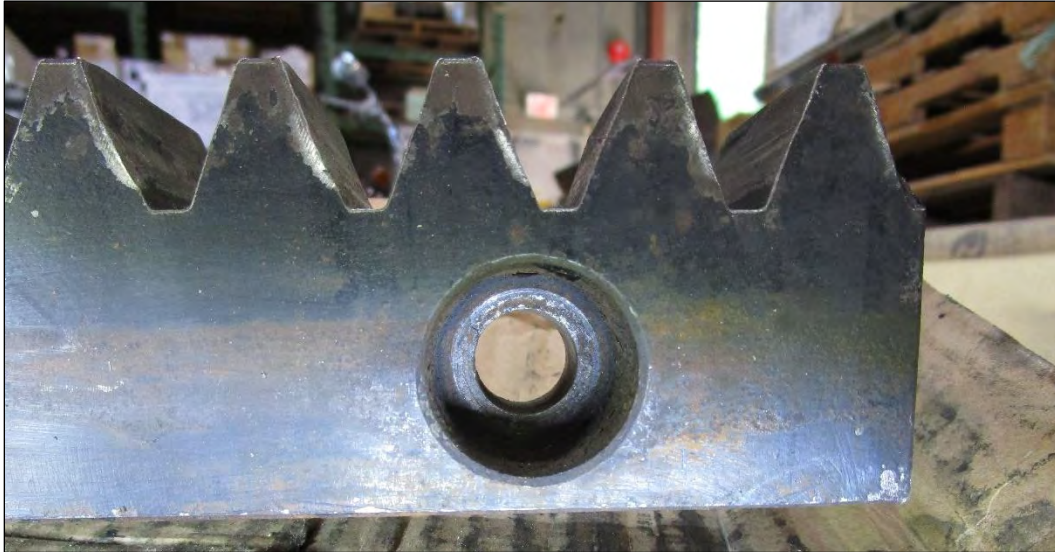
The rack section was measured 1.5 meters long and it had one bolt hole on each end (see **Figure 10**). The rack on the hoist would have been made up of several such rack sections that were bolted on a rack frame.

**Figure 10** Rack section has bolt hole on each end.

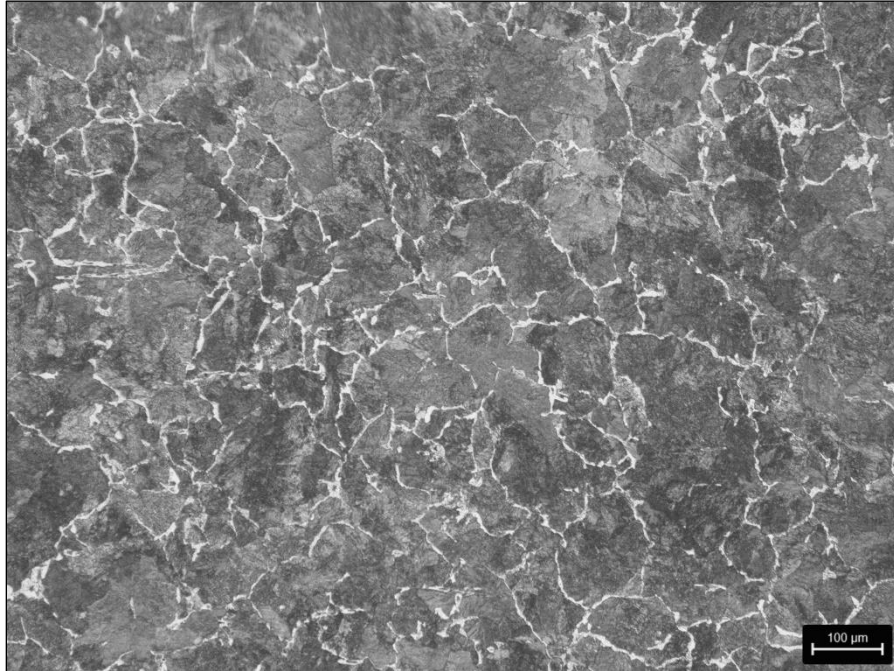
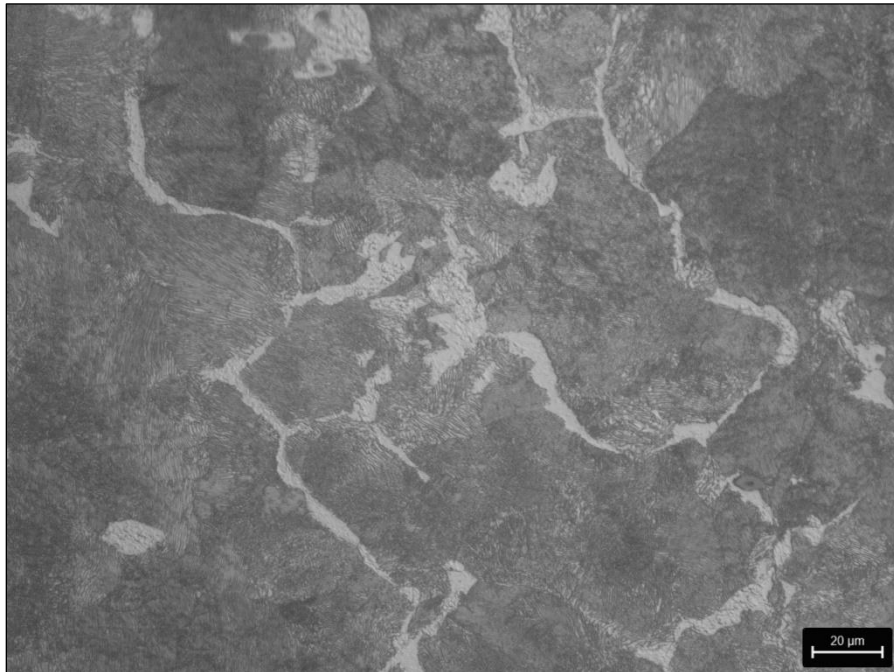
Metallographic examination revealed that the rack exhibited a uniform microstructure throughout its teeth and body (see **Figure 18**). The microstructure of the rack consisted of a mixture of coarse-grained pearlite colonies and grain boundary ferrite (see **Figure 19**). These metallographic features indicated that the rack was machined out of a hot-rolled bar stock of GB/T 699 Grade 60 carbon steel.

**Figure 19** General microstructure of rack steel.

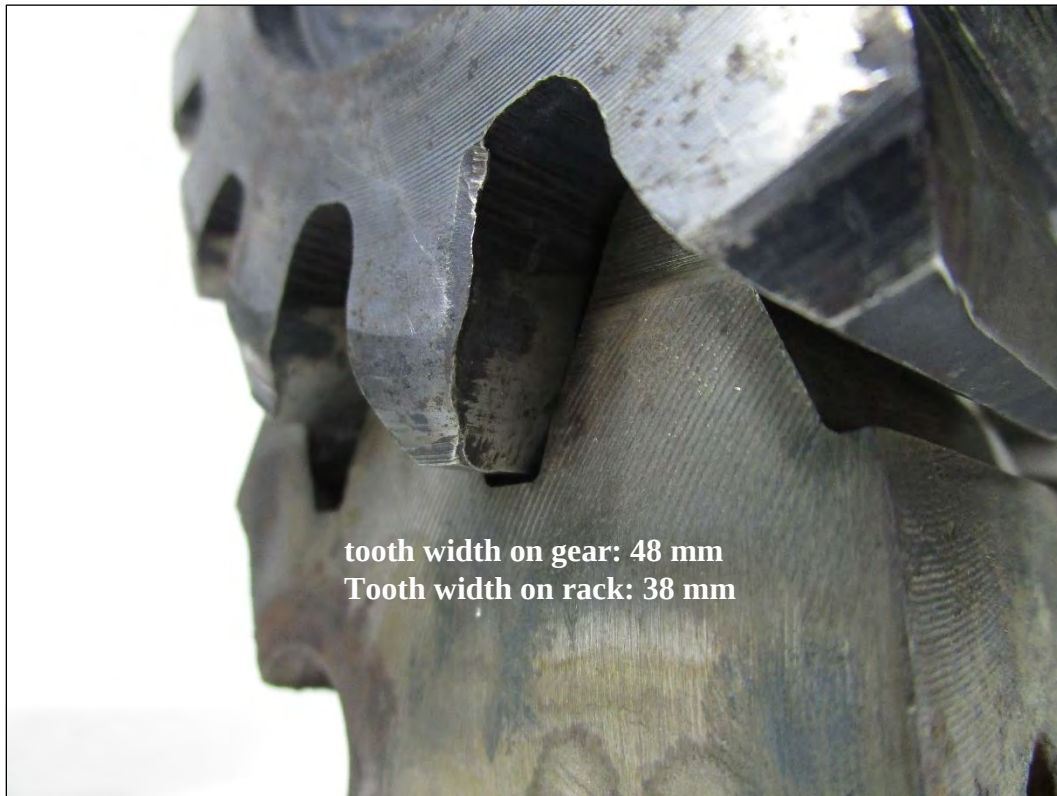
Other than the broken tooth on the bottom gear, these gears exhibited a similar wear pattern as shown in **Figure 23**. The teeth on all three gears showed engagement marks of 38 mm wide over the 48 mm tooth width starting from the inboard edge. The 48 mm wide gears would have been aligned with the 38 mm wide rack on the inboard edge. **Figure 24** illustrates the mismatching outboard side of the gear-rack engagement.

**Figure 24** Illustration of meshing teeth of gear and rack.

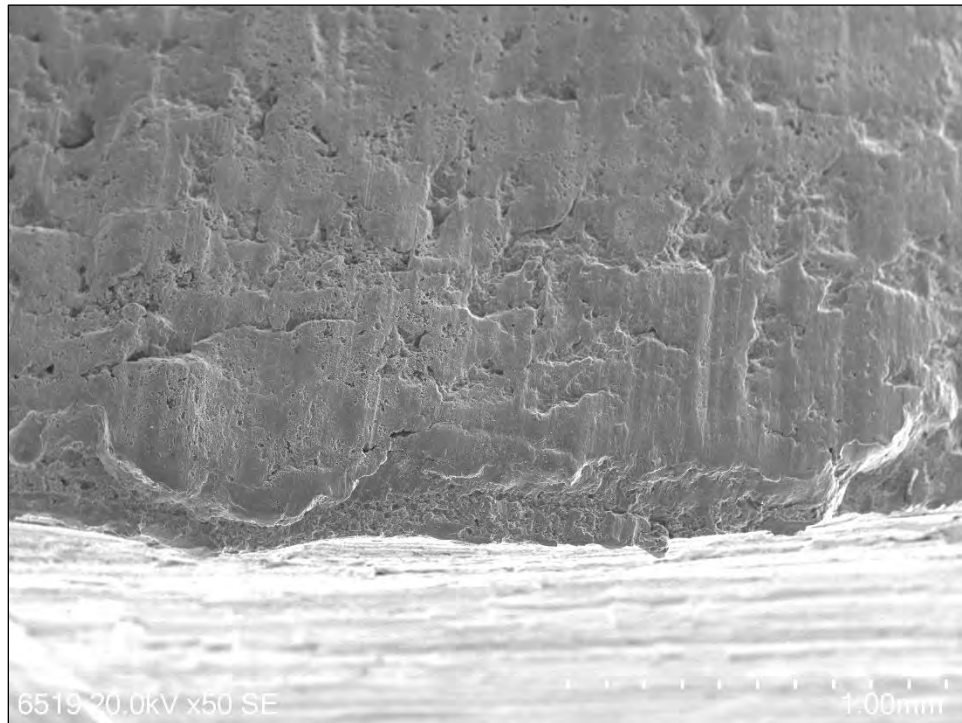
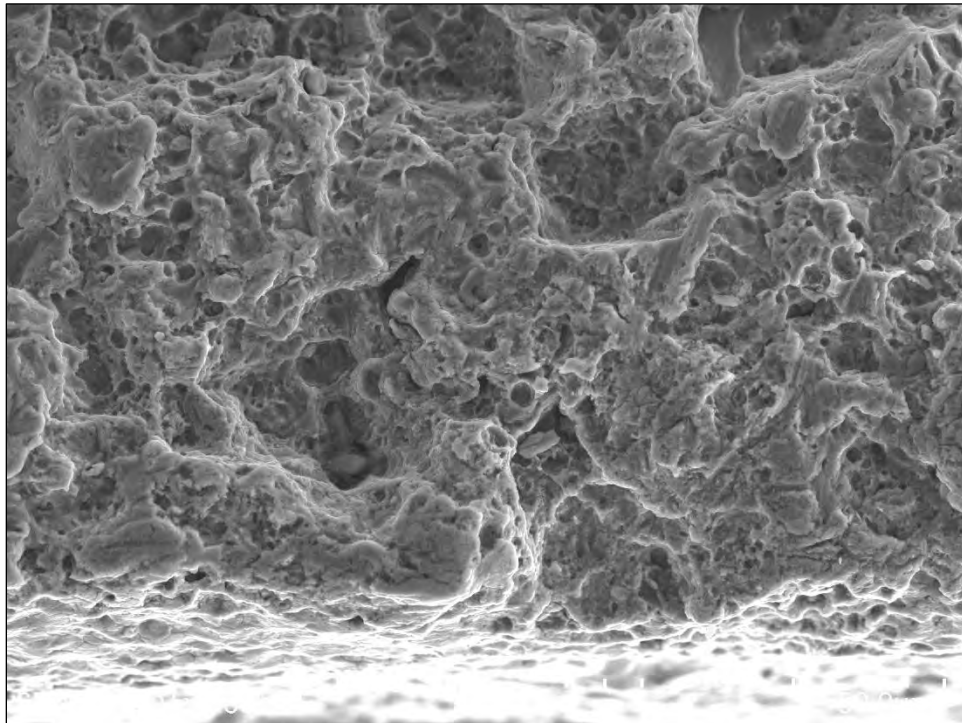
The fracture on the drive side was severely damaged by rubbing against the opposing fracture surface (see **Figure 30a**). A small undamaged area along the edge of the fracture was found to have been severely corroded (see **Figure 30b**). The fracture on the non-drive side also exhibited similar mechanical and corrosion damage, except for less extent of corrosion (see **Figure 31**). The extent of corrosion on the gear fracture indicated that the cracking had occurred long ago.

**Figure 31** SEM images of fracture along edge of non-drive side.
