Incident Summary #II-863230-2018 (#13186) (FINAL)

| | Regulated industry sector | Electrical - Low voltage electrical system (30V to 750V) | |
| Incident overview | A component of a door latching mechanism that secures the door of a motor control center motor starter dislodged when the starter control switch lever was closed. The dislodged component contacted energized components inside the motor starter enclosure creating an electrical incident. | | |

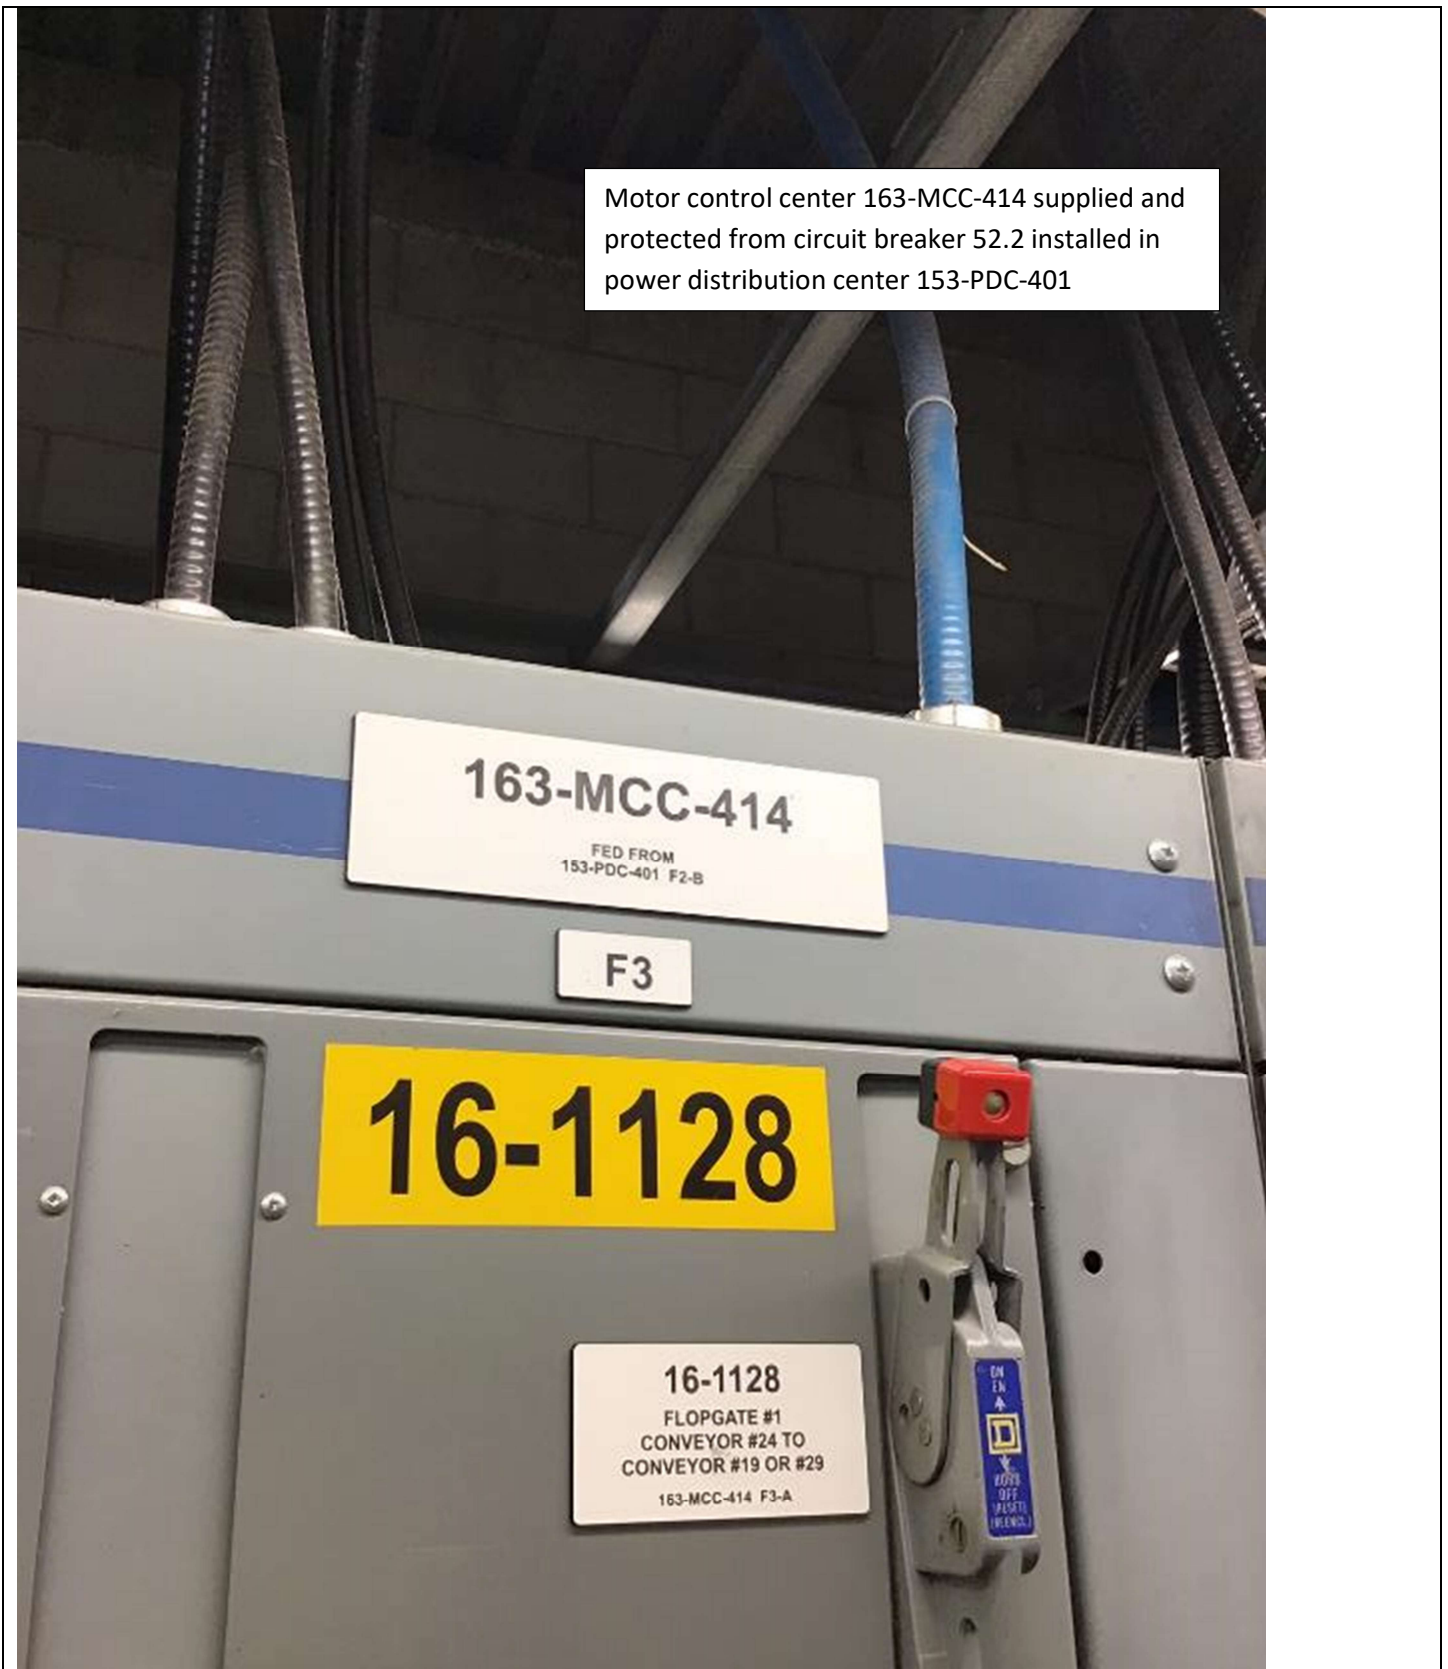
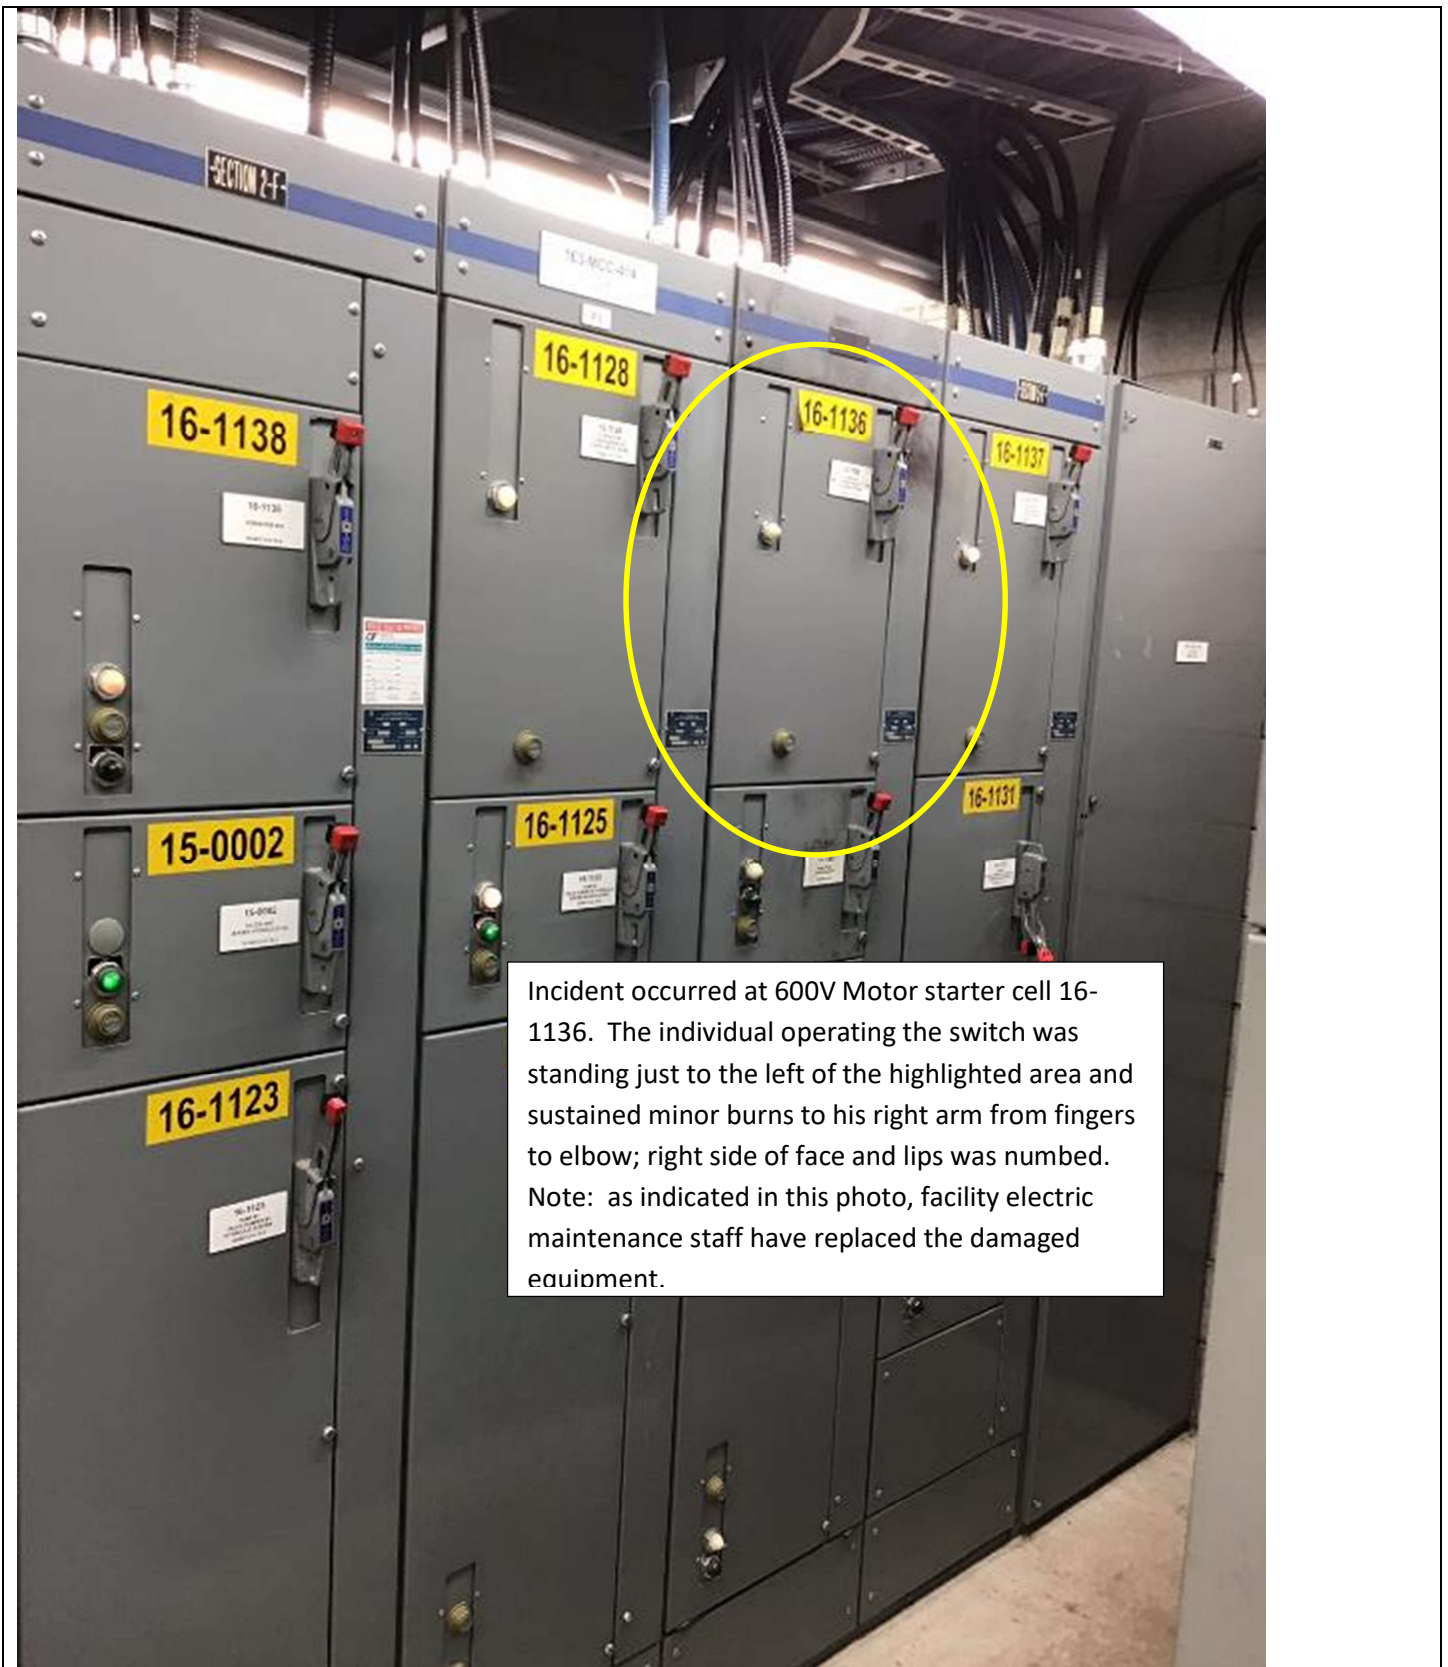
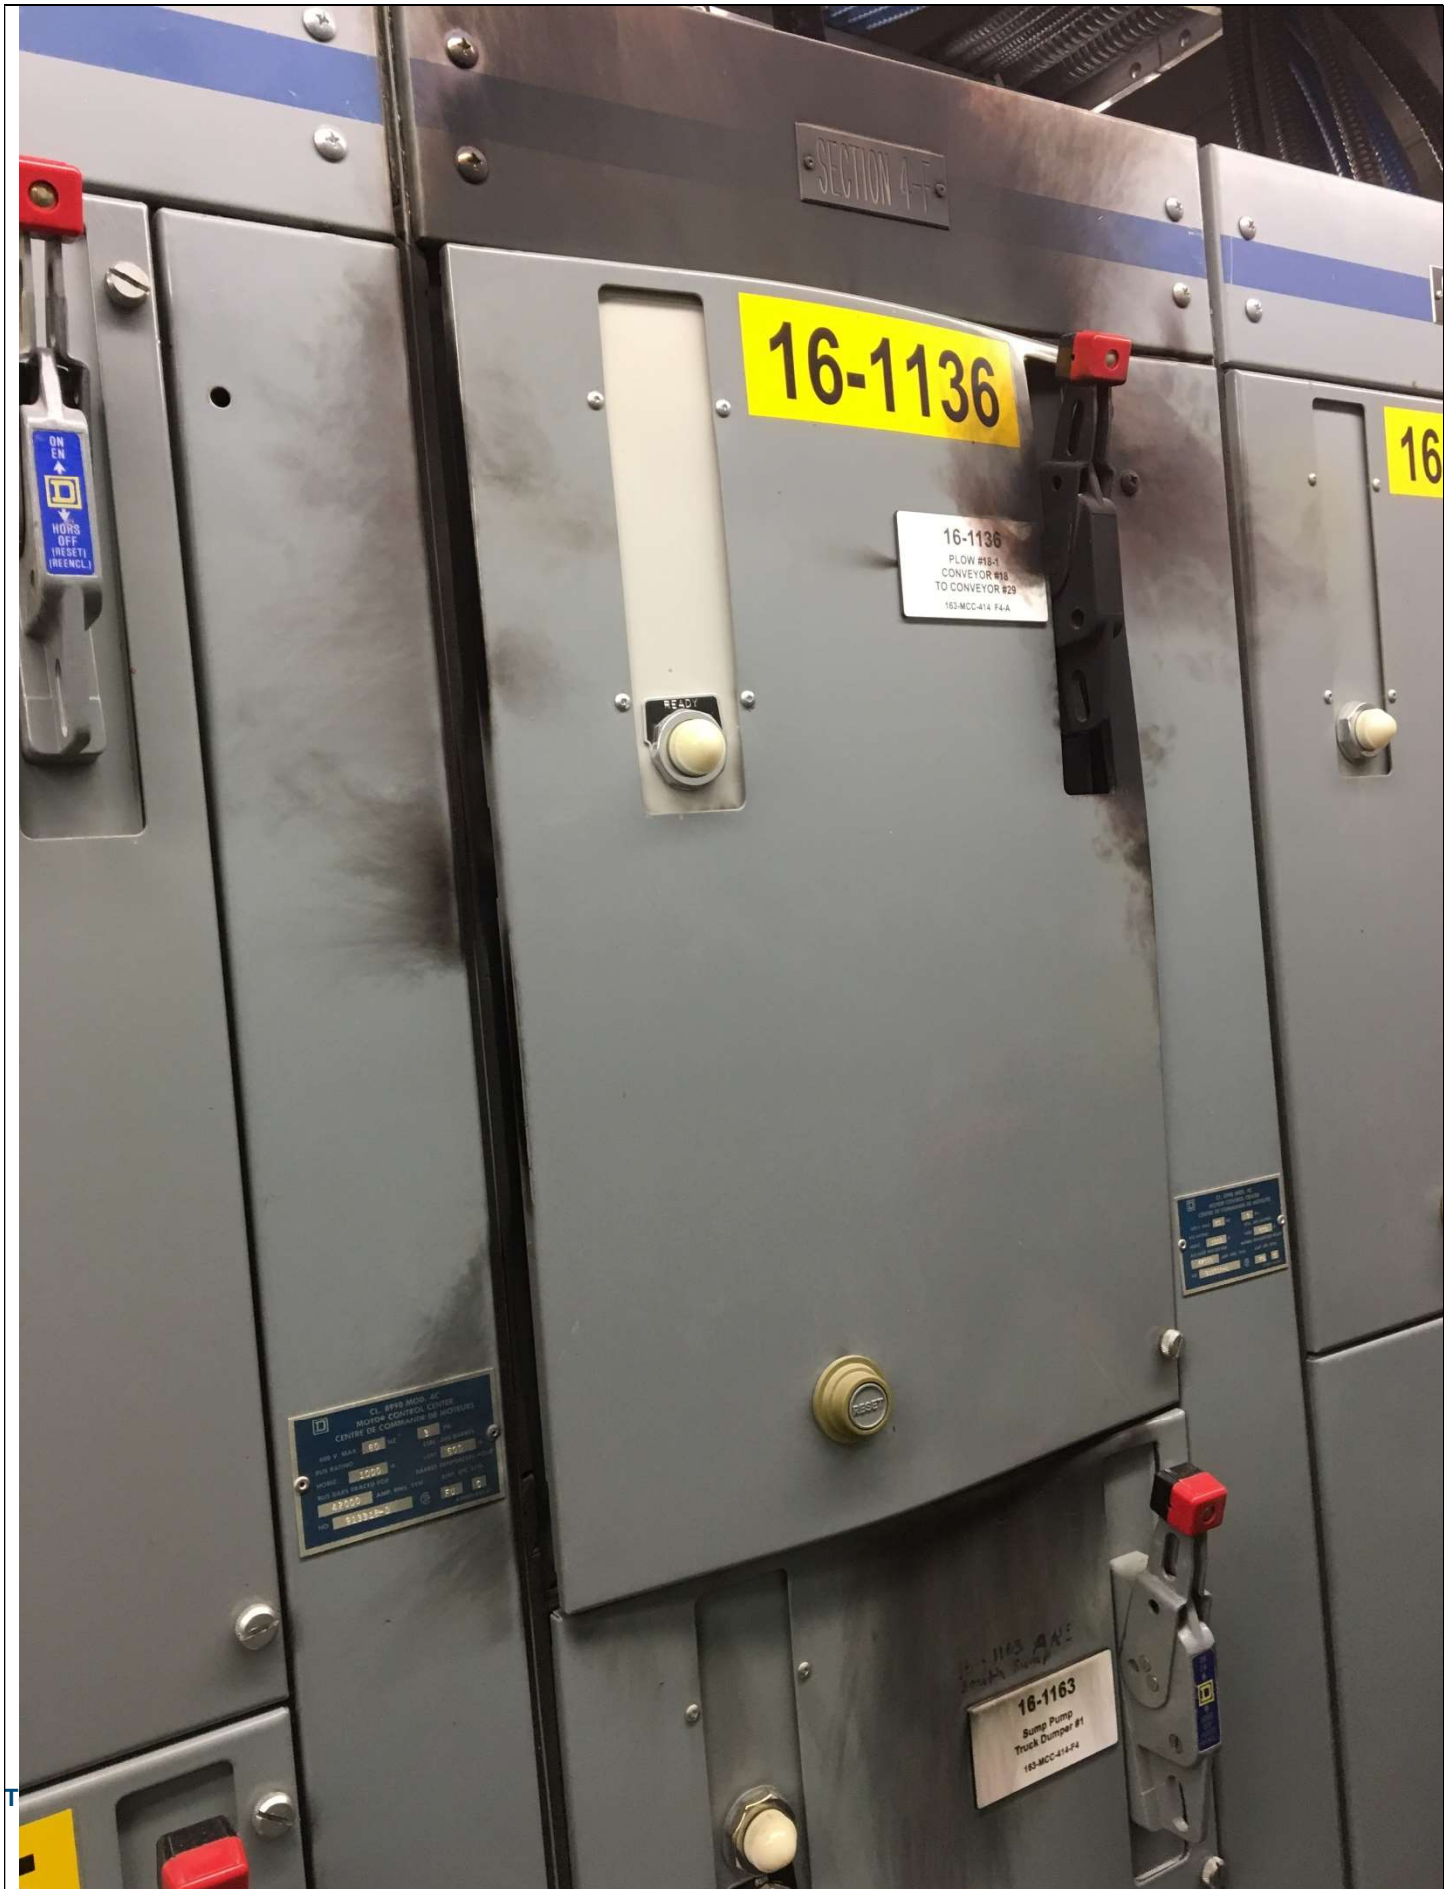
Damaged motor starter 16-1136. Incident occurred in highlighted area. All evidence and indications point toward a failure in the switch mechanism which resulted in an unintentional contact between a component of the switch mechanism and the line side of the fuses. Because the contact occurred on the line side of the fuses, upstream circuit protection initiated at circuit breaker 52.2 in power distribution center 153-PDC-401. The magnitude of damage and fault current levels was limited by the impedance grounding feature of the 600VAC power distribution.

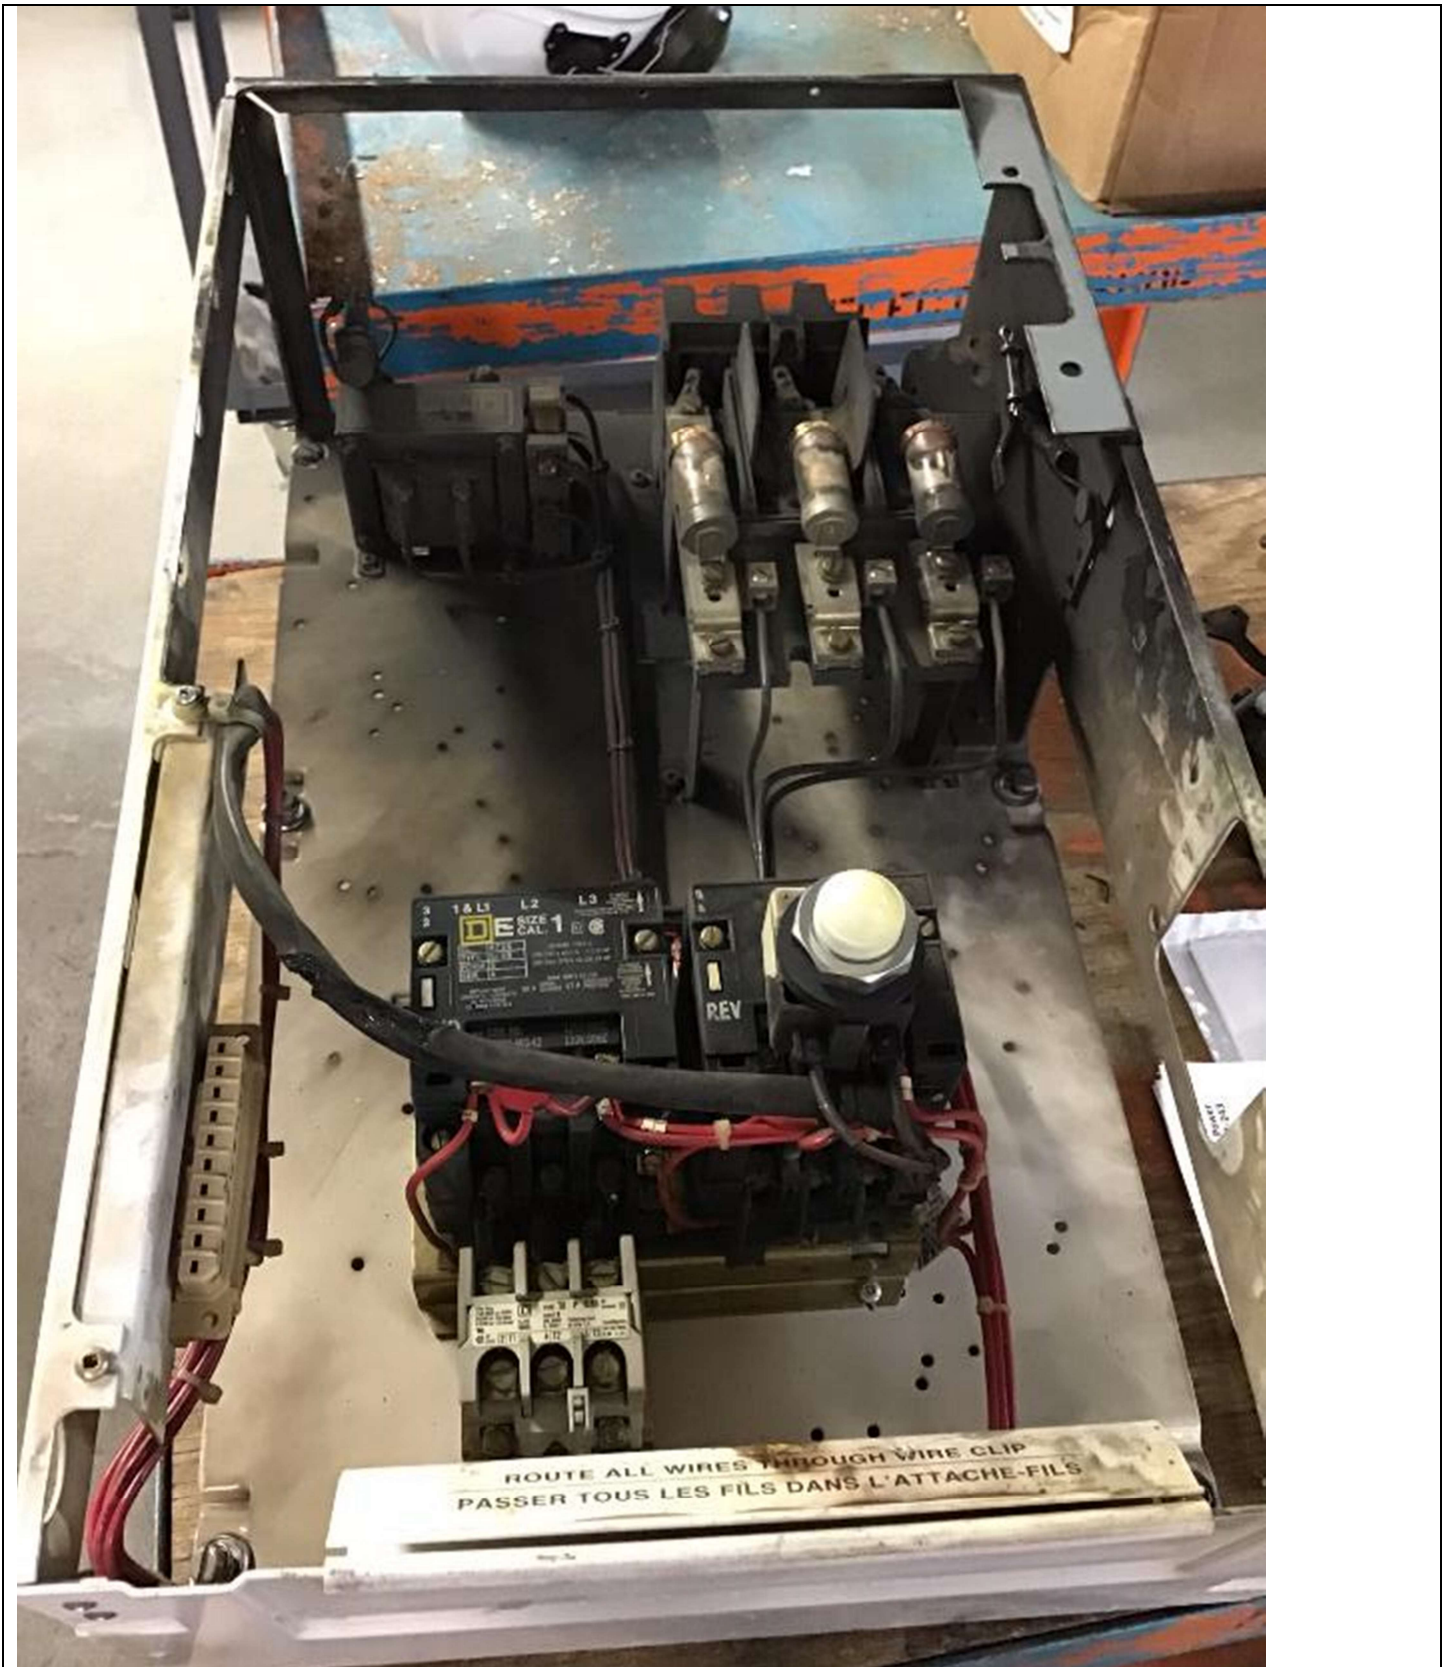
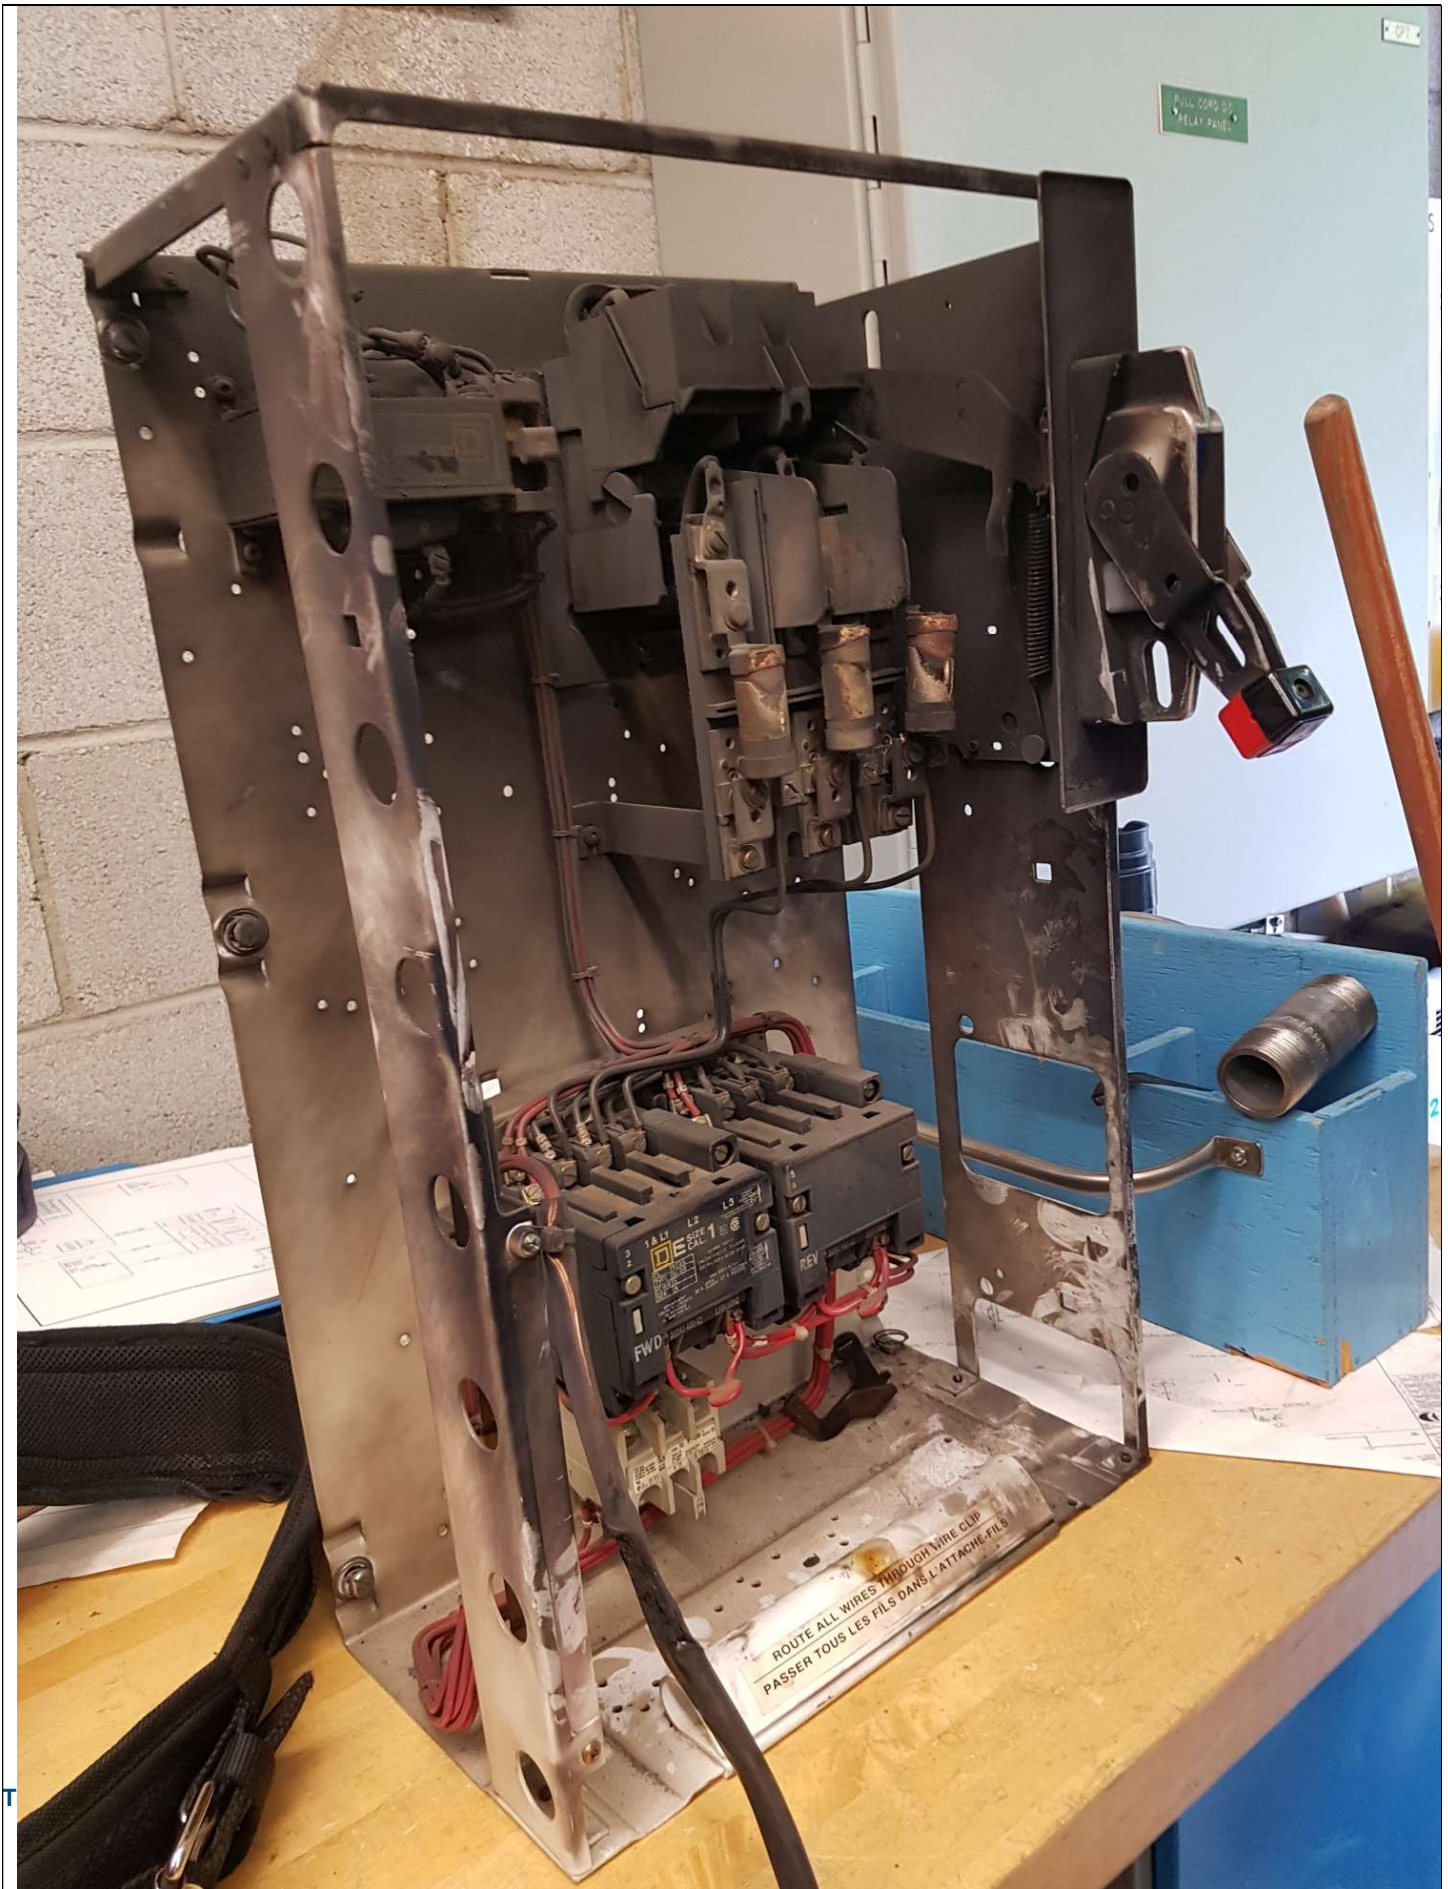
| | Facts and evidence | A retainer pin keeps the door latching interlock secured to the control switch mechanism. Examination of the control switch identified the retainer as missing. The missing retainer permitted the door latch interlock to fall out of the switch mechanism. | |

Dislodged door latching component contacted line side of fuses when switch was closed. The latching arm contacted two fuses creating both phase to phase and phase to ground faults
