## Incident Summary #II-934425-2019 (#15805) (FINAL)

SUPPORTING INFORMATION	Incident Date	October 24, 2019	
	Location	Mara	
	Regulated industry sector	Electrical - Low voltage electrical system (30V to 750V)	
	Impact	Qty injuries	0
		Injury description	N/A
		Injury rating	None
	Damage	Damage description	A fire was found on an exterior wall of a dwelling where a Generator was located with a coolant heater cord plugged in. The fire extended to within the wall space and damaged various electrical and structure
		Damage rating	Minor
	Incident rating	Minor	
	Incident overview	A fire that caused damage to an exterior receptacle where a 1500watt generator coolant heater was plugged into burnt the exterior and interior wall with additional interior wiring for a Hot Tub, exterior Air Conditioning unit and speaker wiring were badly damaged	
INVESTIGATION CONCLUSIONS	Site, system and components	<p>A dwelling had</p> <ul style="list-style-type: none"> <li>A- a 17kw 120/240volt back up Generator installed that had a 1500watt 120volt coolant heater with thermostatic control installed to keep the Generator block warm to allow the Generator to start within a safe operating temperature to provide

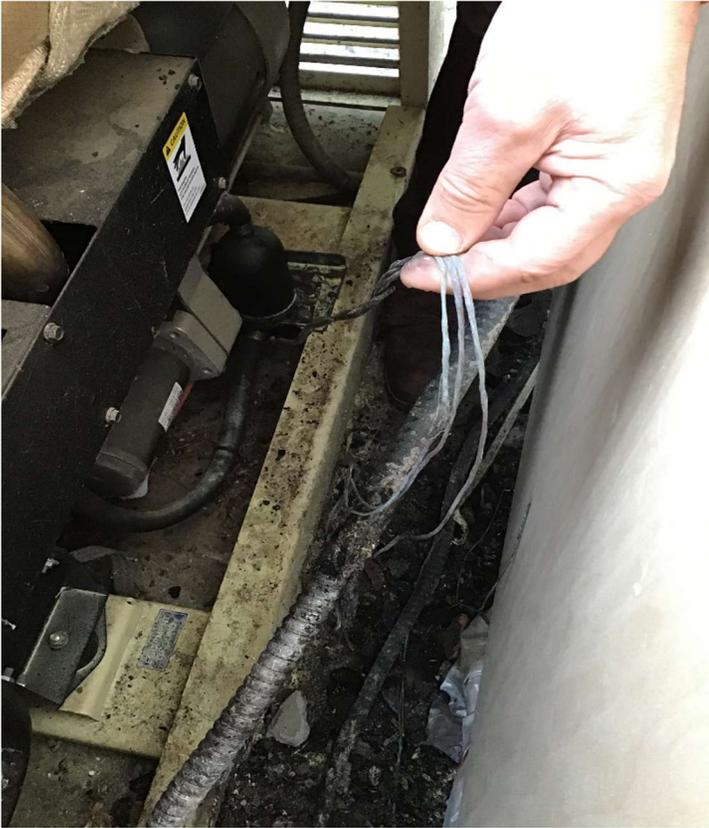
1- EXTERIOR RECEPTACLE (A) initiated by an faulty cord connection to the exterior receptacle. The damage of the receptacle has slight green tinge noted on the conductor and this may have been evidence that the cord connection 24hours/ day created some oxidization from moisture and this could have led to a poor electrical contact on the receptacle and/or (B) the heater 'was' utilizing power and overheated the cord connection or

Generator Coolant heater cord burnt
