## Incident Summary (Posse File#5620261)

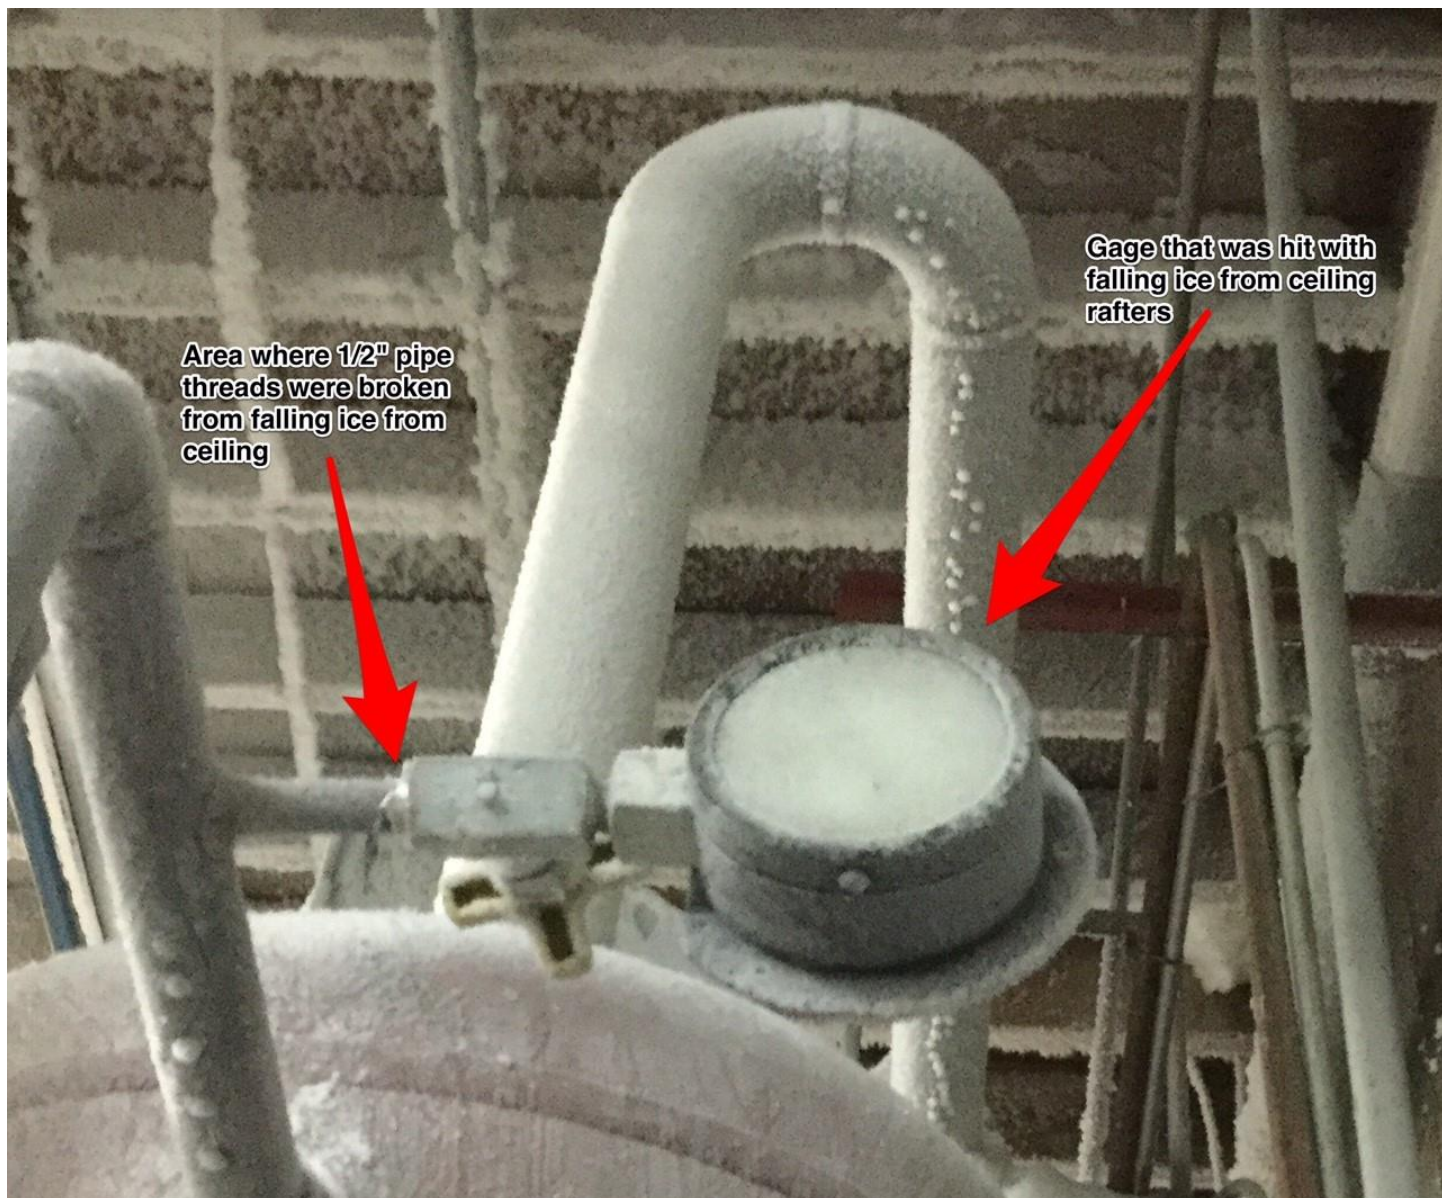
Failure scenario(s)		Exposed wooden ceiling rafters located in the older area of the large scale commercial freezer, developed ice build-up on the surface directly above the pressure gauge that was mounted on the ammonia pressurized vessel. A piece of ice fell from the ceiling and hit the pressure gauge below, breaking its threaded connection causing ammonia to leak out.	
	Facts and evidence		-Ice Build-up on exposed rafters of ceiling in commercial freezer area. -Pressure Gauge directly below the rafters, installed on the pressurized ammonia vessel. -Evidence based on observations during investigation, and witness account from Chief Operating Engineer. -Licensed contractor was onsite at the time and contained the leak immediately, then made the necessary repairs. -Protective barriers were mounted above pressure gage to prevent a future occurrence.	
	Causes and contributing factors		It is Highly probable that the build-up of ice on exposed ceiling rafters was the cause of the ammonia leak from the system. This is based on observations during the investigation, plus witnessed accounts by the Chief Engineer and Licensed Contractor onsite at the time of leakage.

**Exposed wooden ceiling  
rafters where ice was built  
up that fell down onto gage  
below mounted to vessel  
with 1/2" threads.**
