Incident Summary #II-1200345-2021 (#22189) (FINAL)

SUPPORTING INFORMATION	Incident Date	November 19, 2019
	Location	Port Coquitlam
	Regulated industry sector	Electrical - Low voltage electrical system (30V to 750V)
	Impact	Qty injuries
		0
		Injury description
		None
		Injury rating
		None
INVESTIGATION CONCLUSIONS	Damage	Damage description
		Fire damage to the communications wiring, cable box and the wooden siding and ceiling in the carport area. Melting damage to the overhead cable TV and 120/240 Volt service conductors.
		Damage rating
		Moderate
		Incident rating
		Moderate
	Incident overview	
	An open service neutral condition related to a melted overhead conductor on a 120/240 Volt service resulted in a home's communication boxes, cables and the surrounding walls and ceilings being burnt due to a fire in the carport.	
INVESTIGATION CONCLUSIONS	Site, system and components	Overhead services:
		<ul style="list-style-type: none"> Overhead power and communications services for residential homes run from the utility pole systems, at height through the open air, to the house. The power service provides electricity from the pole mount power transformers to the home's main electrical

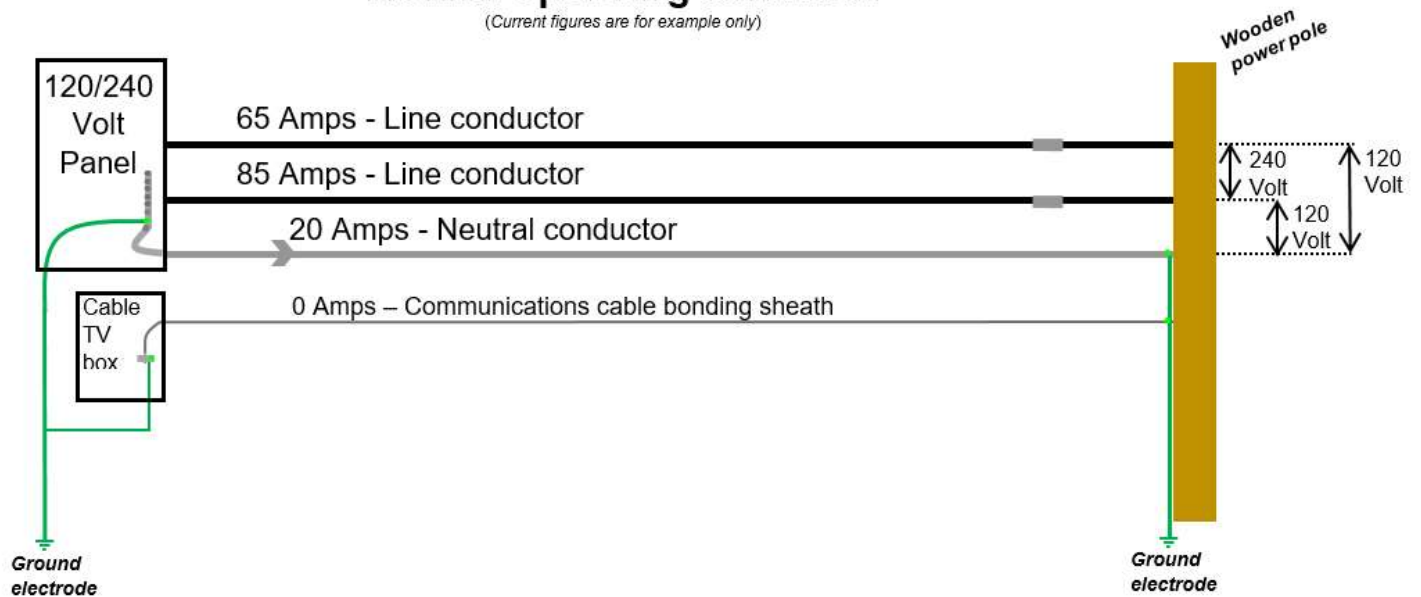
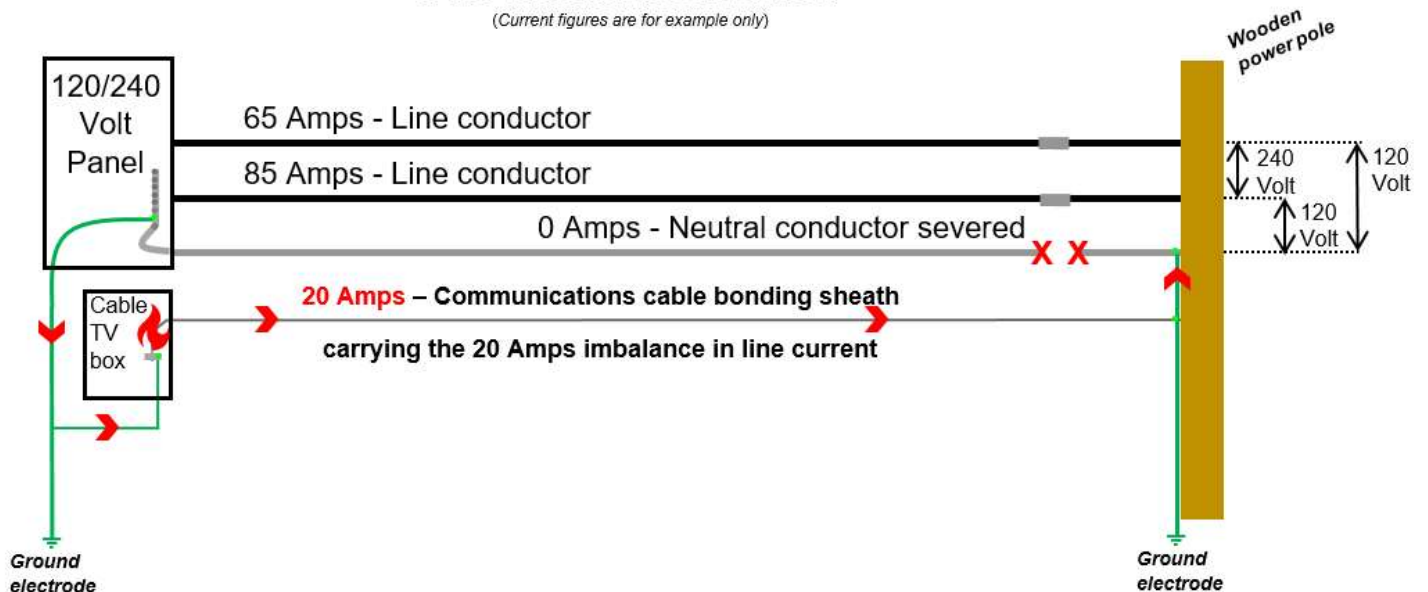
Lack of separation between the neutral and the service line conductor compression connectors was likely the cause of the incident.

Diagram 1a, 1b - Normal operating condition vs. fire incident condition.
