Incident Summary #II-1612461-2023 (#39700) (FINAL)

SUPPORTING INFORMATION	Incident Date	September 29, 2023	
	Location	Vancouver	
	Regulated industry sector	Elevating devices - Escalator or moving walkway	
	Impact	Qty injuries	3
		Injury description	Three people were reported injured due to the escalator overspeed runaway and several more piled up at the bottom of the escalator during the runaways.
		Injury rating	Minor
	Damage	Damage description	Physical damage to the inside of the escalator gearbox.
		Damage rating	Moderate
Incident rating	Moderate		
Incident overview	A 3-year-old, down-traveling escalator at a public transit SkyTrain station, suffered a mechanical failure that rendered the safety and braking systems ineffective and caused multiple uncontrolled descents of the loaded escalator steps at high-speed causing riders to fall and pile up at the bottom resulting in multiple injuries.		
INVESTIGATION CONCLUSIONS	Site, system and components	<p>The transit location has a bank of three escalators installed next to each other used for conveying passengers to and from the transit platform situated approximately 25m (82') underground. The escalators were originally installed at

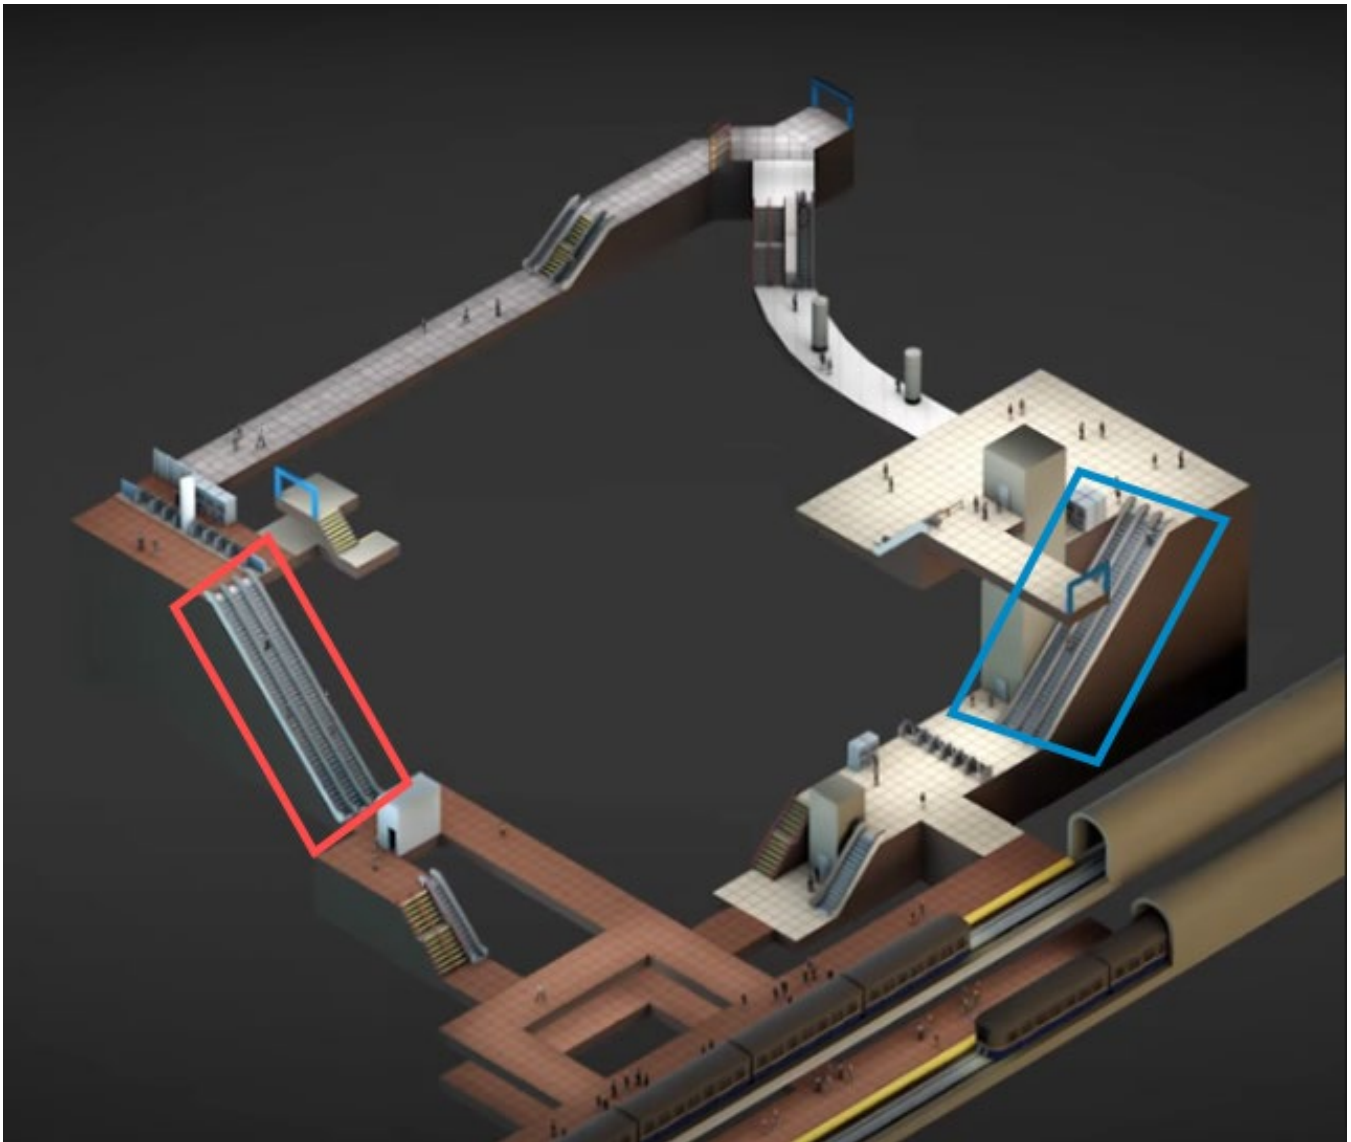
Image 1 – Escalator locations at transit station. [RED] Location of escalator involved in incident. [BLUE] location of alternative access to transit platform from above.

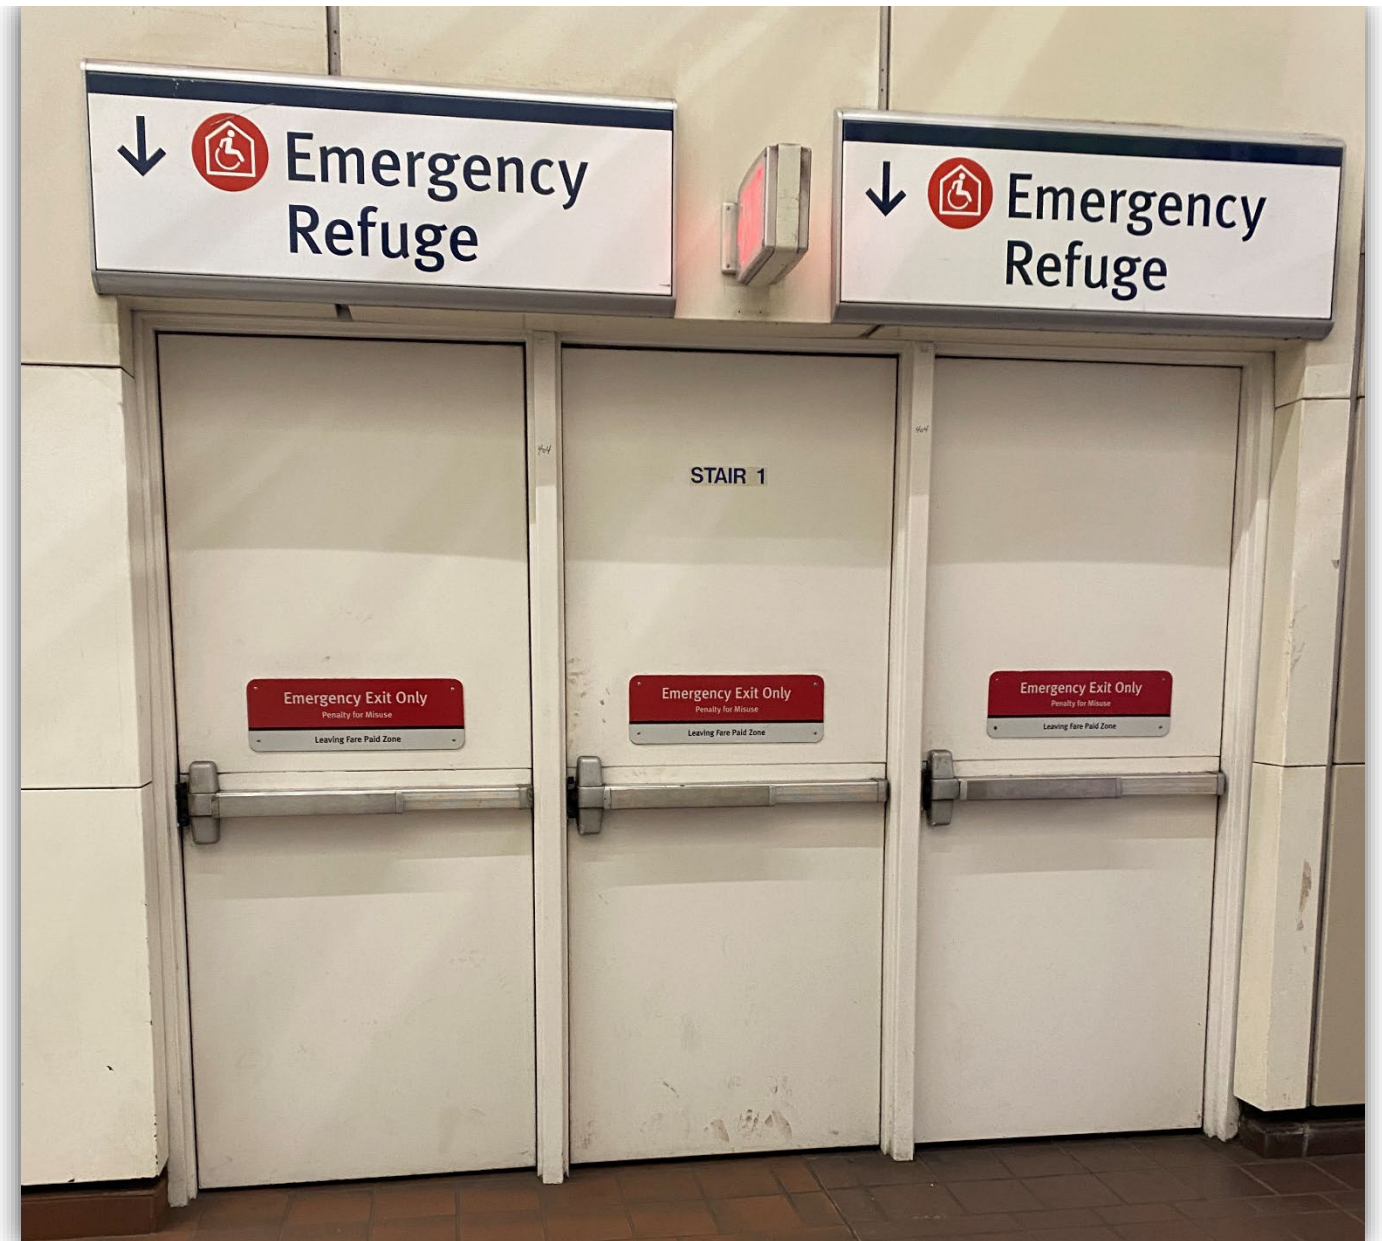
Image 16 - Staircases from transit platform for emergency exit use only.
