## Incident Summary (Reference # 4824) (Final)

SUPPORTING INFORMATION	Incident Date	January 10, 2018	
	Location	North Eastern BC	
	Regulated industry sector	Boilers, PV & Refrigeration	
	Impact	Qty injuries	None
		Injury description	None
		Injury rating	None
	Damage	Damage description	Fire ignited the external wall adjacent to boiler 1 and made its way through to the building exterior. Boiler #1 was extensively damaged in the fire. The fire also damaged the mechanical room ceiling and walls. Please see photos enclosed.
		Damage rating	Major
Incident rating	Major		
Incident overview	Flames ignited in the basement boiler room of an eleven unit residential apartment building.		
INVESTIGATION CONCLUSIONS	Site, system and components	<p>This boiler was located in the basement mechanical room in an eleven unit apartment building.</p> <p>The boiler combustion chamber is to hold the heat and flame of combustion inside the boiler.</p> <p>This wall mounted boiler heats a glycol mixture by the combustion chamber. The heated glycol circulates throughout the building via a piping system to bring heat to each apartment residence.</p> <p>In the event of that glycol stops circulating the flow swit

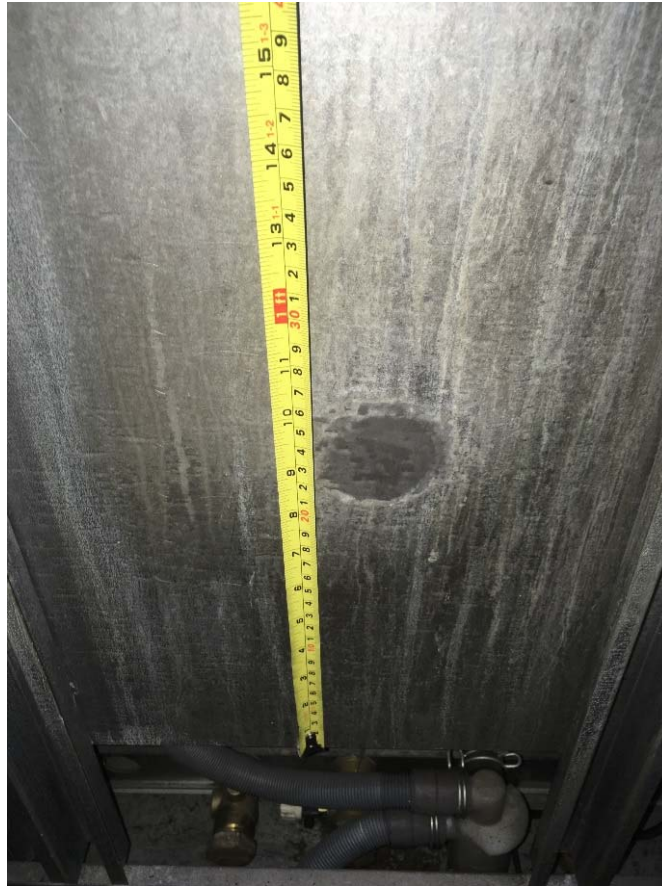
Rear of boiler #2 - area of interest in same approximate location as boiler #1  
(boiler #2 removed from wall by contractor)
