## Incident Report #II-935221-2019 (#15840) (FINAL)

Appendix B: Chiller Failure – Root Cause Analysis

**PORT ALBERNI SPORTSPLEX CHILLER  
FAILURE – ROOT CAUSE ANALYSIS**

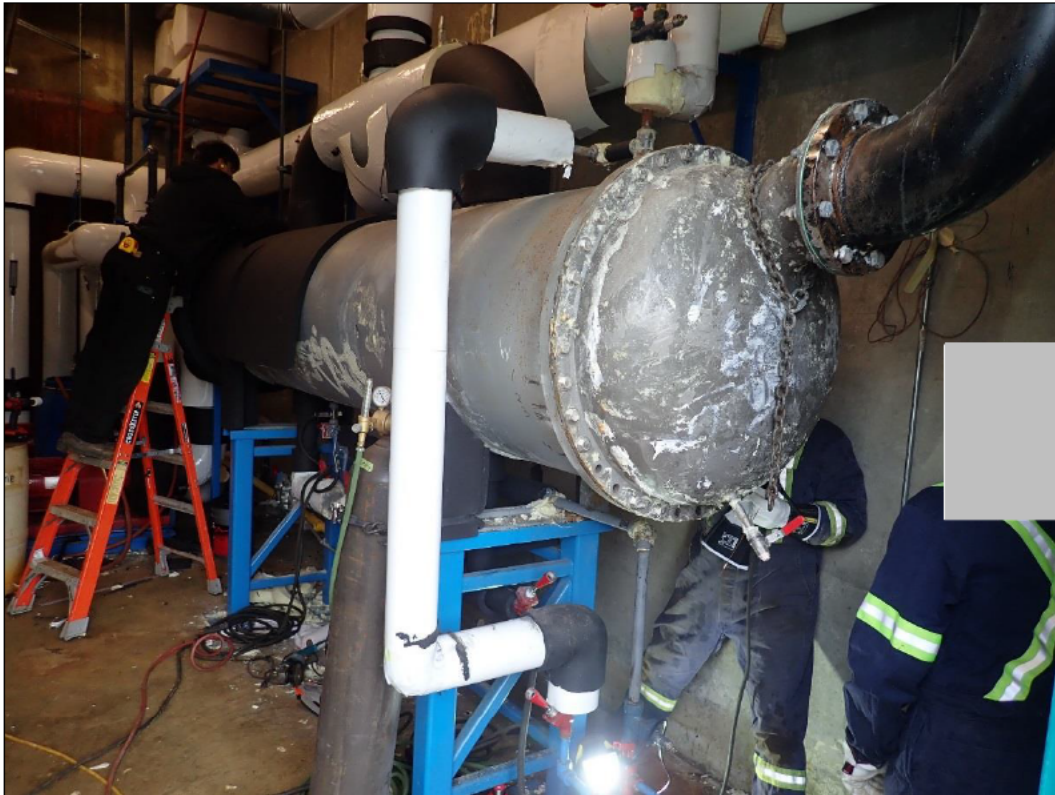
[REDACTED] P.Eng. travelled to the Port Alberni site on 9 November 2019. The chiller had been stripped of its insulation and checked for defects at 100% of the weld locations. Both MT and UT were used for the inspection. An overall view of the stripped chiller is shown in Figures 1 and 2. A total of 10 new cracks were found on the lower half of the chiller end (see NDT reports; Appendix B). All of these

**Figure A-1** Overall view of stripped chiller. Heads are titanium alloy.

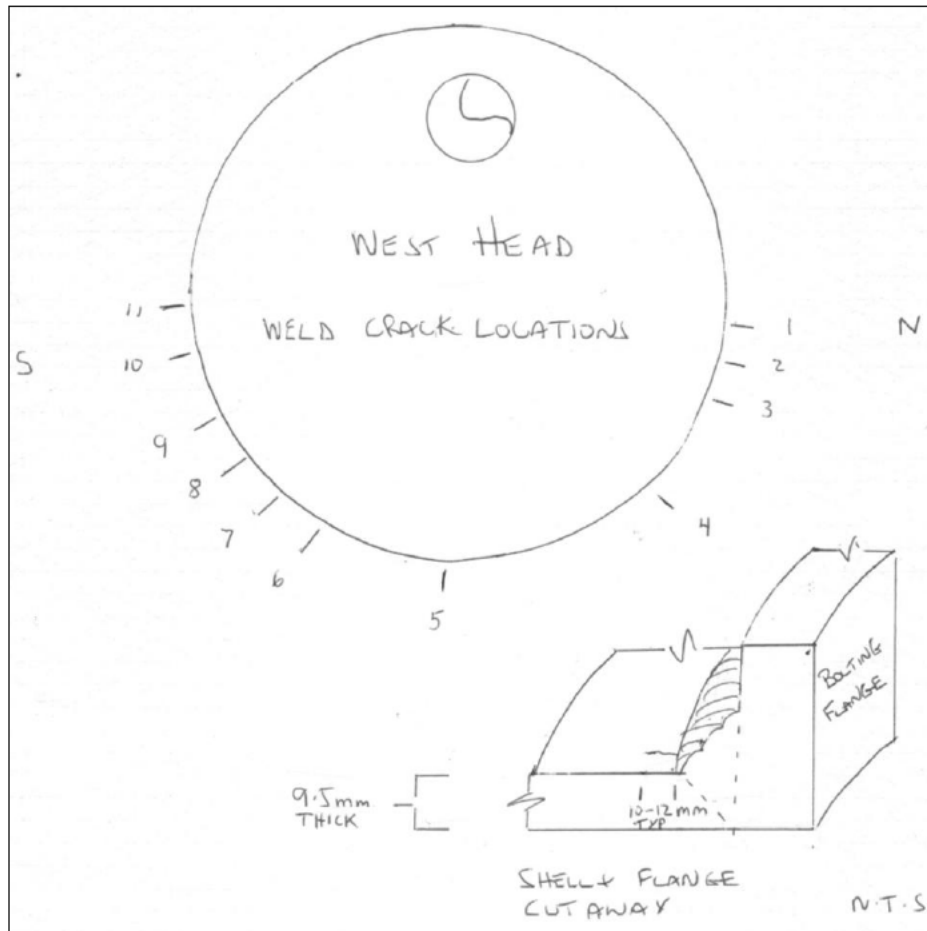
*Photo 1:*

The west head revealed 9 additional subsurface transverse crack indications running perpendicular to the circumferential groove weld.

All crack locations were identified on the vessel shell. All cracks ran into the shell plate out below the toe of the fillet weld for a distance of 8mm -12mm.

Vessel overview.

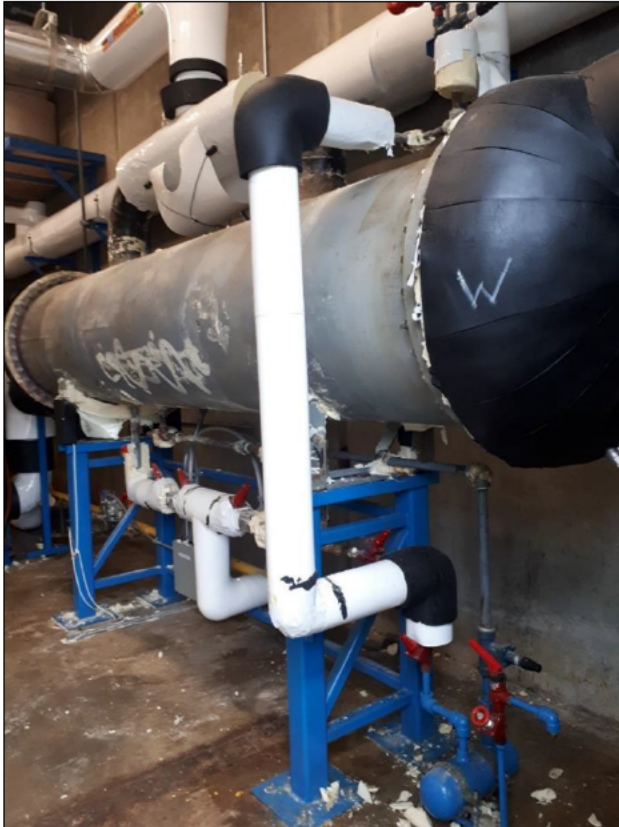
*Photo B-1:*  
Brine Chiller overview.

With the exception of location #10 which required additional grinding to remove the original indication all other cracks had been removed on the first attempt with LPI.

All TIG root passes have been inspected and found acceptable with MPI.

All stick filler passes and the final fillet weld have been inspected with MPI and found acceptable.

A post 24-hour inspection of all repair welds was also carried out with acceptable results.

In addition the writer witnessed all pressure tests post 24-hr weld repair. All results were found acceptable and were recorded on the Geo Tech traveller.
