Incident Summary (II-773843-2018) (Incident ID: 9705)

RESIDENTIAL HOUSE STRUCTURE FIRE

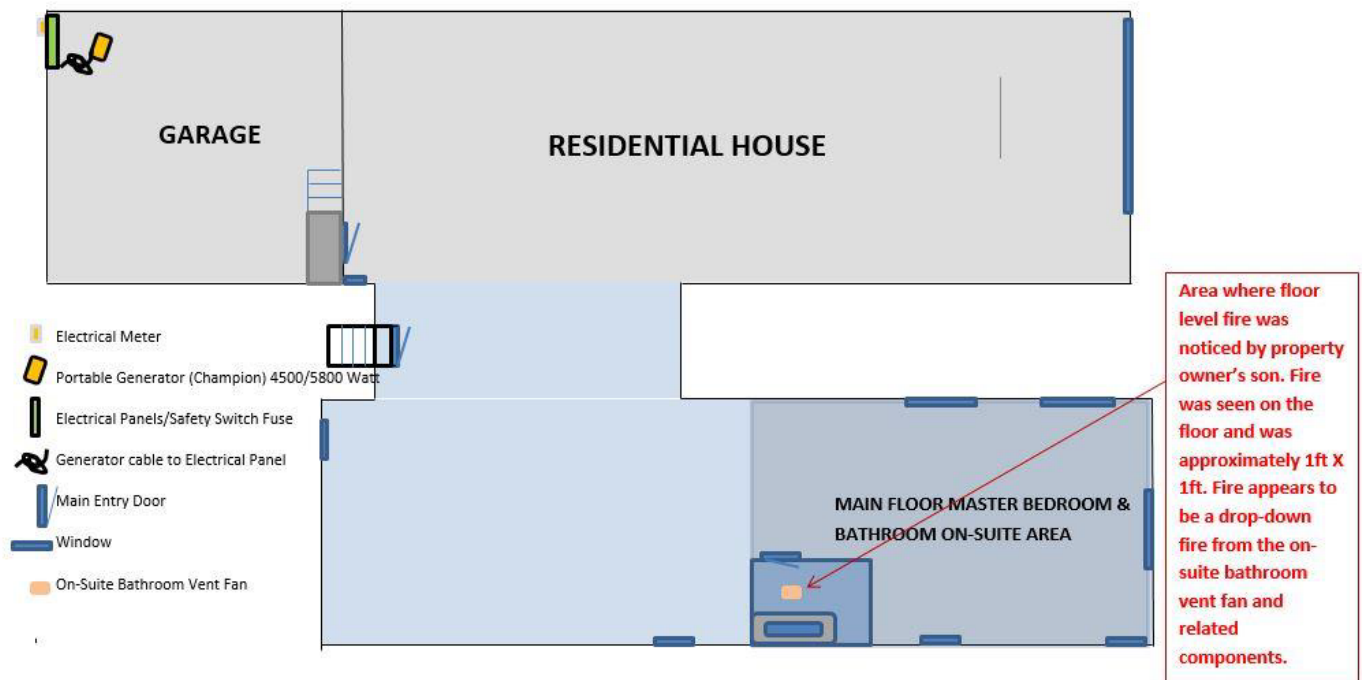
Page A5

Figure 1 –Layout of residential dwelling where incident took place. Sketch provided by local fire department fire prevention officer.
