Incident Summary #II-1464040-2022 (#30333) (FINAL)

SUPPORTING INFORMATION	Incident Date	November 5, 2022	
	Location	Chilliwack	
	Regulated industry sector	Electrical - Low voltage electrical system (30V to 750V)	
	Impact	Qty injuries	0
		Injury description	N/A
		Injury rating	None
	Damage	Damage description	Damage to the electrical service equipment, and damage to an exterior wall of a detached shop.
		Damage rating	Moderate
	Incident rating	Moderate	
Incident overview	A manual transfer switch for a generator failed resulting in a small fire in a detached shop that destroyed the transfer switch, and a 200-amp 120/240-volt panel. The fire also damaged the exterior wall that the transfer switch and panel were mounted to.		
INVESTIGATION CONCLUSIONS	Site, system and components	<p>The site consists of an overhead 200-amp 120/240-volt single phase utility service to a detached shop on a rural farm property. From the utility meter on the exterior of the shop, the service conductors enter into a 200-amp 120/240 fused service switch on the building interior, then into a 200-amp 120/240-volt rated generator manual transfer switch, and then into a 200-amp 120/240-volt electrical panel (Imag

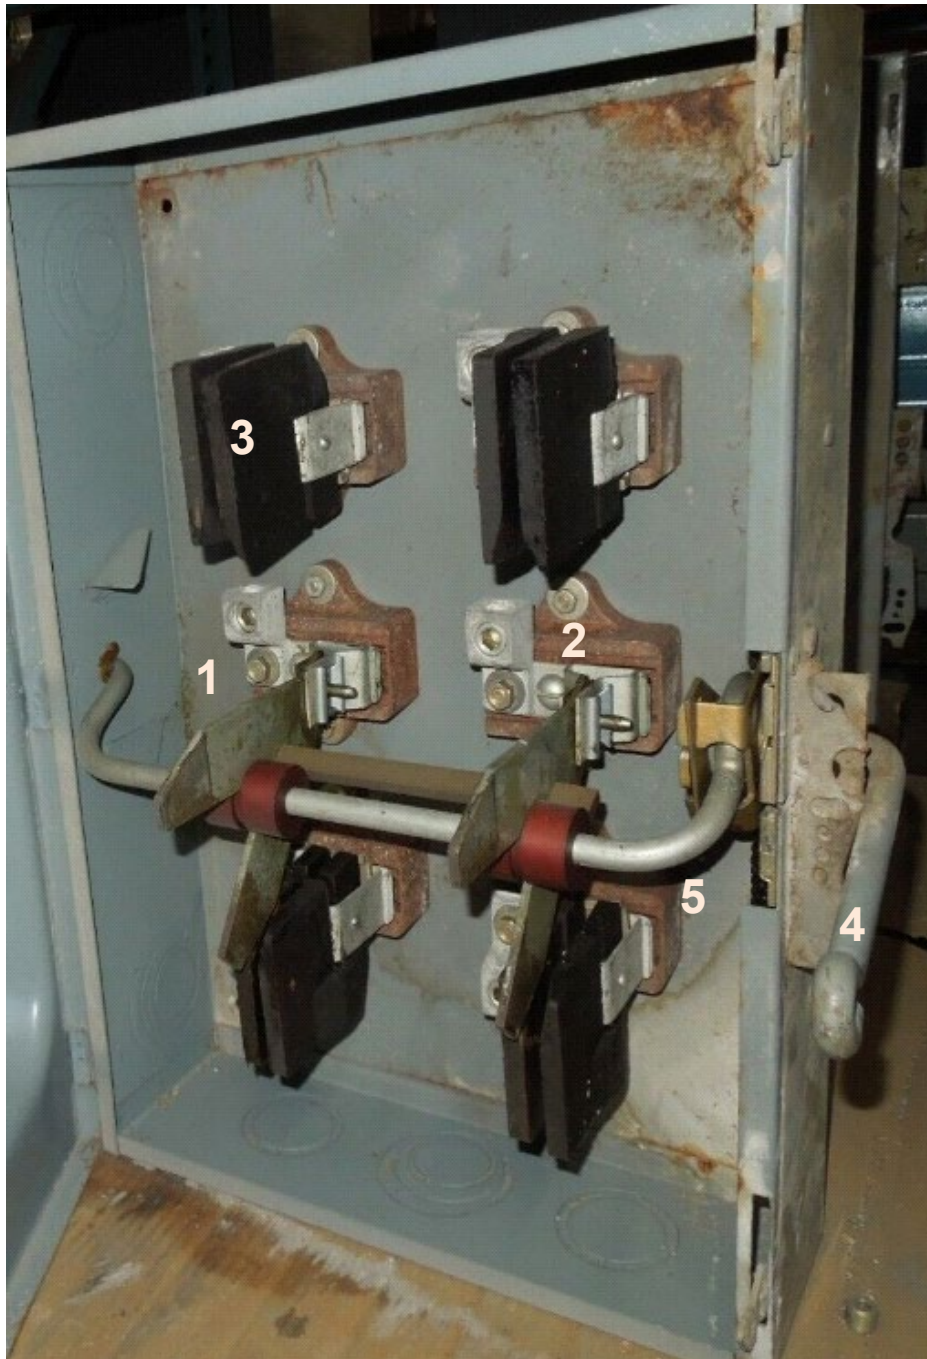
Image 3 – Similar style manual transfer switch.

1. Knife blades.
2. Knife blade pivot point.
3. Insulator with the jaws in between.
4. Handle on outside of switch to change the knife blades between top and bottom positions.
5. Metal bar that is connected to handle on the outside of switch to move knife blades up and down.
