Incident Summary (II-624782-2017)

SUPPORTING INFORMATION	Incident Date	<i>November 28, 2017</i>	
	Location	<i>Port Moody</i>	
	Regulated industry sector	<i>Refrigeration system</i>	
	Impact	Qty injuries	<i>0</i>
		Injury description	<i>None</i>
		Injury rating	<i>None</i>
	Damage	Damage description	<i>An electric solenoid valve developed a leak on the flange gaskets.</i>
		Damage rating	<i>Insignificant</i>
Incident rating	<i>Insignificant</i>		
Incident overview	<i>The electric solenoid valve / strainer utilizes sealing gaskets between the valve and strainer and the pipe connections. The sealing gaskets developed a leak allowing ammonia gas to leak in to the compressor room. The compressor room ammonia leak detection activated the low level alarm at 25ppm. The leak was traced to the solenoid valve on one of the compressors that was online at the time. The refrigeration plant Chief Engineer and the maintenance contractor were able to shut down the compressor and isolate the leaking solenoid valve.</i>

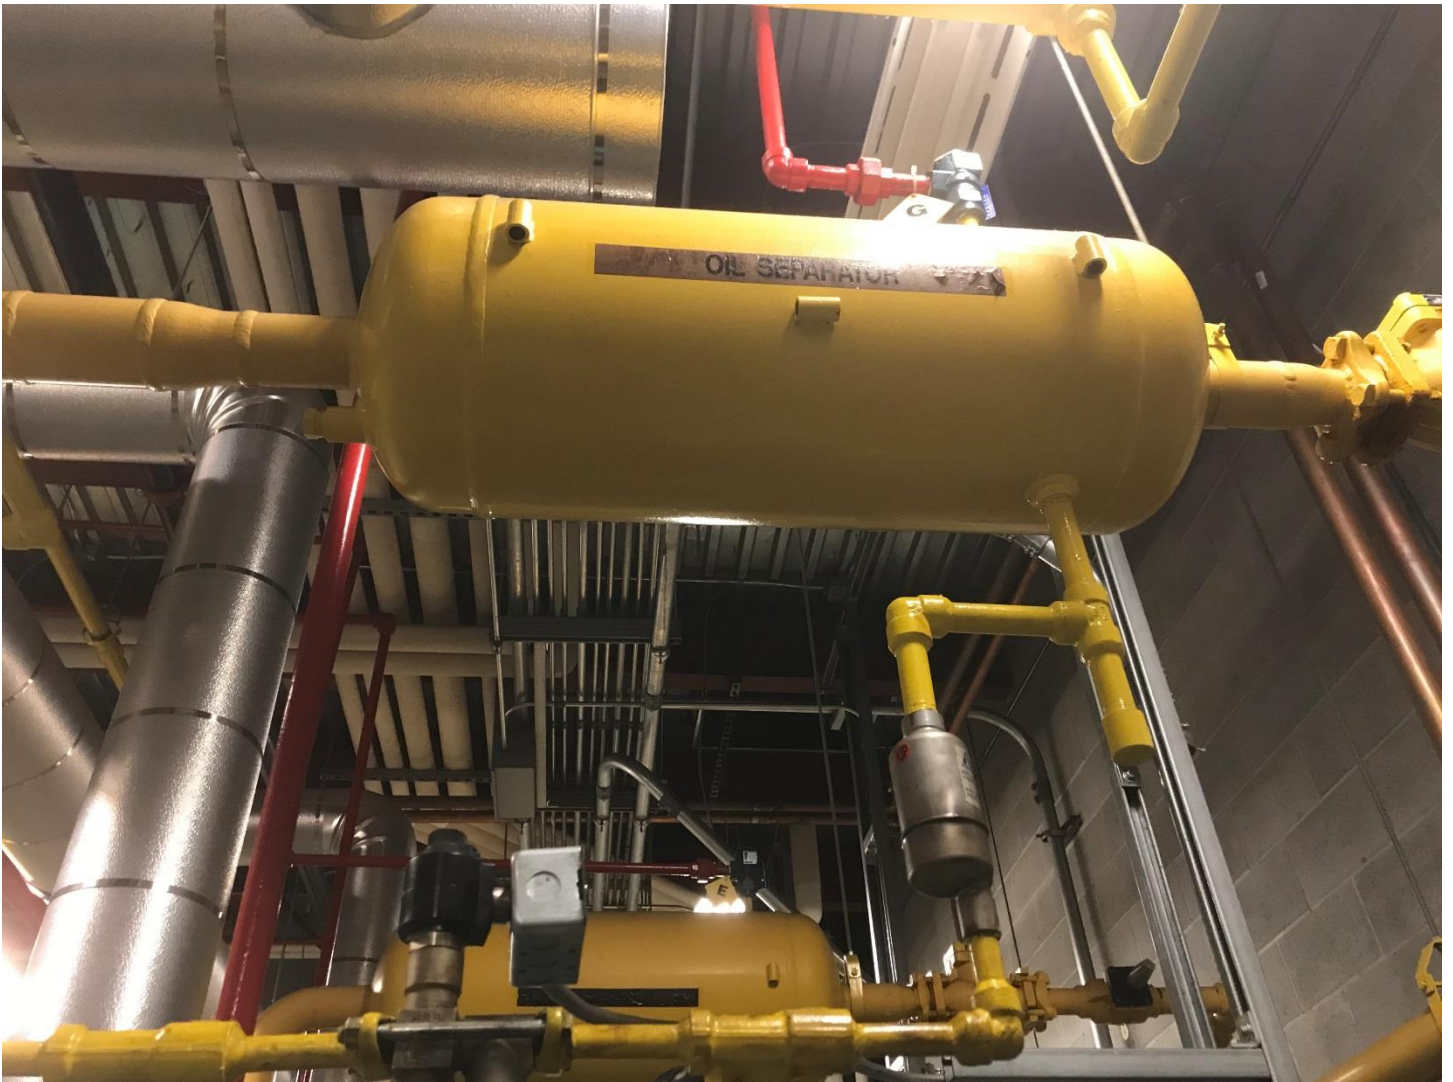
1 Solenoid Valve / Strainer

<p>of ammonia in to the compressor. The concentration of ammonia reached a point of 69ppm during the leak investigation and compressor valve isolation period.</p> <p>-Gaskets Dry and brittle</p>
Causes and contributing factors	<ul style="list-style-type: none">- It is likely with the solenoid valve being subjected to a certain amount of vibration from the refrigeration compressor over time this impacts the sealing capability of the gaskets due to the flange bolts loosening.- The gaskets were dry and brittle and this impacts the sealing capability.
