INVESTIGATION REPORT

AMMONIA RELEASE — FERNIE MEMORIAL ARENA

DATE OF INCIDENT: OCTOBER 17, 2017

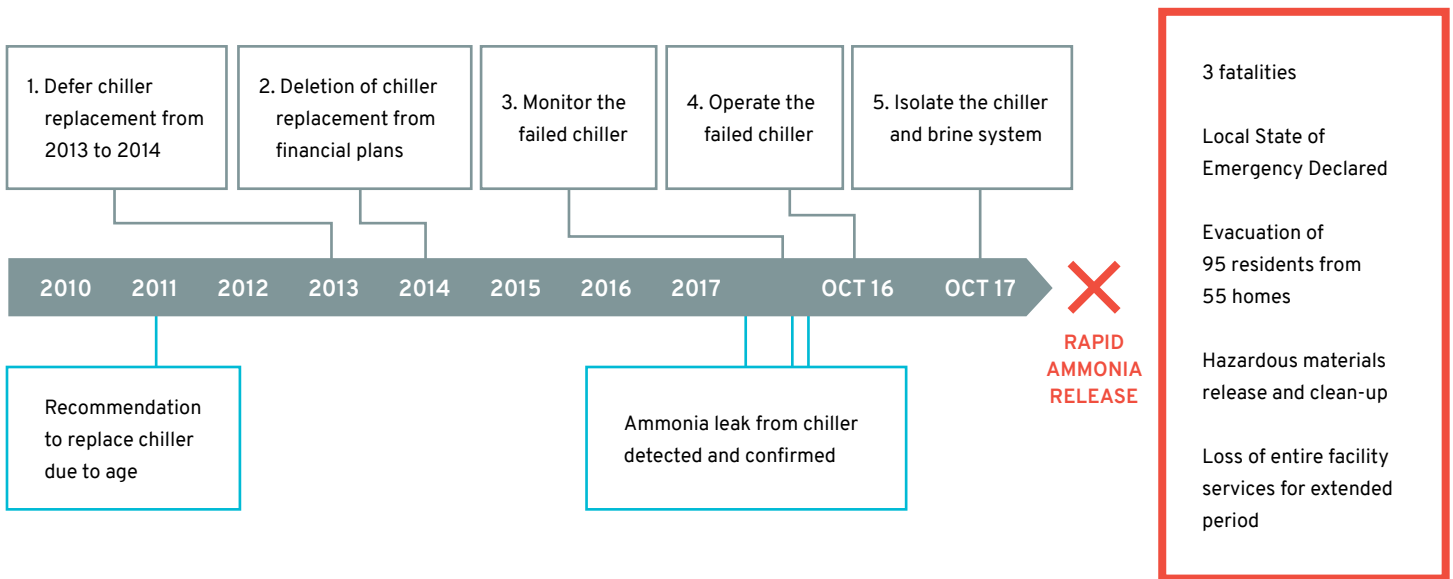
Figure 7: Timeline of key decisions that contributed to the eventual rapid release of ammonia into the mechanical room on October 17, 2017.

The decision to isolate the curling chiller and brine system is directly connected to the system configuration and equipment failure, as described in the previous section of this report. This decision was made in response to a situation that resulted from preceding decision outcomes affecting the refrigeration system and curling chiller. These decisions contributed to the situation that developed on October 17, 2017, where a leaking chiller and system configuration resulted in a rapid ammonia release.

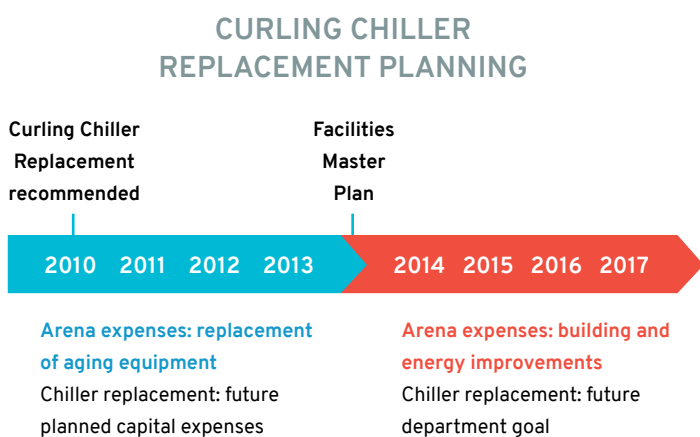
A financial planning and spending analysis (Appendix M) shows that prior to the introduction of the Facilities Master Plan, capital planning and spending for the arena focused on replacement of aging refrigeration system components and larger maintenance costs as recommended by the refrigeration maintenance contractors. In 2014 and years following the Facilities Master Plan, planning and spending on the arena changed to general building upgrades as recommended by the Facilities Master Plan, as well as energy efficiency improvements.

It is possible that the recommendations of the Facilities Master Plan influenced a change in capital spending priorities on the arena, with an increased focus on building and energy improvements.

Figure 8: Fernie Memorial Arena expense type and curling chiller planning following the recommendation in 2010.

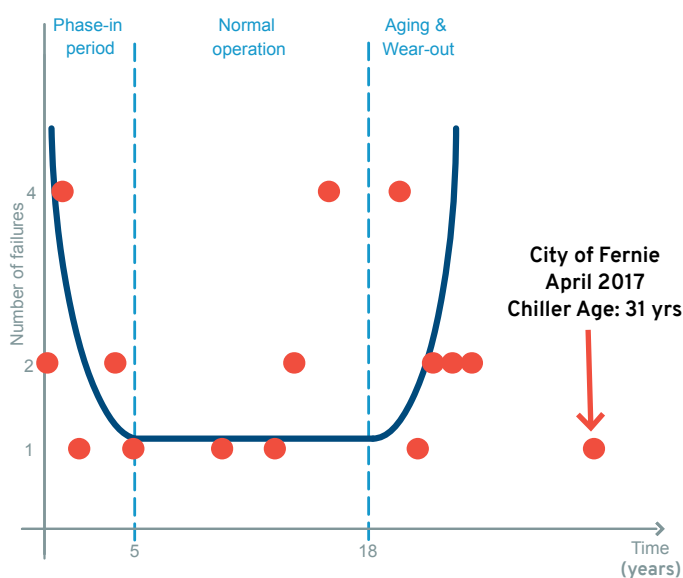
This data indicates that the risk of an arena brine system chiller failure due to wear-out begins to increase after 18 years of service. This timeframe supports the replacement recommendation made by the refrigeration contractor based on an average lifespan of 20-25 years as a reasonable estimate of the mean-time-to-failure for a chiller in this type of service.

Figure 9: "Bathtub" curve showing arena brine system chiller failures detected via ammonia in the brine.

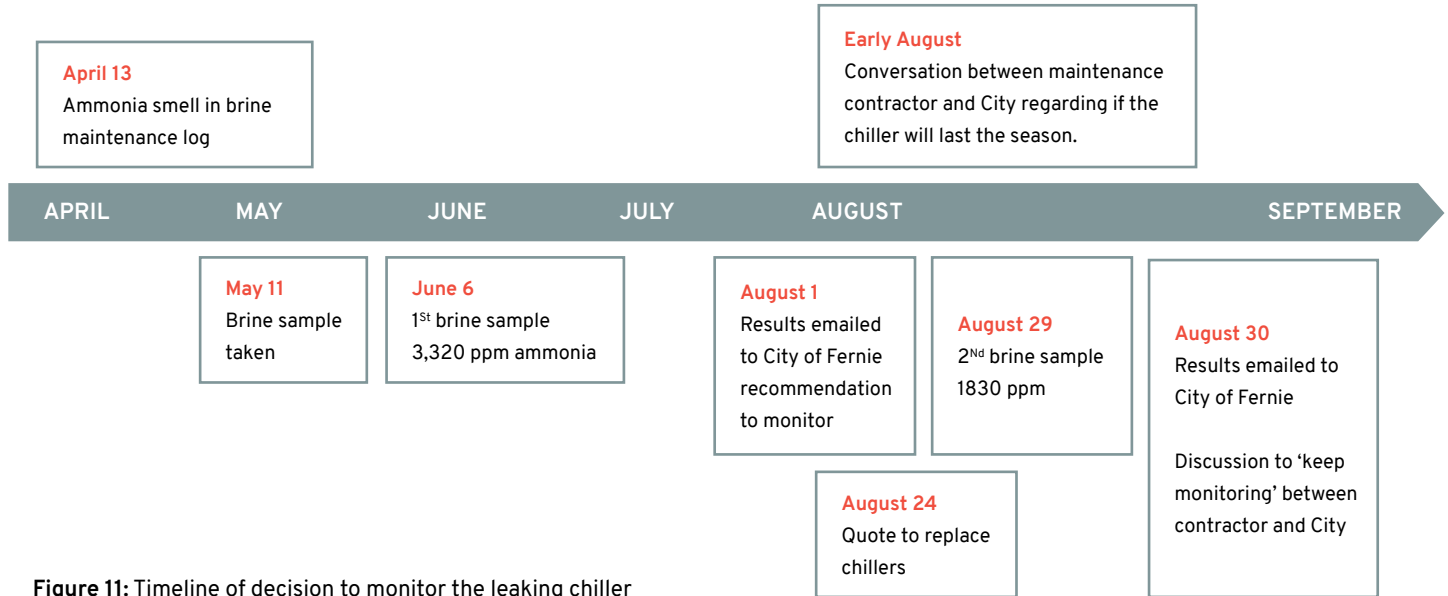
Evidence obtained by Technical Safety BC indicates that a decision was made to monitor the leaking curling brine chiller in the summer of 2017. Technical Safety BC’s investigation identifies evidence that this decision was likely influenced by a failure to recognize a leaking chiller as hazardous.

Figure 11: Timeline of decision to monitor the leaking chiller

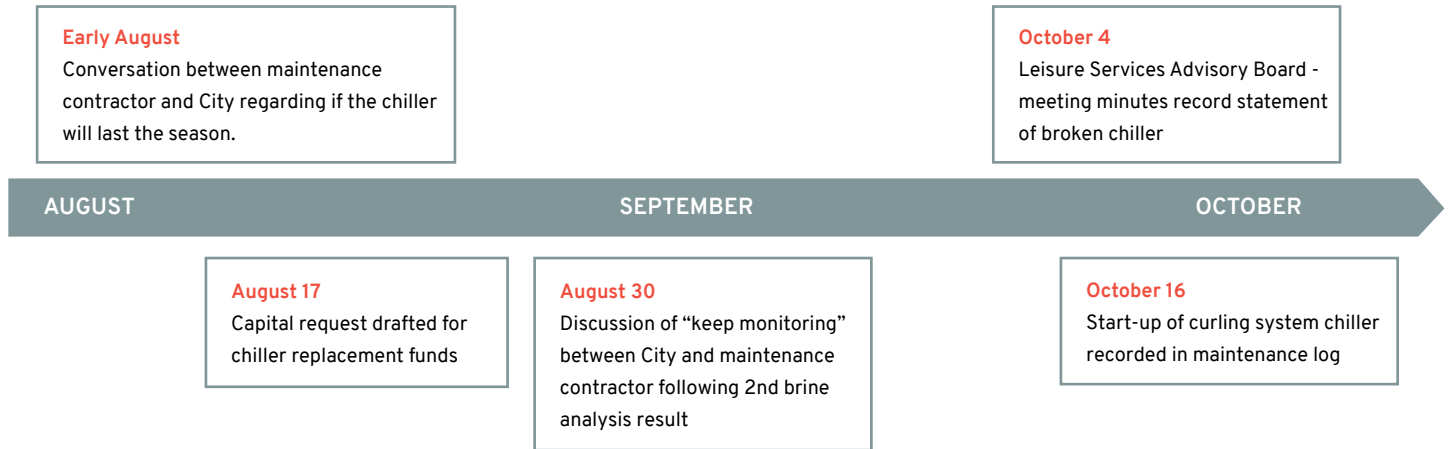
Technical Safety BC's investigation concludes that the City of Fernie knew the chiller had failed, yet chose to operate it until a replacement could be arranged. Evidence obtained by Technical Safety BC identifies that this decision was likely influenced by the failure to recognize the leaking chiller as hazardous, an intention to monitor the chiller in operation, and ineffective communication about the condition of the chiller.

Figure 12: Timeline of decision to operate the failed chiller

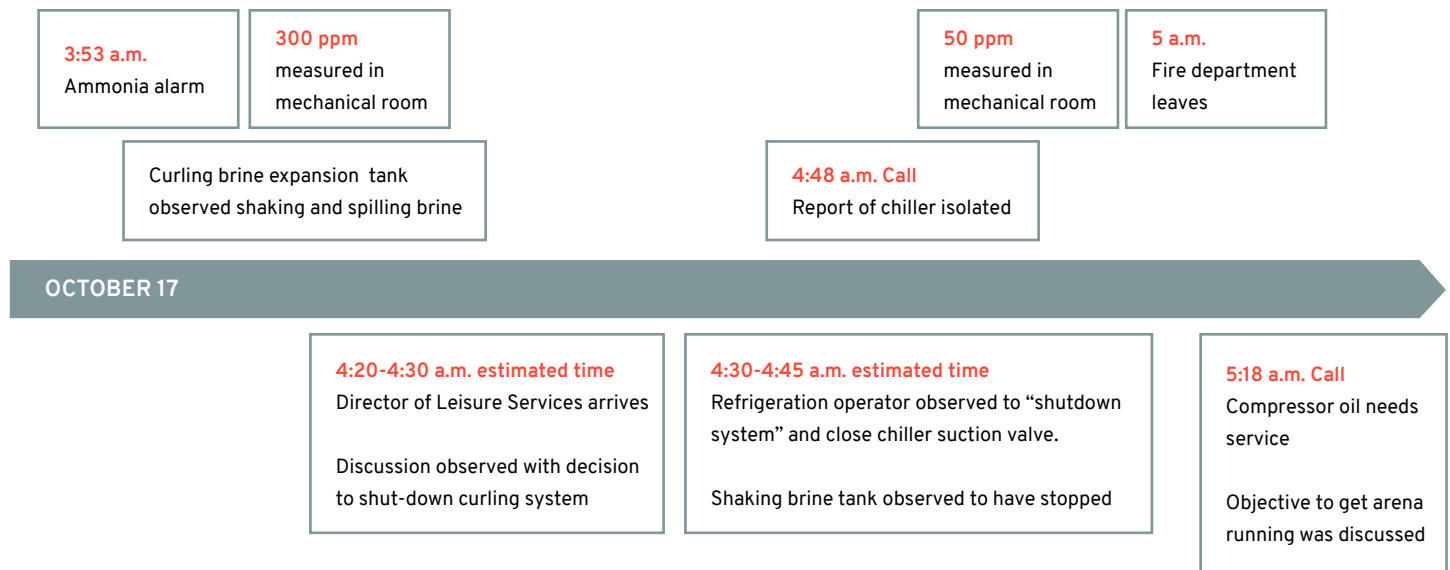
1. closed valves to the brine expansion tank;
2. isolating the liquid ammonia within the chiller by closing the chiller suction valve and shutting down the compressors; and
3. shutdown of the brine system circulation pump and closing the circulation valves.

It is possible that these decisions were influenced by the emergency situation of the leak, an operational priority to preserve the arena ice, and no emergency procedures or training relevant to the specific situation.

Figure 13: Chiller isolation timeline

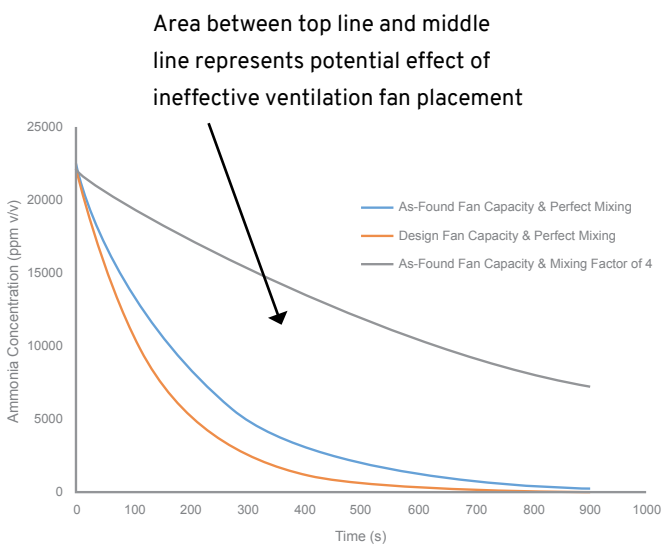
It is possible that the concentration of ammonia reached levels above 20,000 ppm of ammonia and that concentrations above 5,000 ppm remained for several minutes. It is likely that the northeast side of the mechanical room near the vestibule door and maintenance log books remained at elevated concentrations for a much longer period, as a result of ineffective ventilation air flow as demonstrated during the smoke test.

Figure 16 (above): From Appendix A. Simulation result estimating concentration of ammonia within the mechanical room during incident. The top line estimates imperfect mixing of ammonia and room air similar to that observed in the mechanical room, middle line estimates using the required ventilation capacity with perfect mixing and lower line indicates the measured ventilation capacity with perfect mixing.
