Incident Summary (152869272-001 #) (5613345)

SUPPORTING INFORMATION				Incident Date		March 16, 2017			
				Location		Duncan			
				Regulated industry sector		Electrical			
				Impact	Injury	Qty injuries	0		
						Injury description	NA		
						Injury rating	NA		
				Damage	Damage	Damage description	Fire damage to furnace firebox, venting and electrical wiring.		
						Damage rating	Minor		
				Incident rating			Minor		
Incident overview			Poor electrical connection and improper wiring methods caused the electrical termination in the furnace to overheat causing a fire.						
INVESTIGATION CONCLUSIONS				Site, system and components		Furnace manufactures specify the types of wire to be used, generally copper only. Aluminum wire is only to be connected to devices specifically approved for aluminum connections, by devices specifically approved for aluminum terminations. The wire nuts used were rated “copper only”. The main overcurrent protection is a 15amp Federal Pioneer Breaker, installed in a Federal Pioneer 100A combination panel.

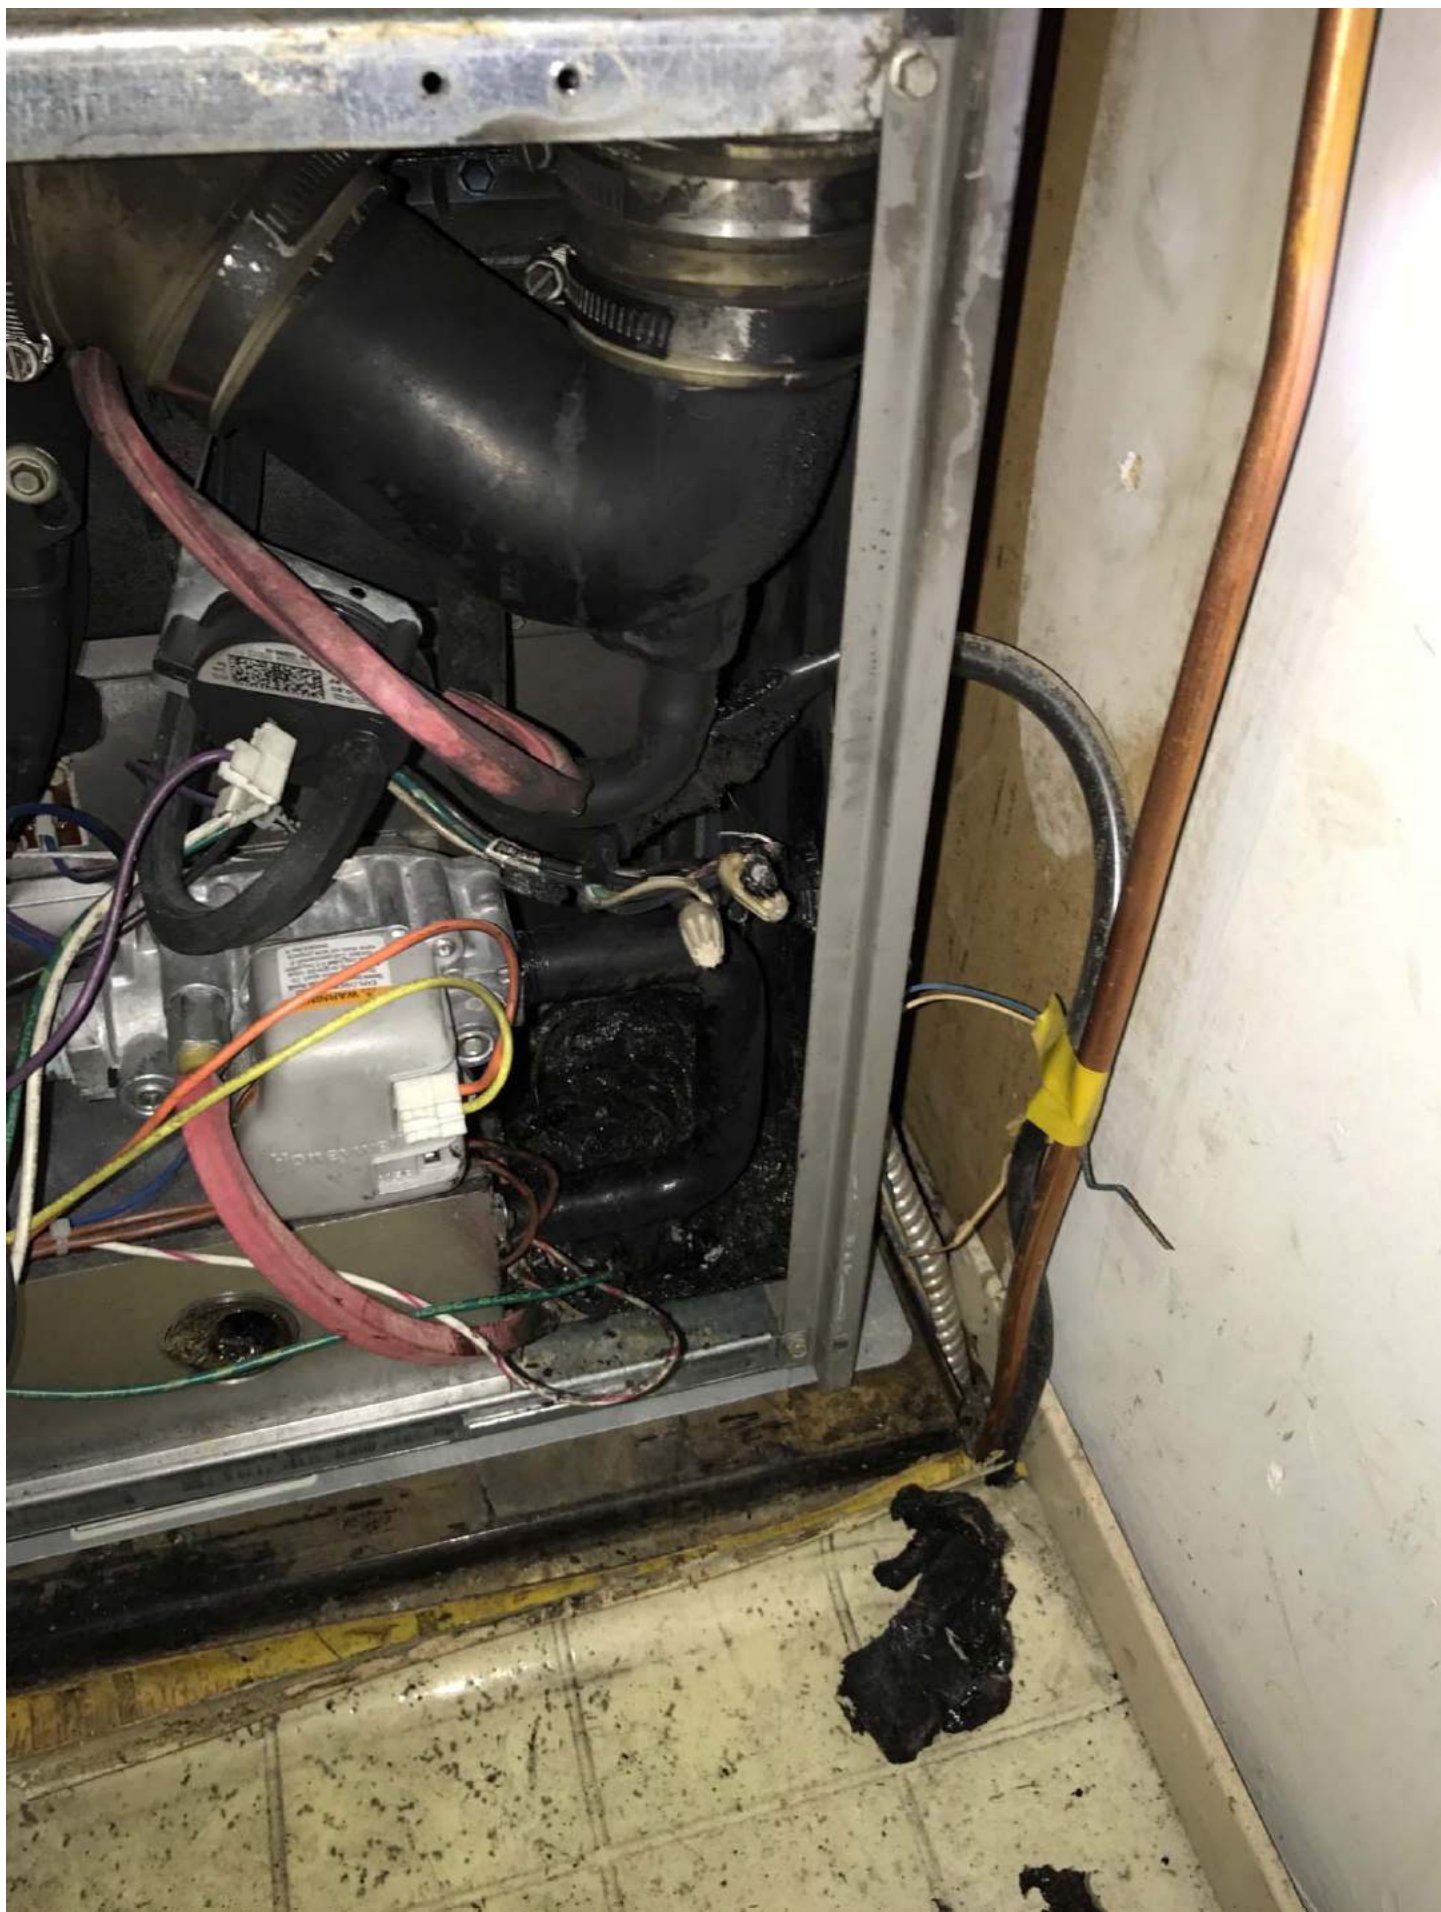
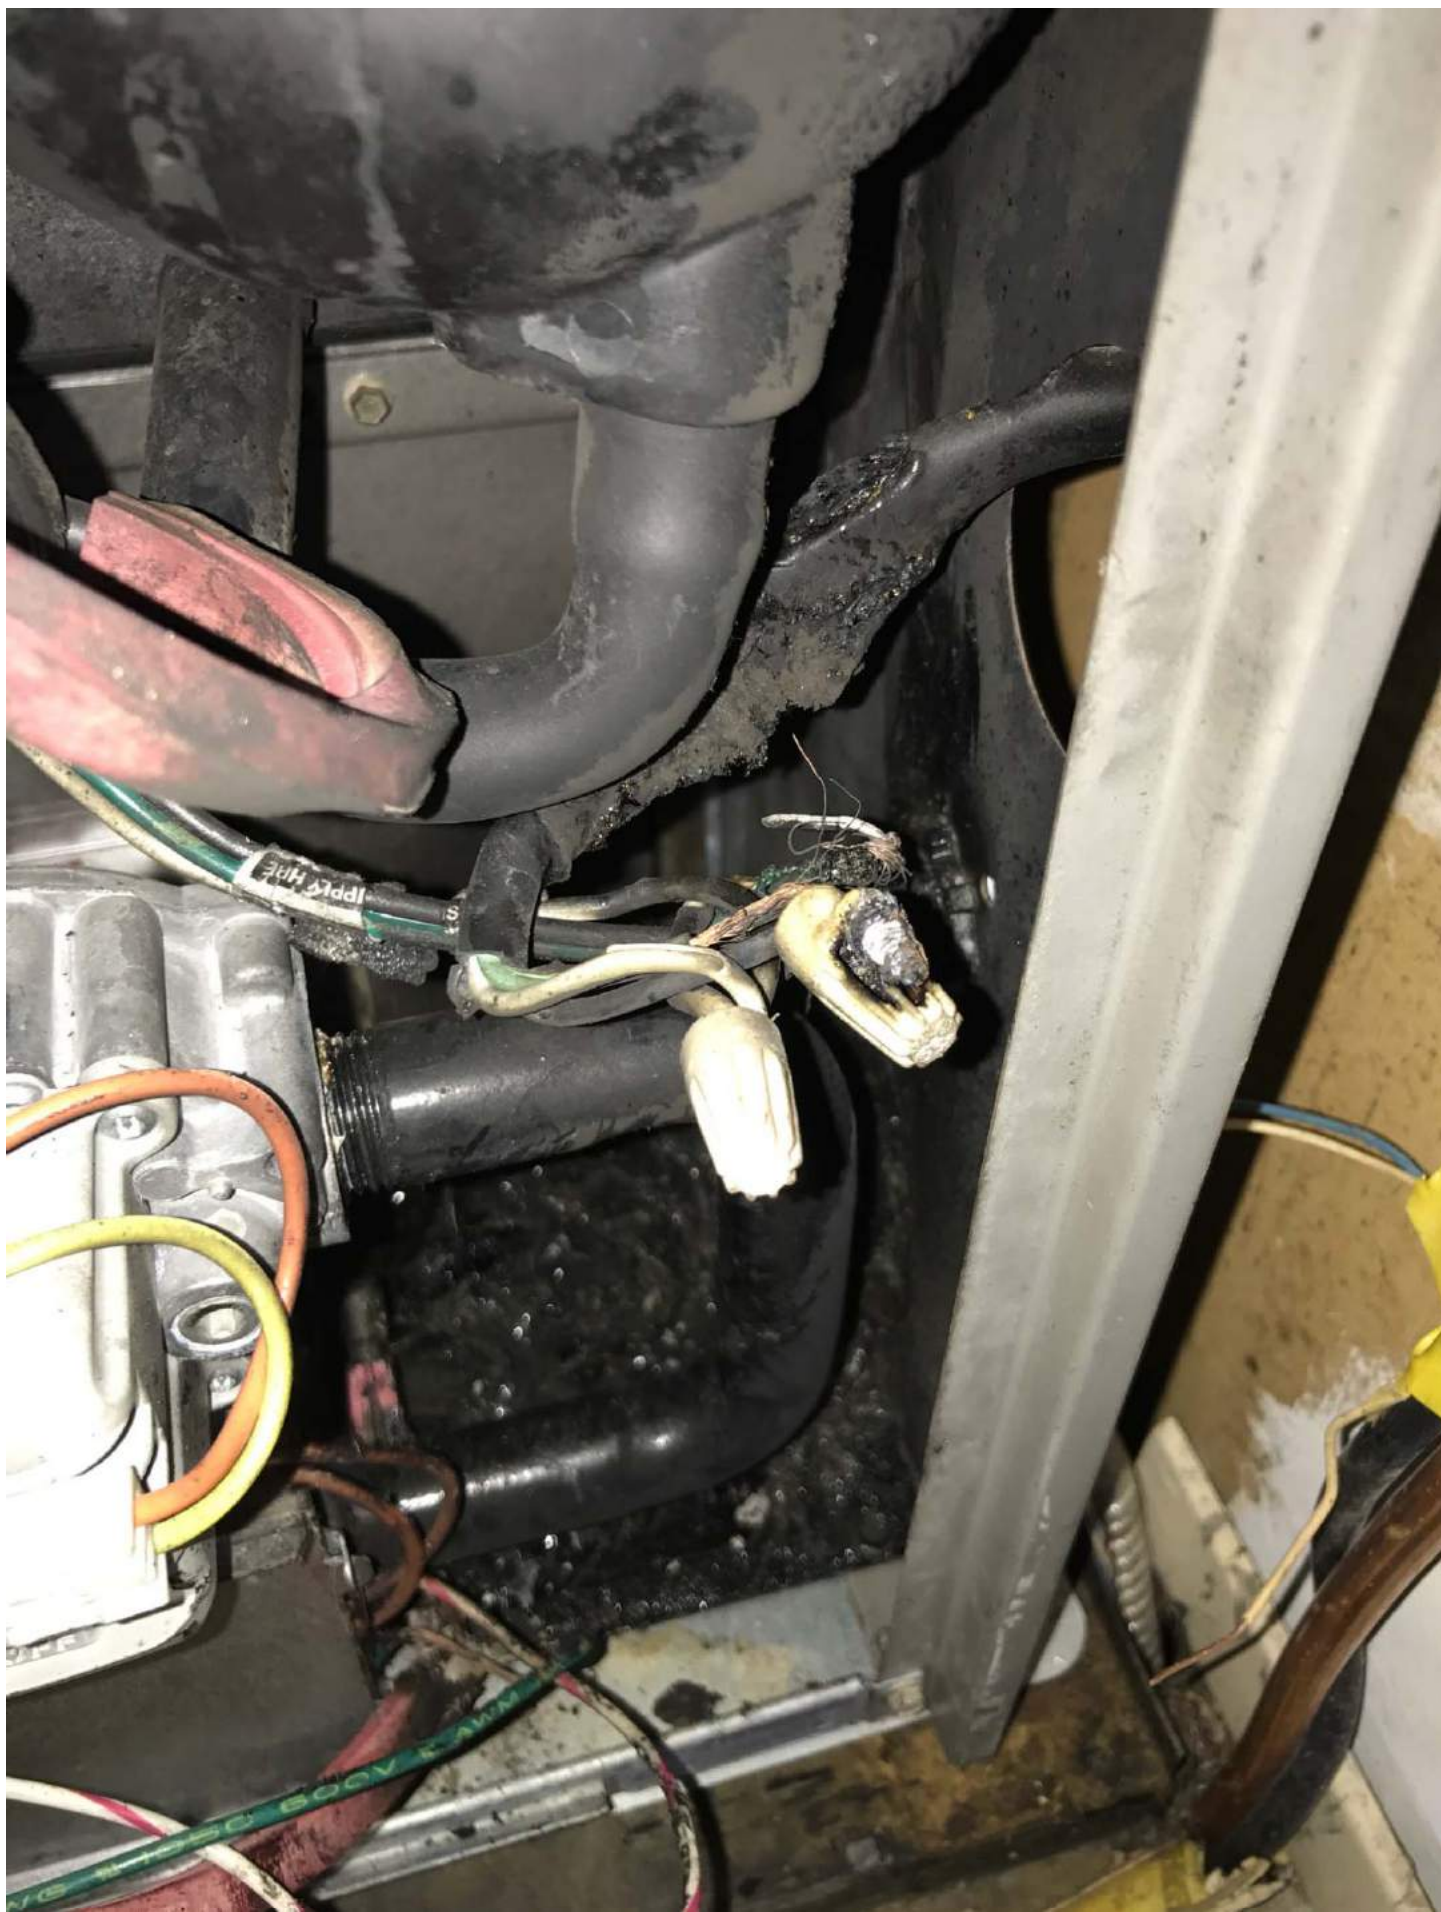
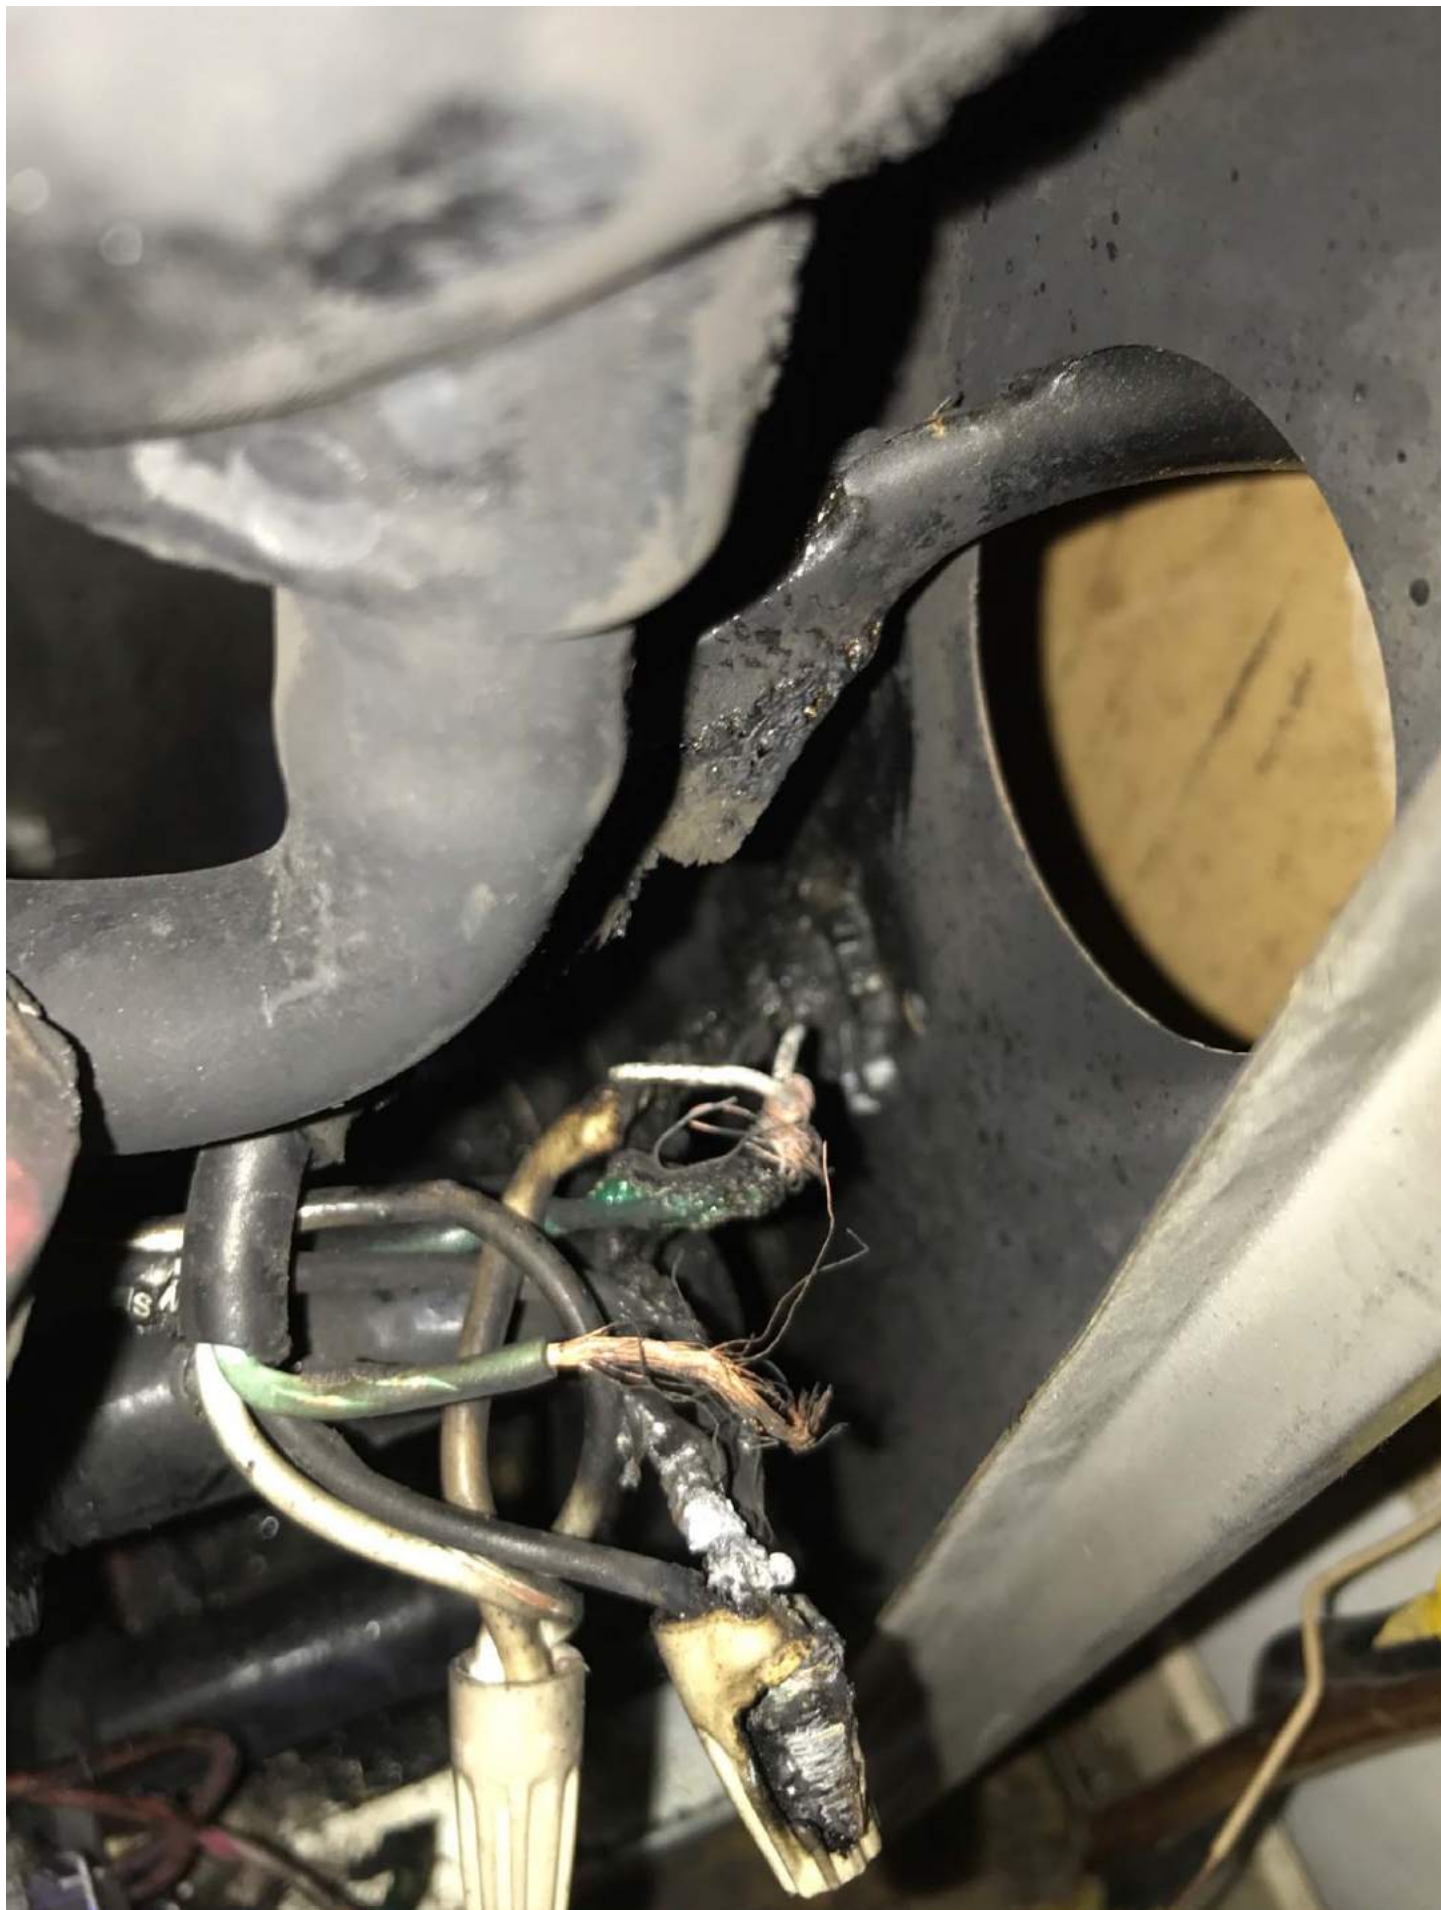
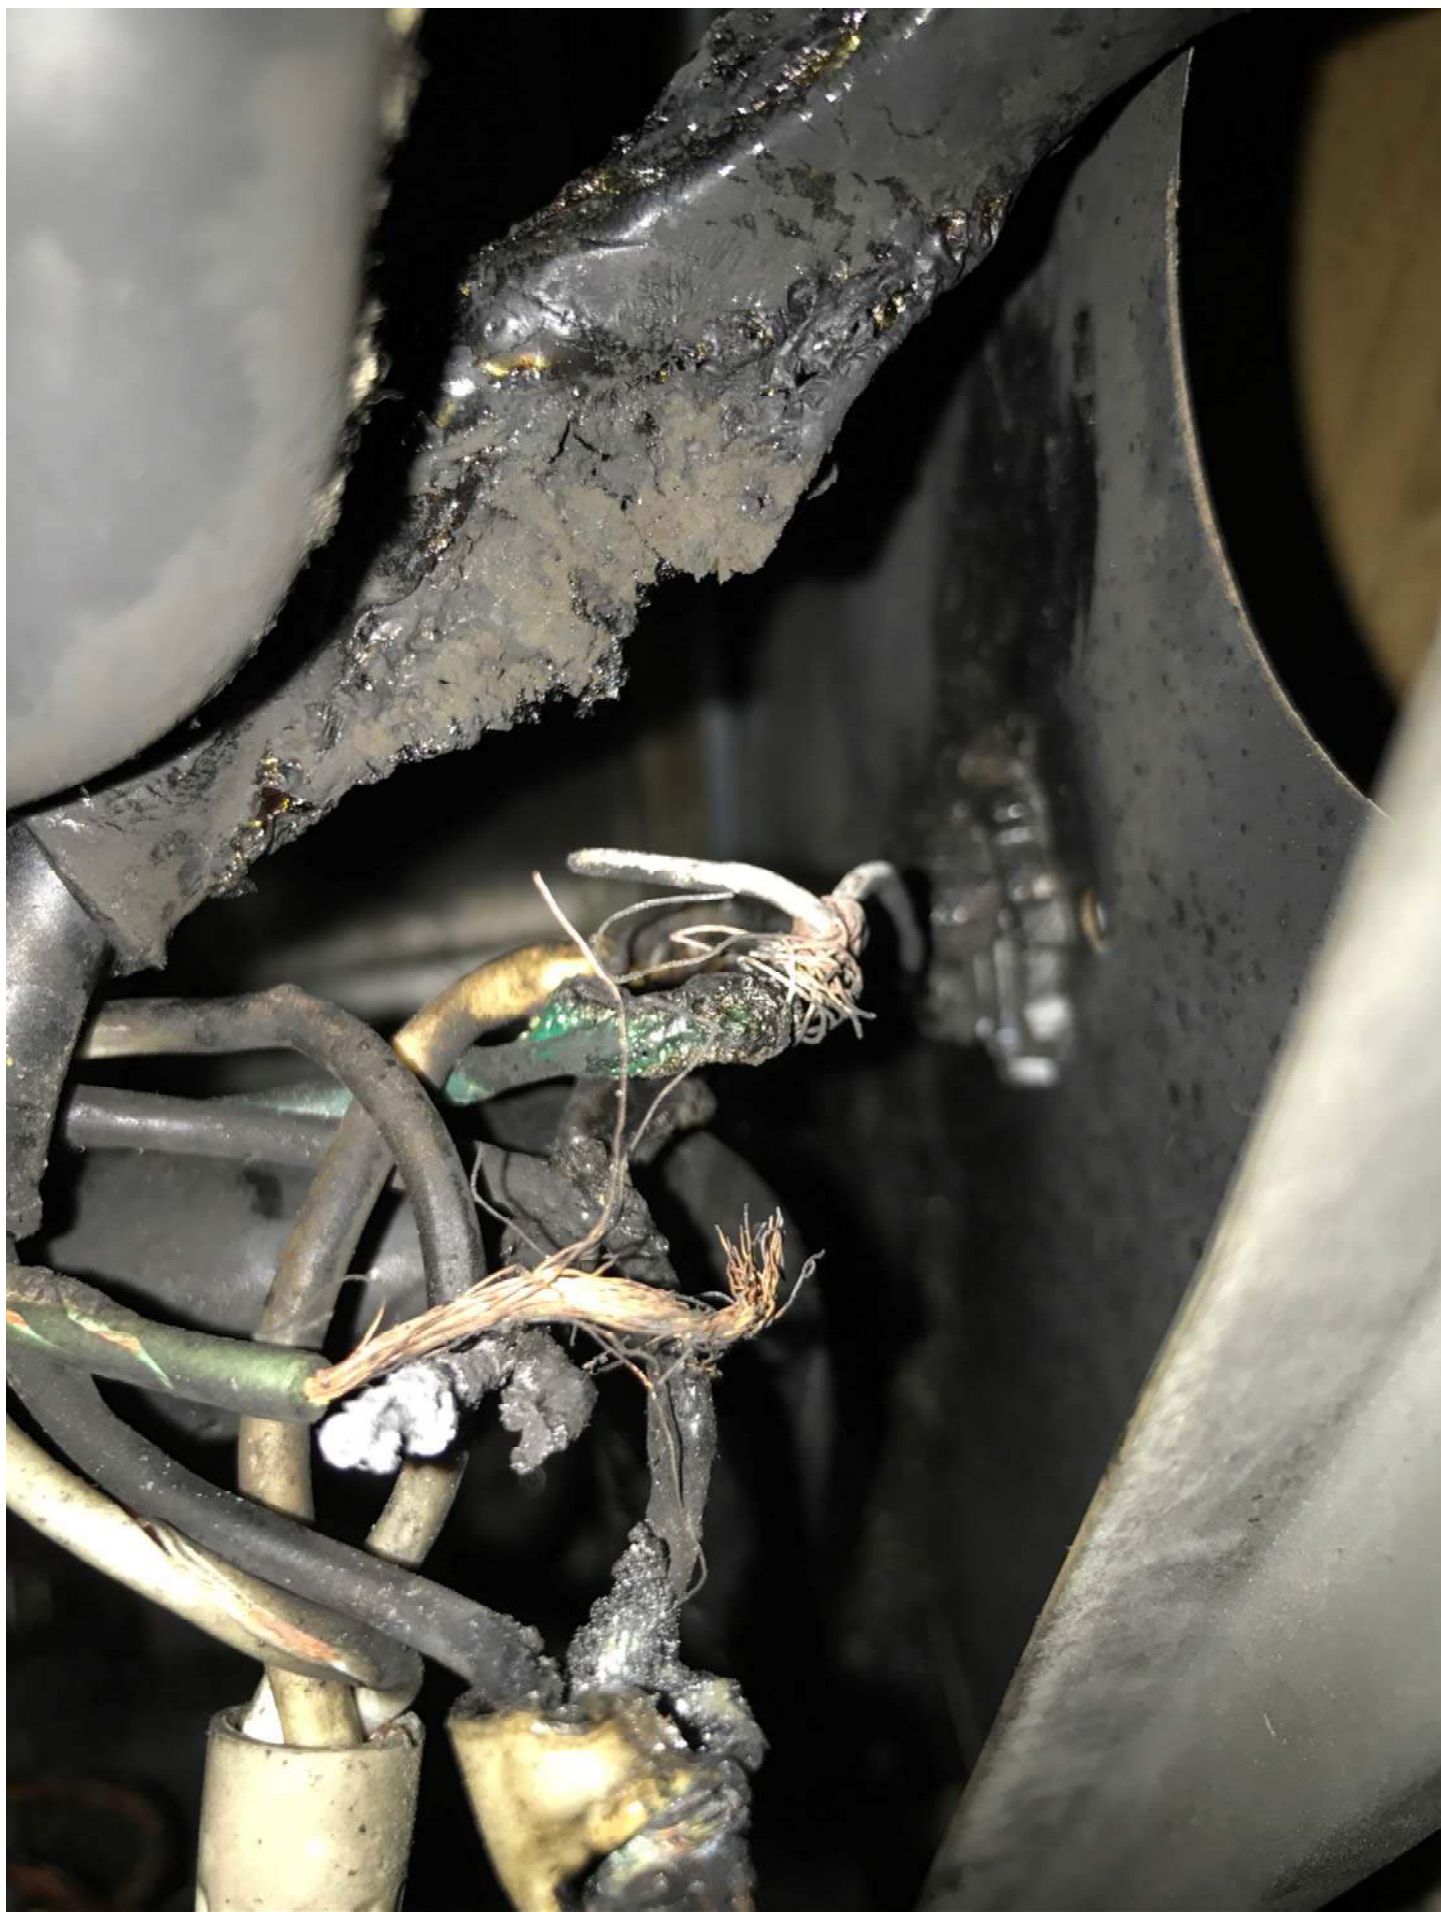
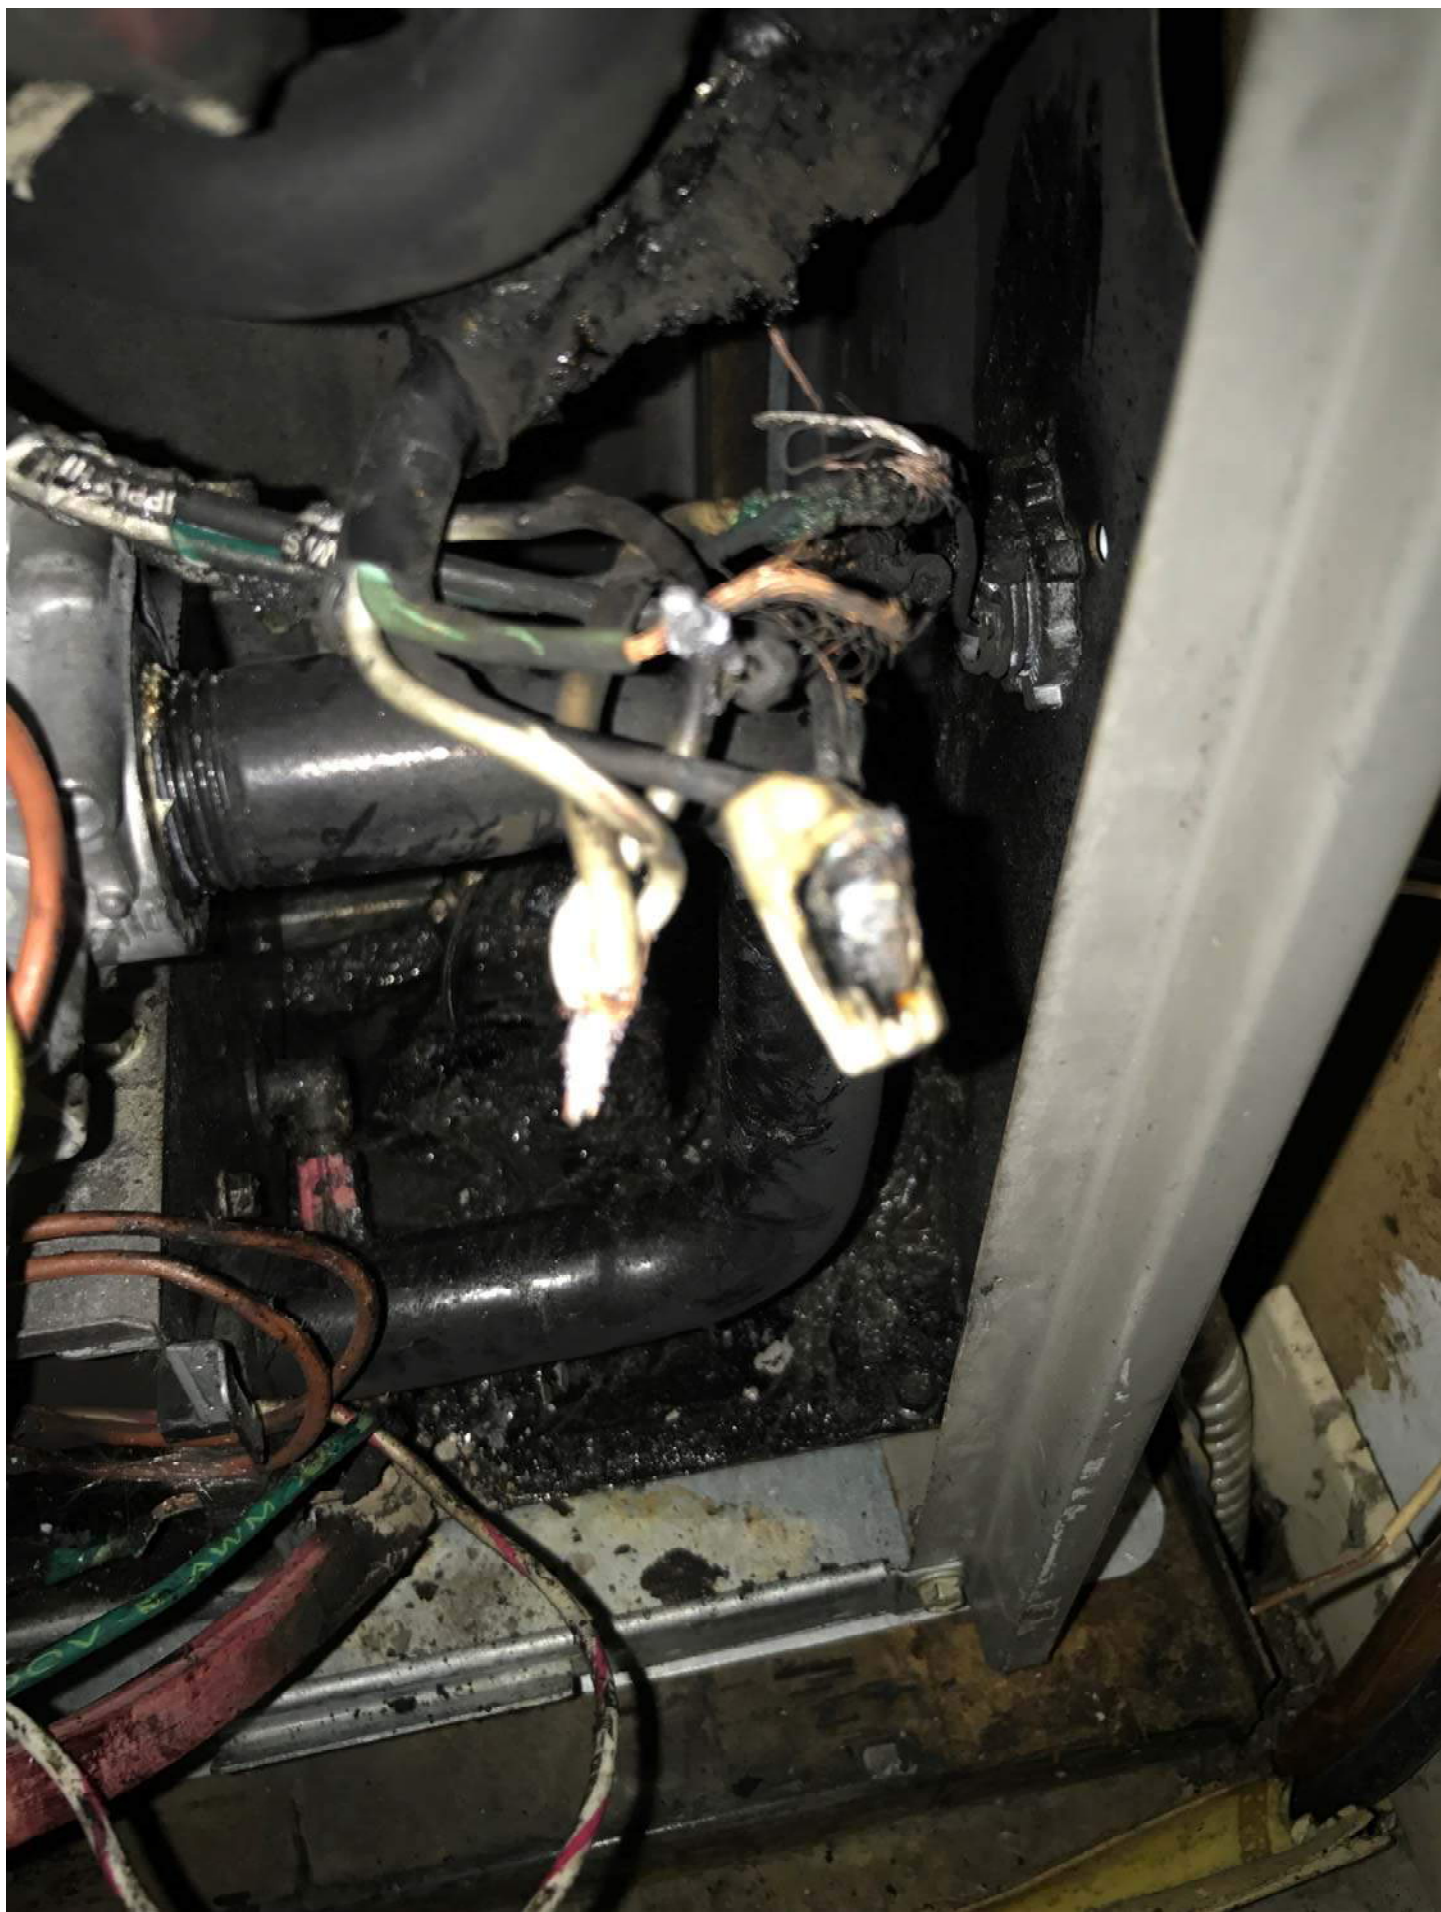
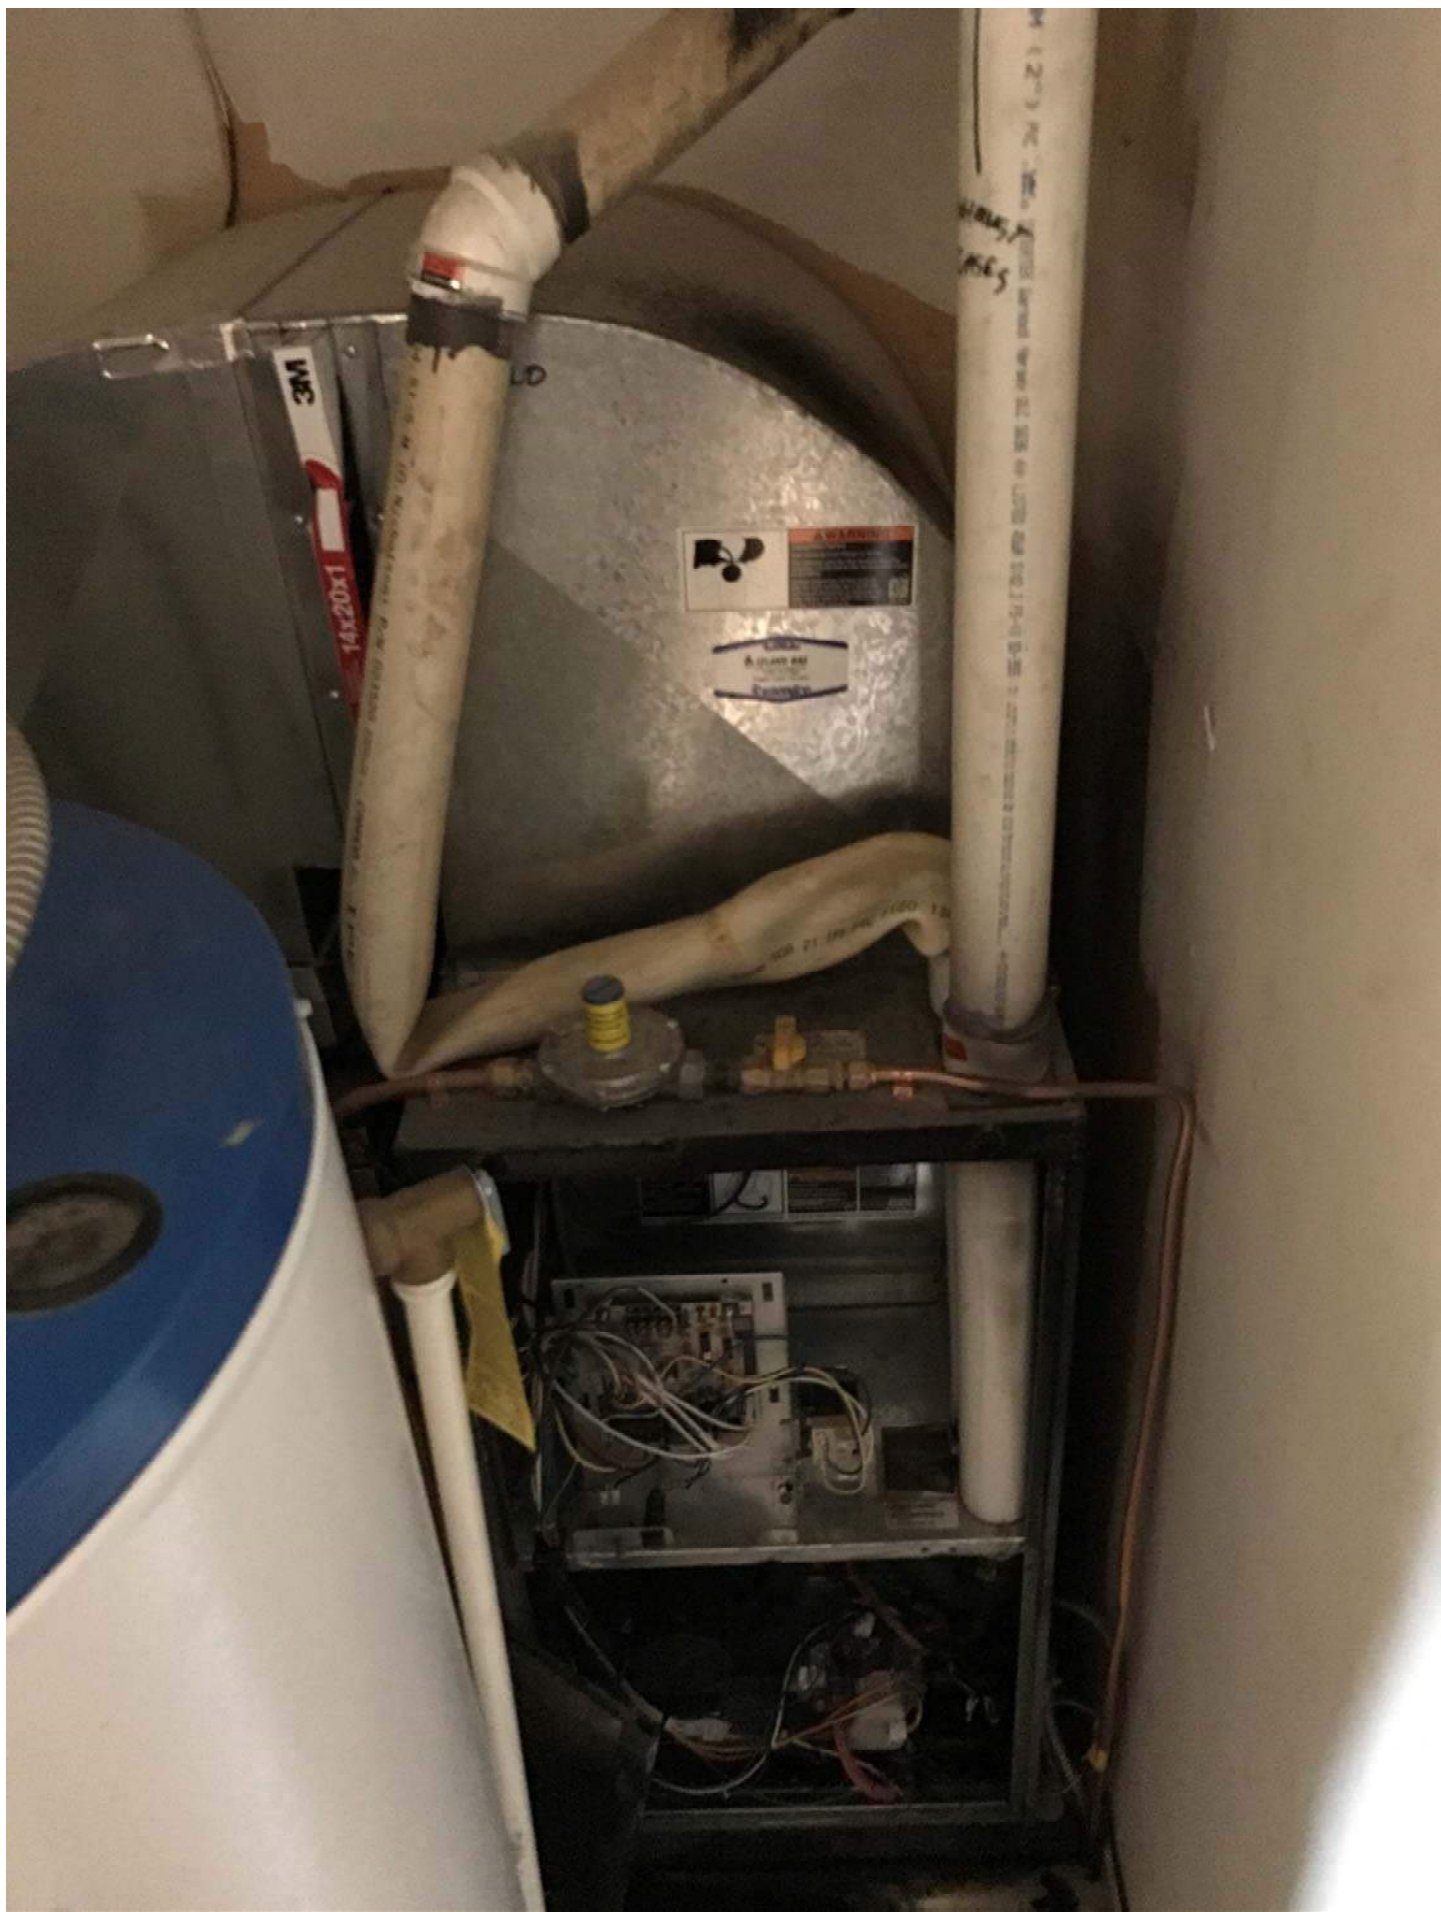
Failure scenario(s)		House originally wired with aluminum wire. New high efficiency furnace installed approximately 4 years ago. The furnace was fed with aluminum wire and terminated with copper only wire nuts. This connection oxidized over time leading to a break down in the connection causing excessive heat. This connection eventually got hot enough to melt the insulation off of the conductor which caused arcing and the subsequent fire. The owners were home at the time were able to quickly extinguish the fire.			
				Facts and evidence		Photos, witness statements.			
				Causes and contributing factors		The fire was caused by the improper use of aluminum conductors.
