Appendix N

Steel Construction Guidance for the Prevention of Brittle Failure

Commentary on Resistance to Brittle Fracture and Material Toughness from European and North American Steel Construction Standards

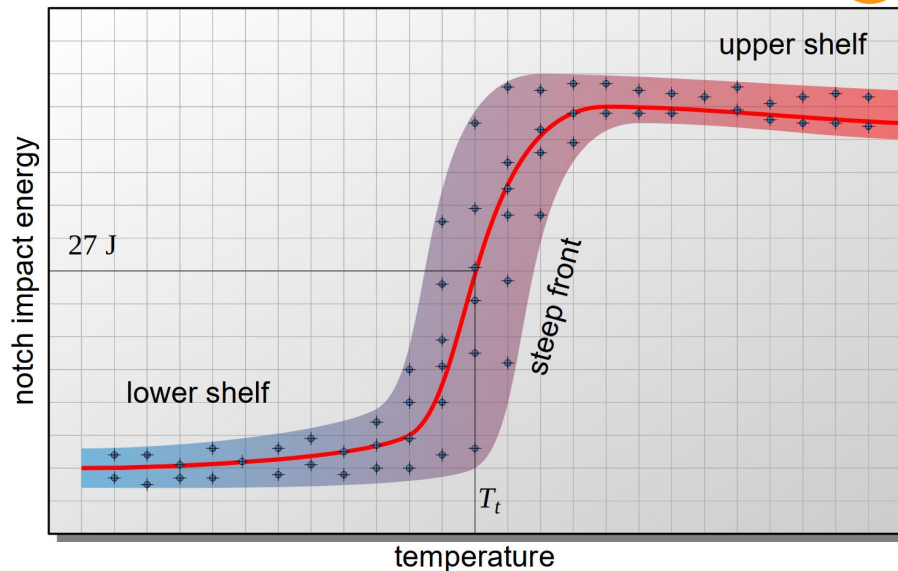
Figure 1 - Notch Toughness as a function of temperature, typical shape for mild steels. Source: tec-science.com (December, 2025)

European standards reviewed often referenced a toughness requirement of (at minimum) 27J at -20 degree C, which consequently is the value the European counterparts of LPOA also specified at the time of gondola construction. This is likely based off empirical data which stipulates that 27 J is the point at which a mild steel is considered to have transitioned from ductile to brittle behaviour (i.e. it’s mid way through the upper to lower shelf transition in the material toughness curve (see figure 1 below).

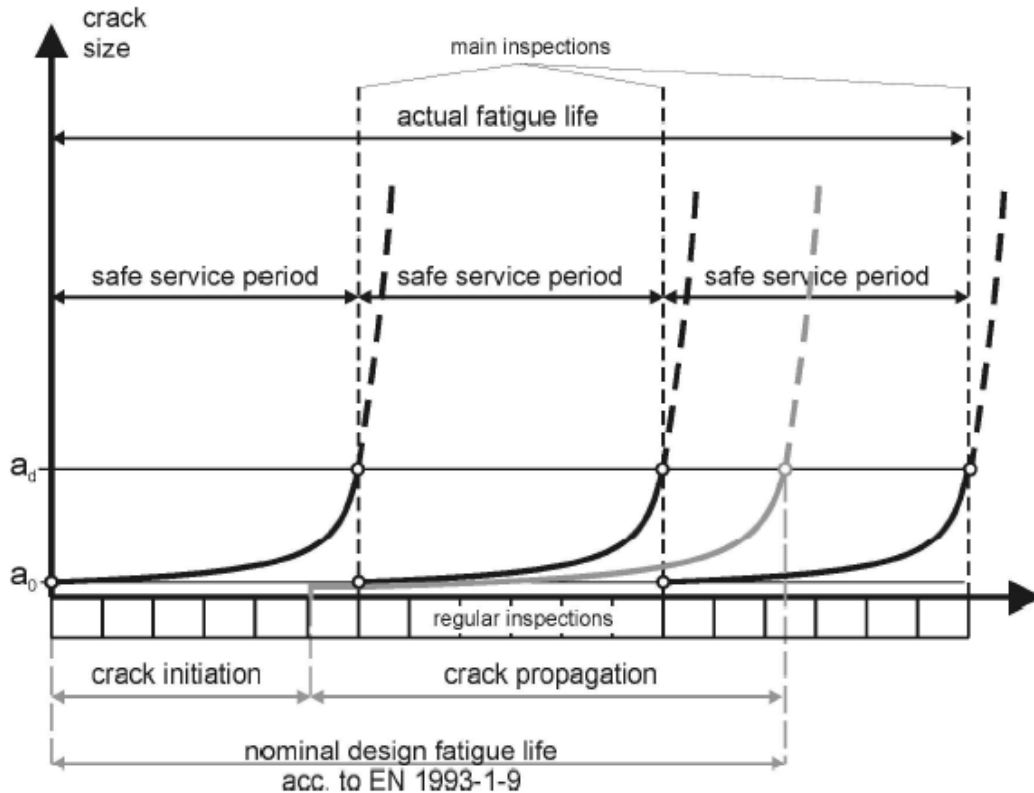
Figure 1 - Graphical representation of the concept of "damage tolerance" as outlined in the EN-1993 commentary. Inspection intervals are commensurate to crack propagation and fatigue life.

The EN 1993 commentary also discusses the concept of damage tolerance which is directly applicable to this incident. It states that service life of a piece of equipment is based on a sequence of safe service periods that are divided by inspections (both regular or “operational” and more in-depth or “main”). It states “The concept of damage

tolerance is a feature of structural robustness as it ensures that no failure can occur without pre-warning by very large and visible cracks. It also justifies the efficiency of inspections in that it ensures that the occurrence of such large and visible cracks is possible and that those cracks are detectable before a failure will happen.” See figure 2 below.
