SUPPORTING INFORMATION	Incident Date		April 22, 2019
	Location		Delta BC
	Regulated industry sector		Gas - Natural gas system
	ıpact Injury	Qty injuries	0
		Injury description	N/A
		Injury rating	None
	ln nage	Damage description	Burner, access door, and venting detached from boiler. Boiler is a total loss.
	Dan	Damage rating	Major
	Incident rating		Major
	Incident overview		While a service technician was working on a boiler that had been experiencing issues with lighting off or establishing a main burner flame. The boiler had a hard light off, meaning the main burner flame did not establish smoothly, this can be the equivalent of a small explosion in the boiler, and is caused by delayed ignition of the main burner flame. This hard light off blew off the burner, access door, and venting on the rear of the appliance. (Figure 1-2)
INVESTIGATION CONCLUSIONS	Site, system and components		 This is a forced draft appliance which relies on a fan on the inlet of the appliance to push and mix an air fuel mixture through the appliance, where the air fuel mixture is burnt and the products of combustion are then vented outdoors. Due to their nature, forced draft appliances (especially appliances

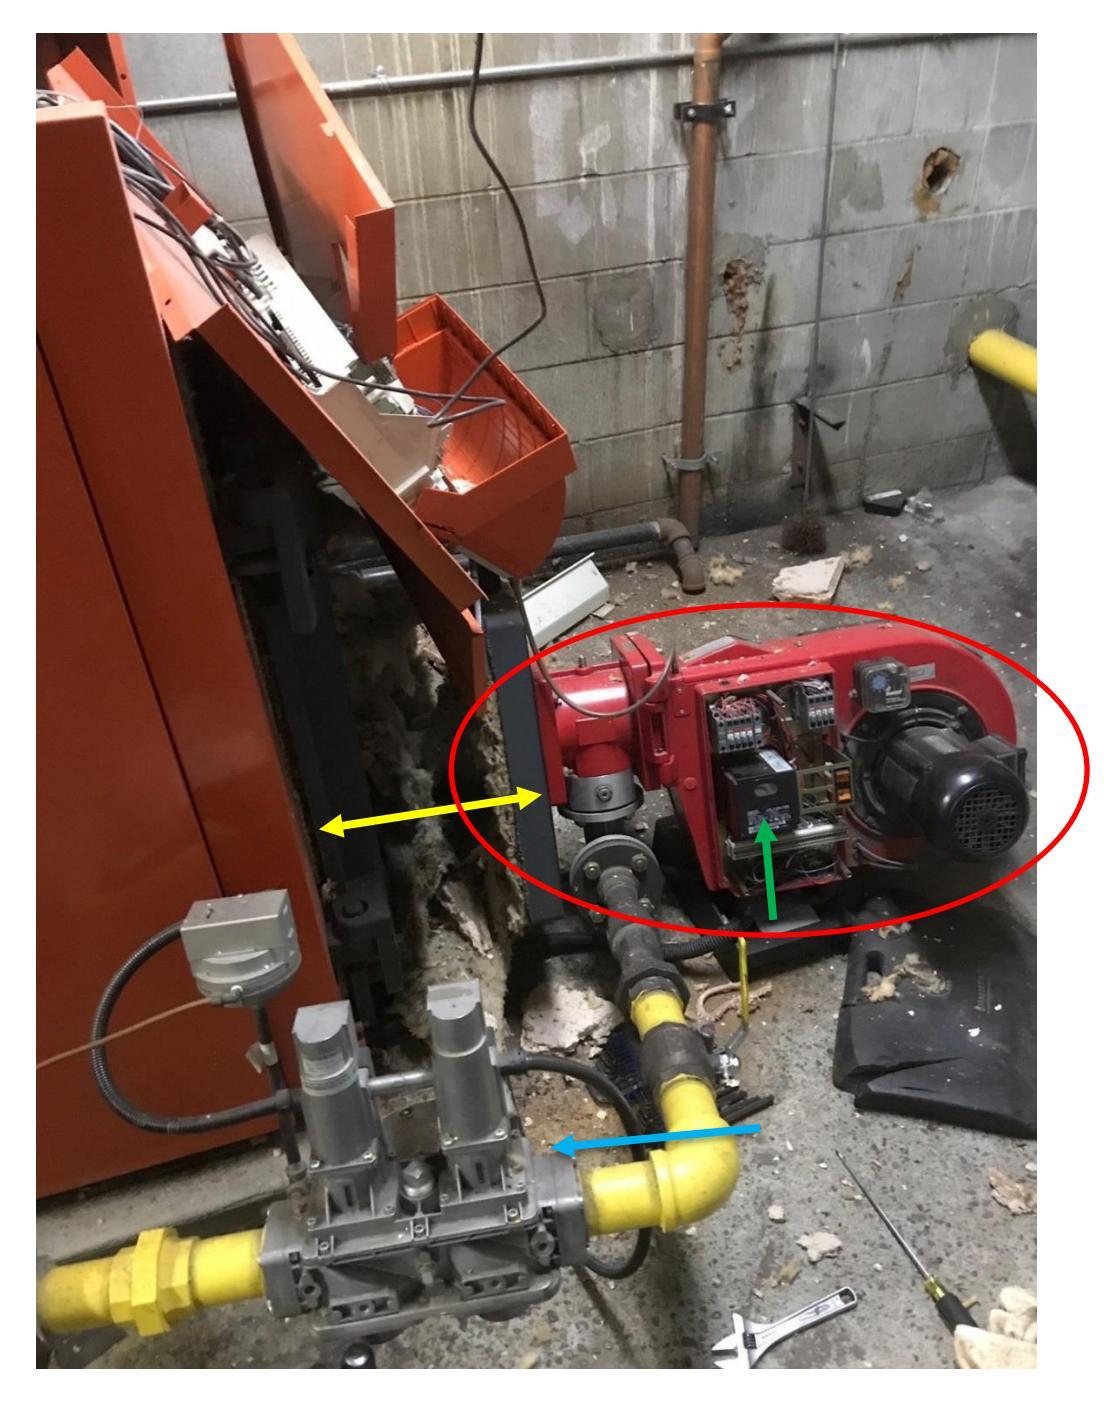
Photo taken from the scene the day of the incident, showing detached burner and damage to the boiler breeching. The red oval shows the burner unit and controller. The yellow arrow shows the separation between the burner unit and the boiler frame as a result of the explosion.

Components visible in picture:

Green Arrow: Flame Safeguard

Blue Arrow: Double block safety shut off valves

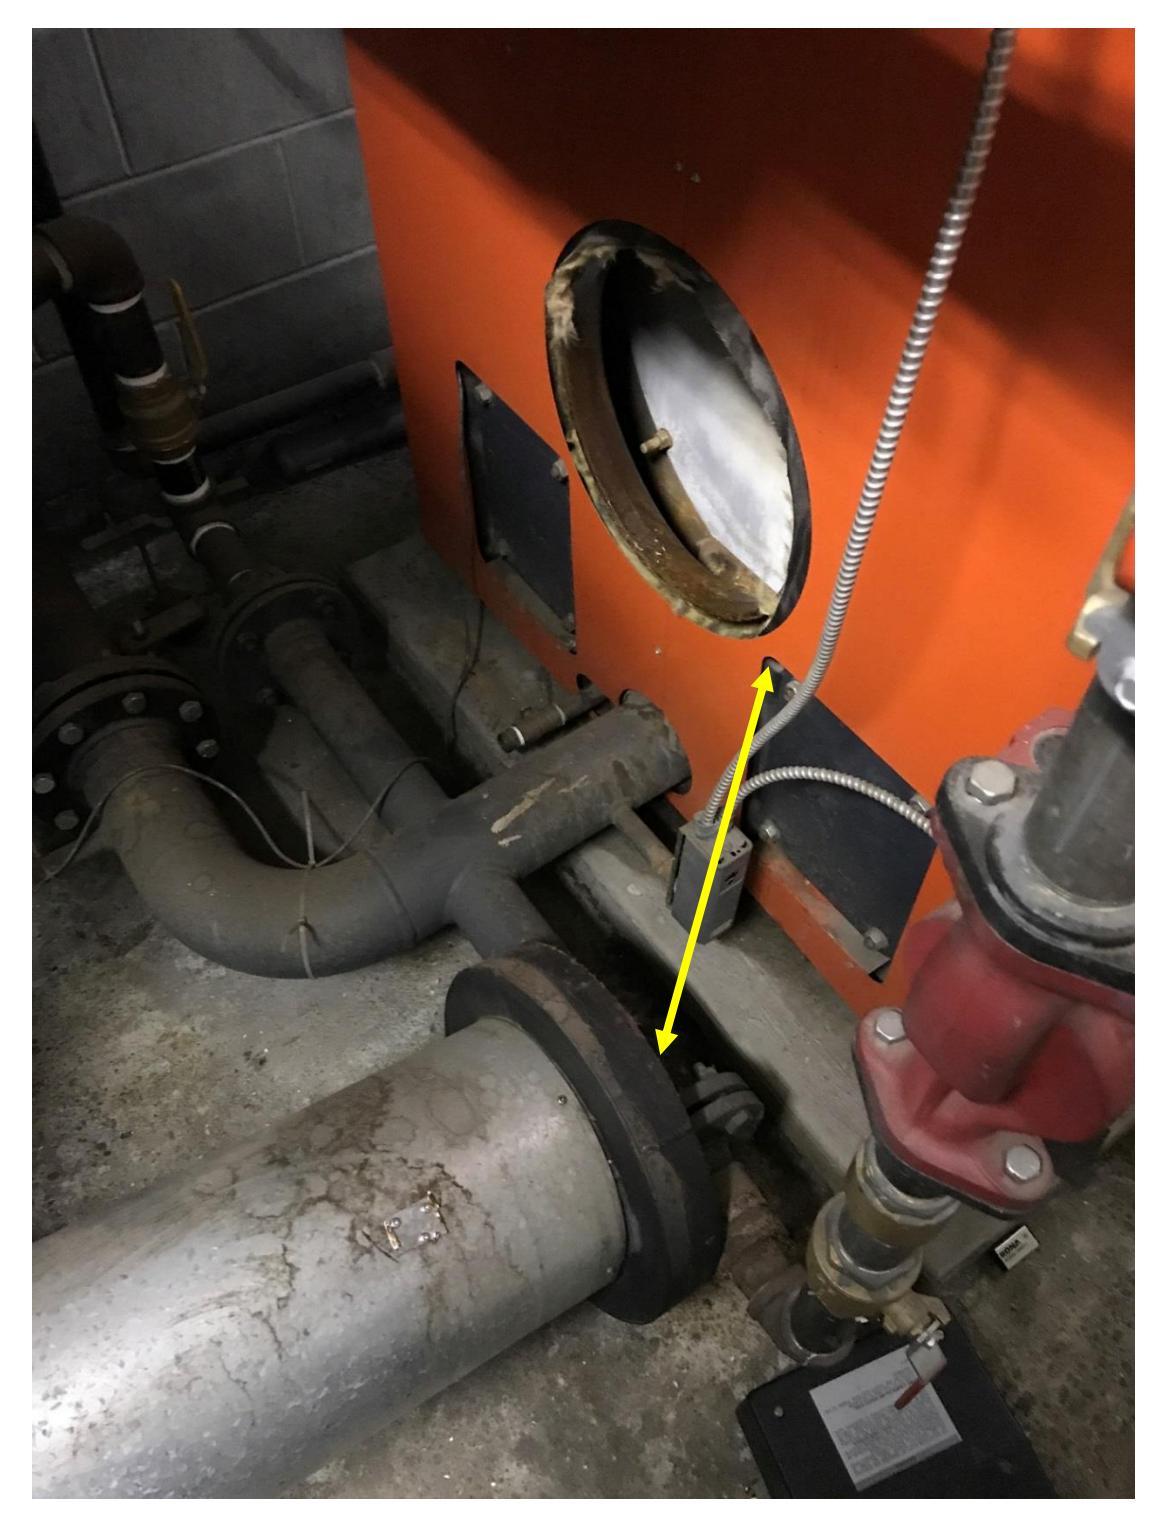
Detached boiler venting, yellow arrow shows the separation between the boiler and the venting.

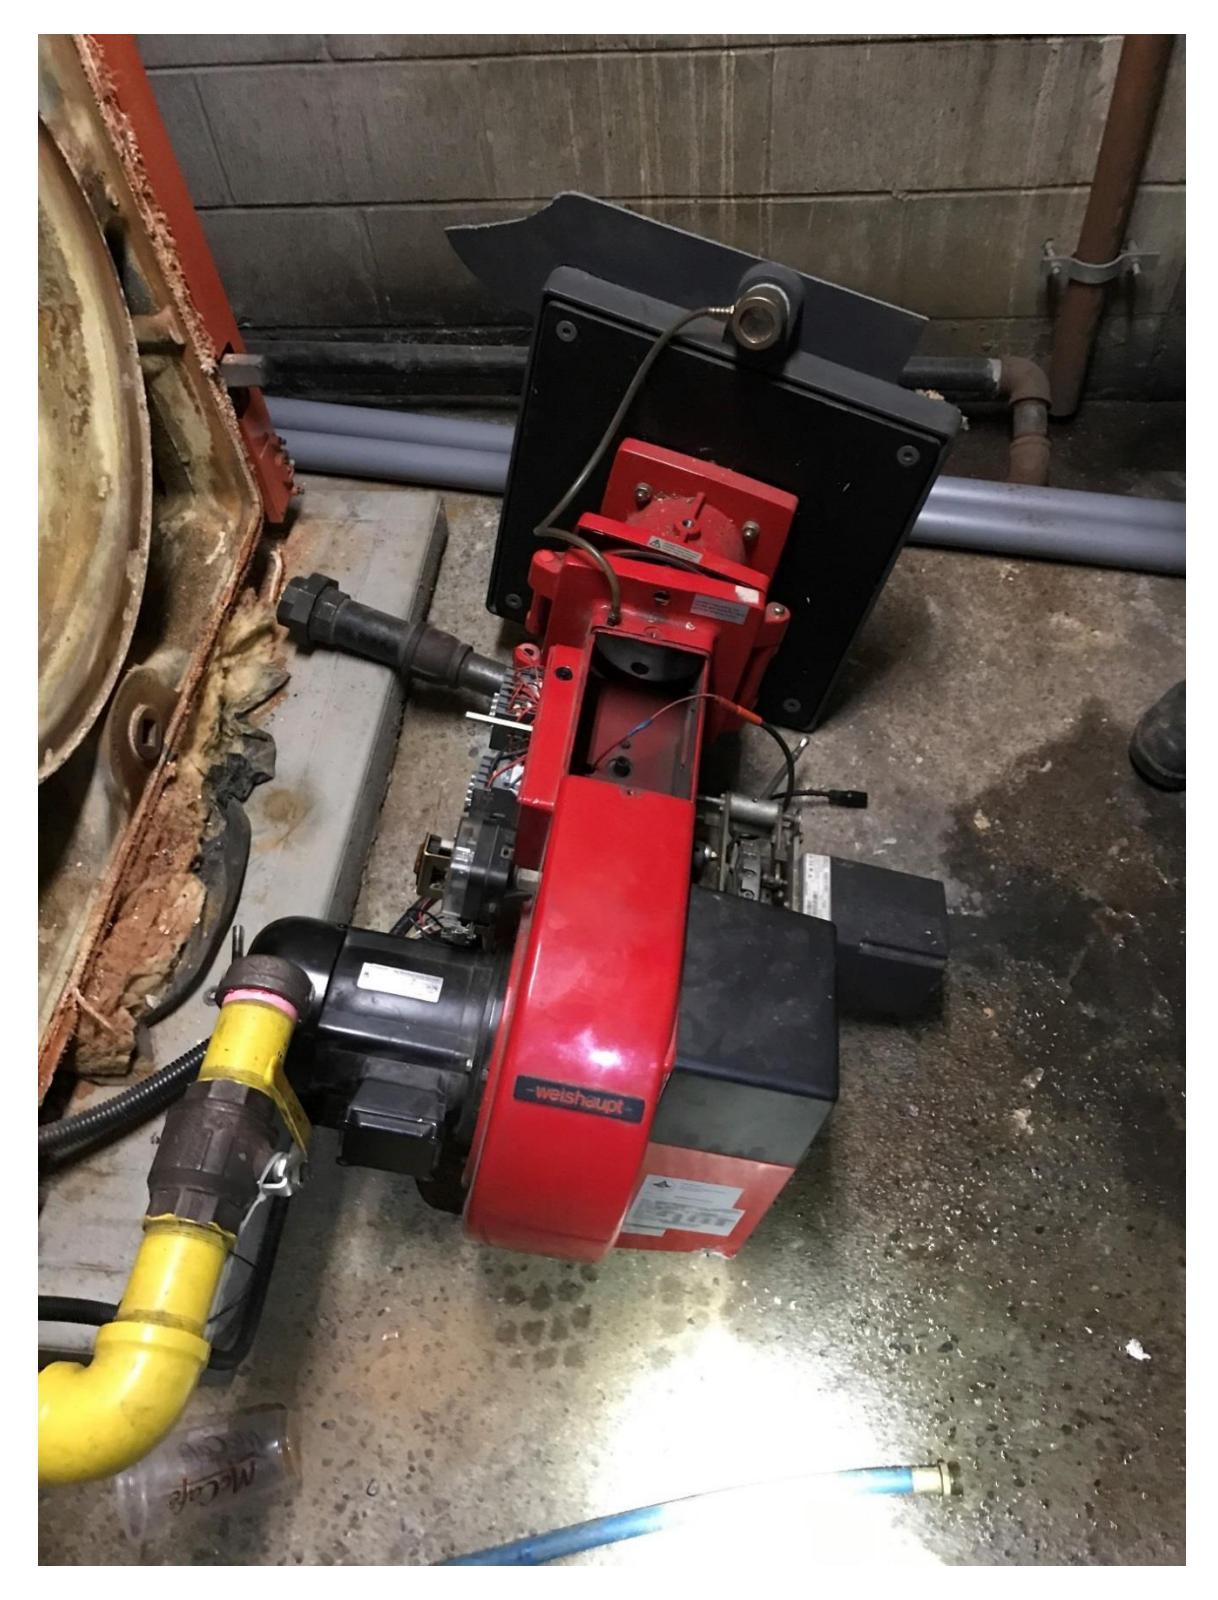
Photo of the scene from the day I attended site. This photo shows the equipment was altered and partially disassembled as the equipment was being worked on in an effort to determine if the equipment was salvageable.

Facts and evidence	 Site Observations -When I attended site the service contractor had already cleaned up most of the damage, and altered the scene during the repair process. (Figure 3) -The interior of the boiler was clean and showed no signs of sooting or incomplete combustion that would indicate the boiler was having ignition or flame issues prior to the incident. (Figure 4) -The burner head for the boiler was examined and determined to be free of cracks or defects which may have caused poor mixing and possibly a hard light off. (Figure 5) - The safety shut off valves for the appliance were leak tested and holding tight, disassembly of the safety shut off valves found no damage to the sealing surfacesThe input controller appeared in good shape, and an interview with the service technician indicated that no adjustments were made to the end switch camsThe dial for the flame safeguard indicated that it had entered the trial for ignition phase when the hard light off happened, so a spark would have been present in the boiler at the time of failure. (Figures 6-8) - The flame safeguard was examined and found to have a pitted contact on the ignition contact. However, testing of the flame safeguard contacts determined that this would have only affected when the ignition spark would have poned. Therefore reducing the possibility that the flame safeguard was at fault. (Figures 9-11) -The weights having been knocked off the barometric damper would indicate that other hard light offs may have occurred during the lock outs during the previous weeks.

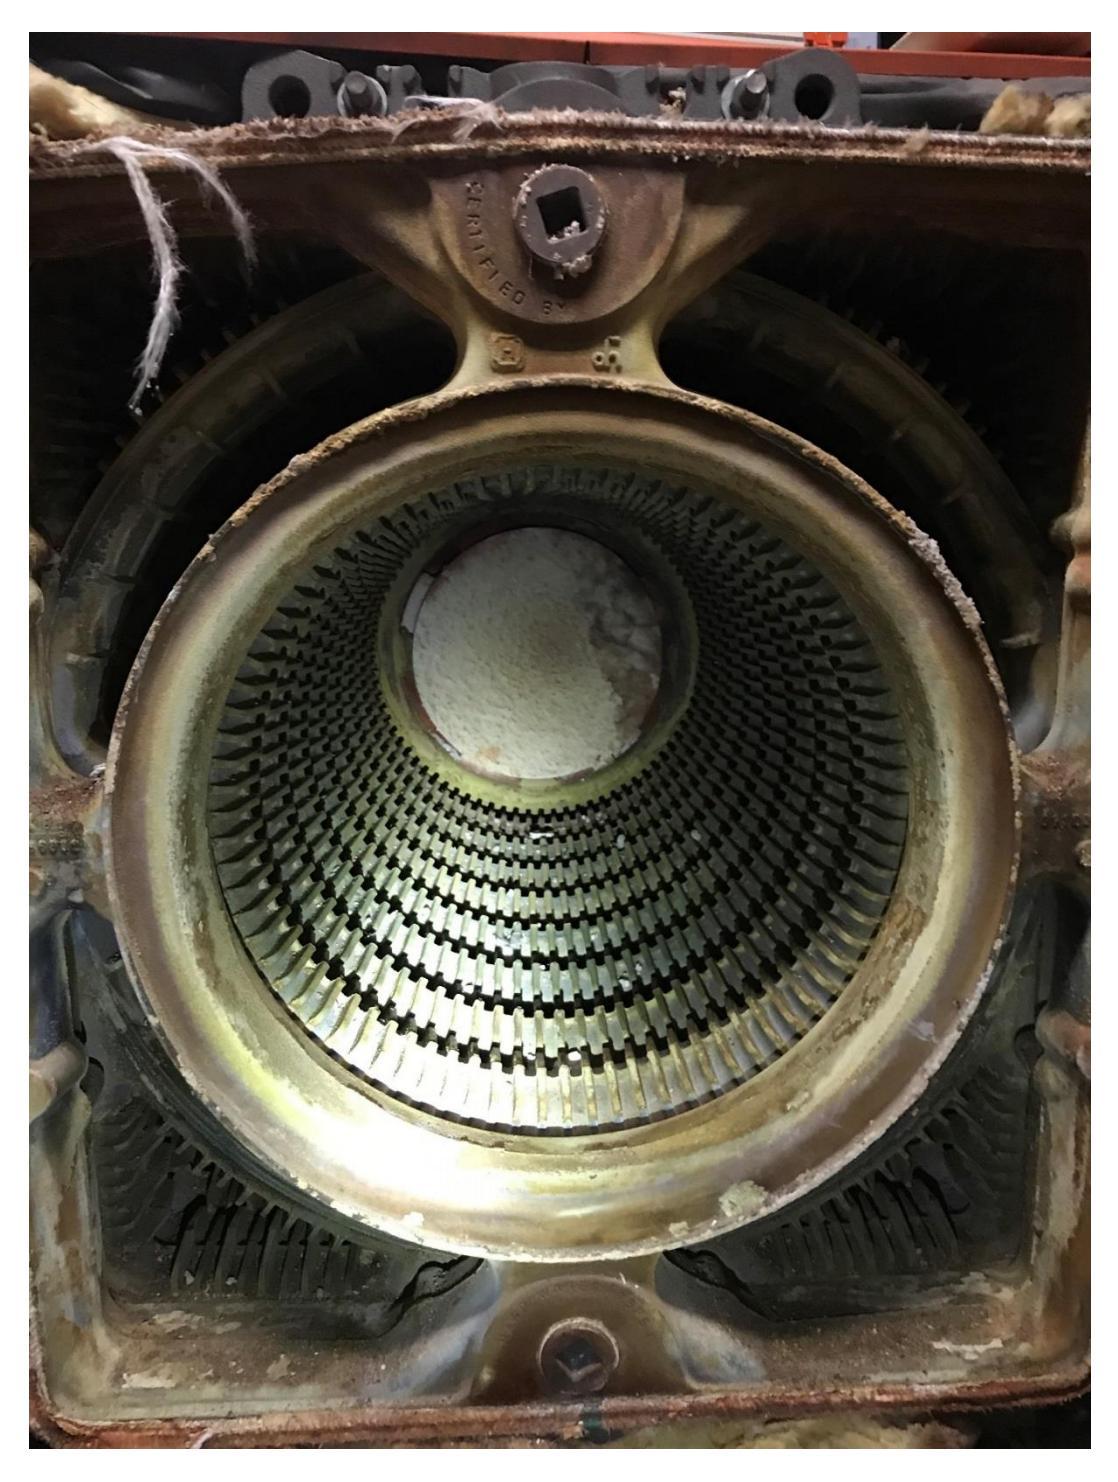
Interior of the boiler, no evidence of sooting or poor combustion. This shows that operation of the boiler while in the run cycle was correct and is not suspected as a potential cause.

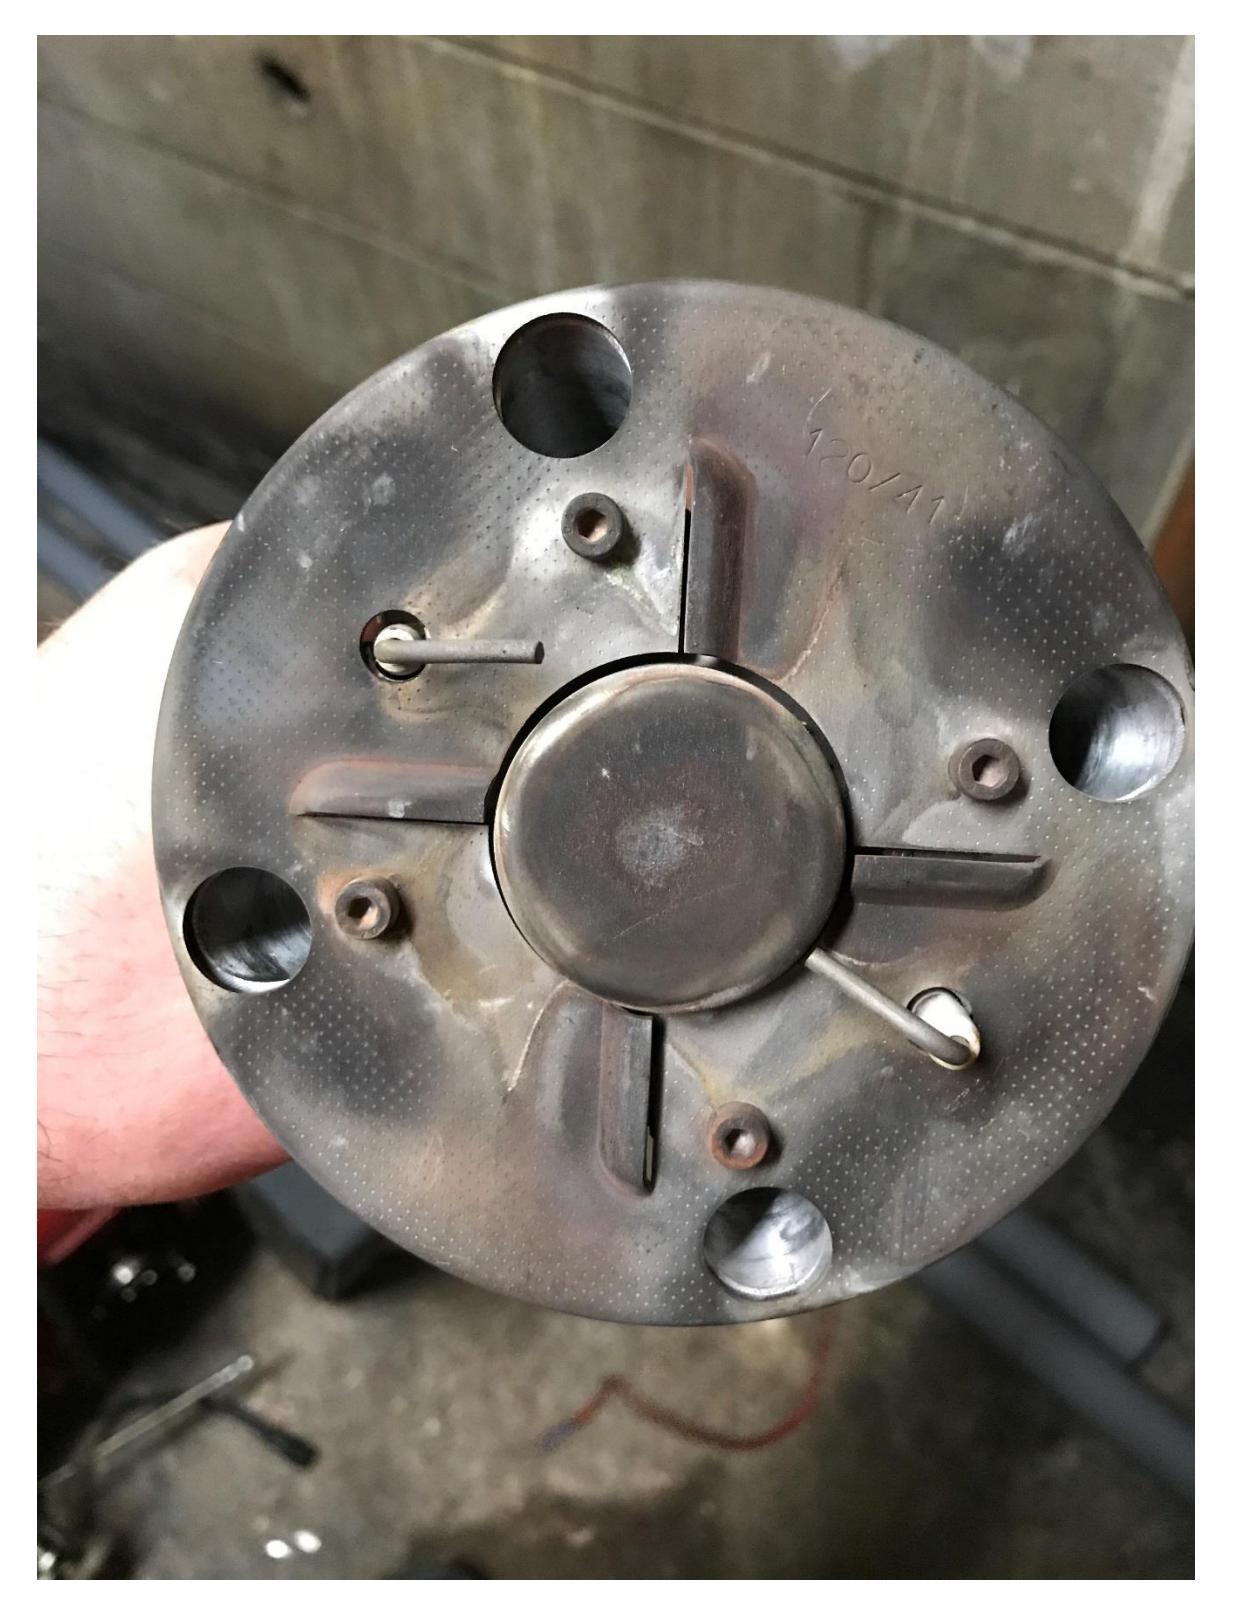
Burner head, with no signs of apparent damage, cracking or warping. This rules out any damage to the burner as being a cause of hard light off in this appliance.

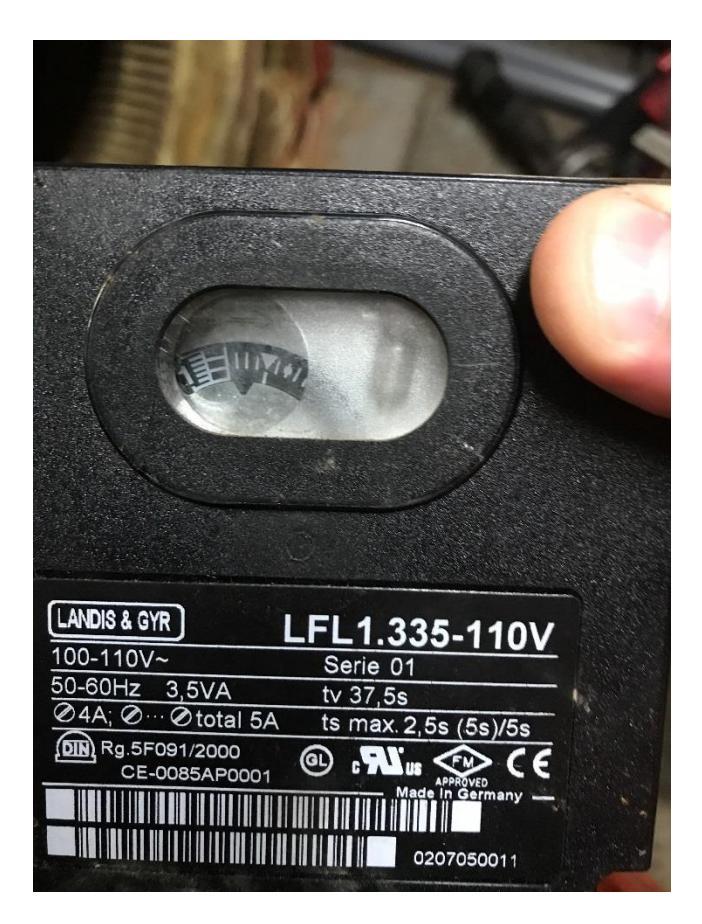
The position of the indicator dial on the flame safeguard at the time of failure. Interpretation of this position in the photos below.

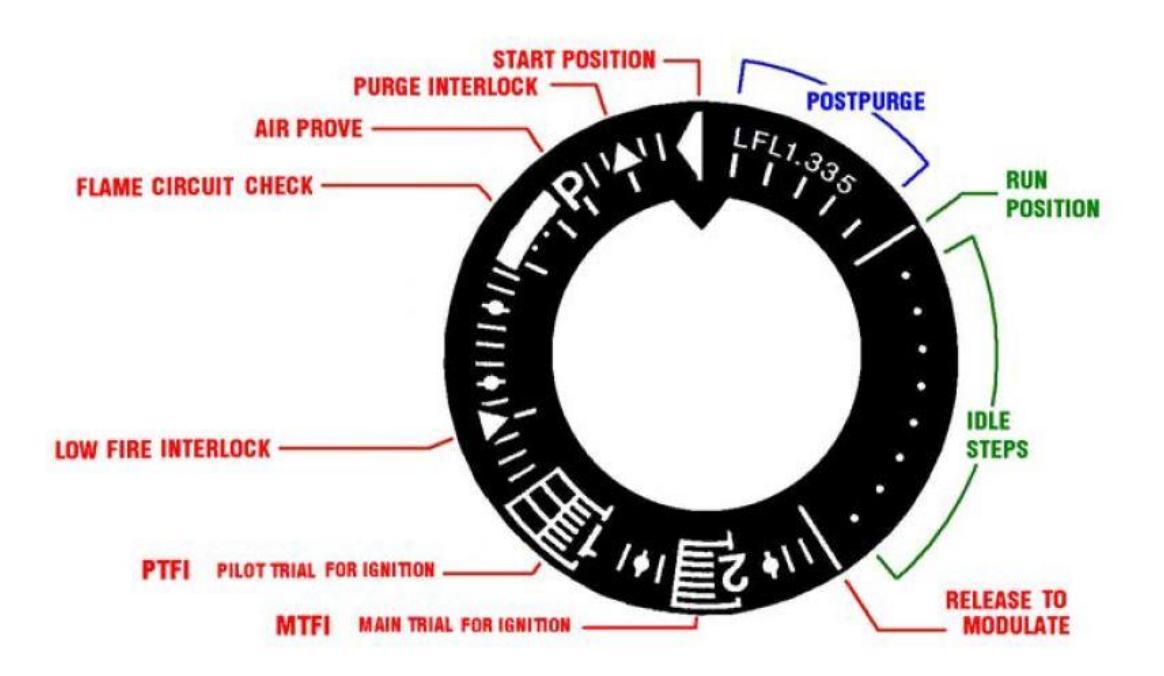
Diagram showing the different positions of the flame safeguard indicator dial. The flame safeguard always begins and ends operation at the start position arrow. When a call for heat is received the dial, and attached cam begin to rotate clockwise to the various points indicated above. At the purge interlock, the appliance is looking for airflow through the boiler before it continues to the pre-purge stage. Between the purge interlock and the low fire interlock is where the pre-purge occurs. When the dial reaches the low fire interlock the low fire start begins. Once the low fire cam is made, the ignition sequence begins, and once a flame is proven the run cycle (release to modulate) begins.

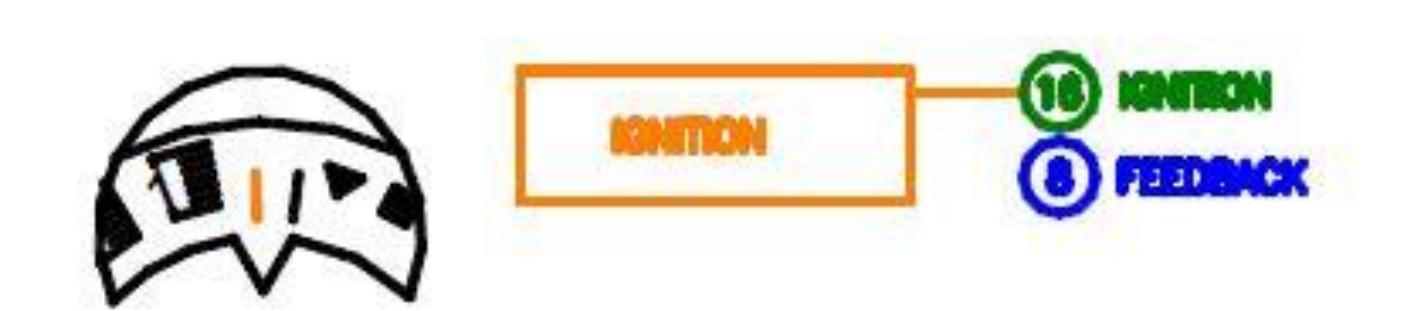
Figure 8

Diagram showing interpretation of the point when the failure occurred. Green text indicates an output that has been energized, blue text indicates an input which is being monitored by the flame safeguard. So in this situation the boiler had energized the spark rod and attempted to light the boiler when the failure occurred.

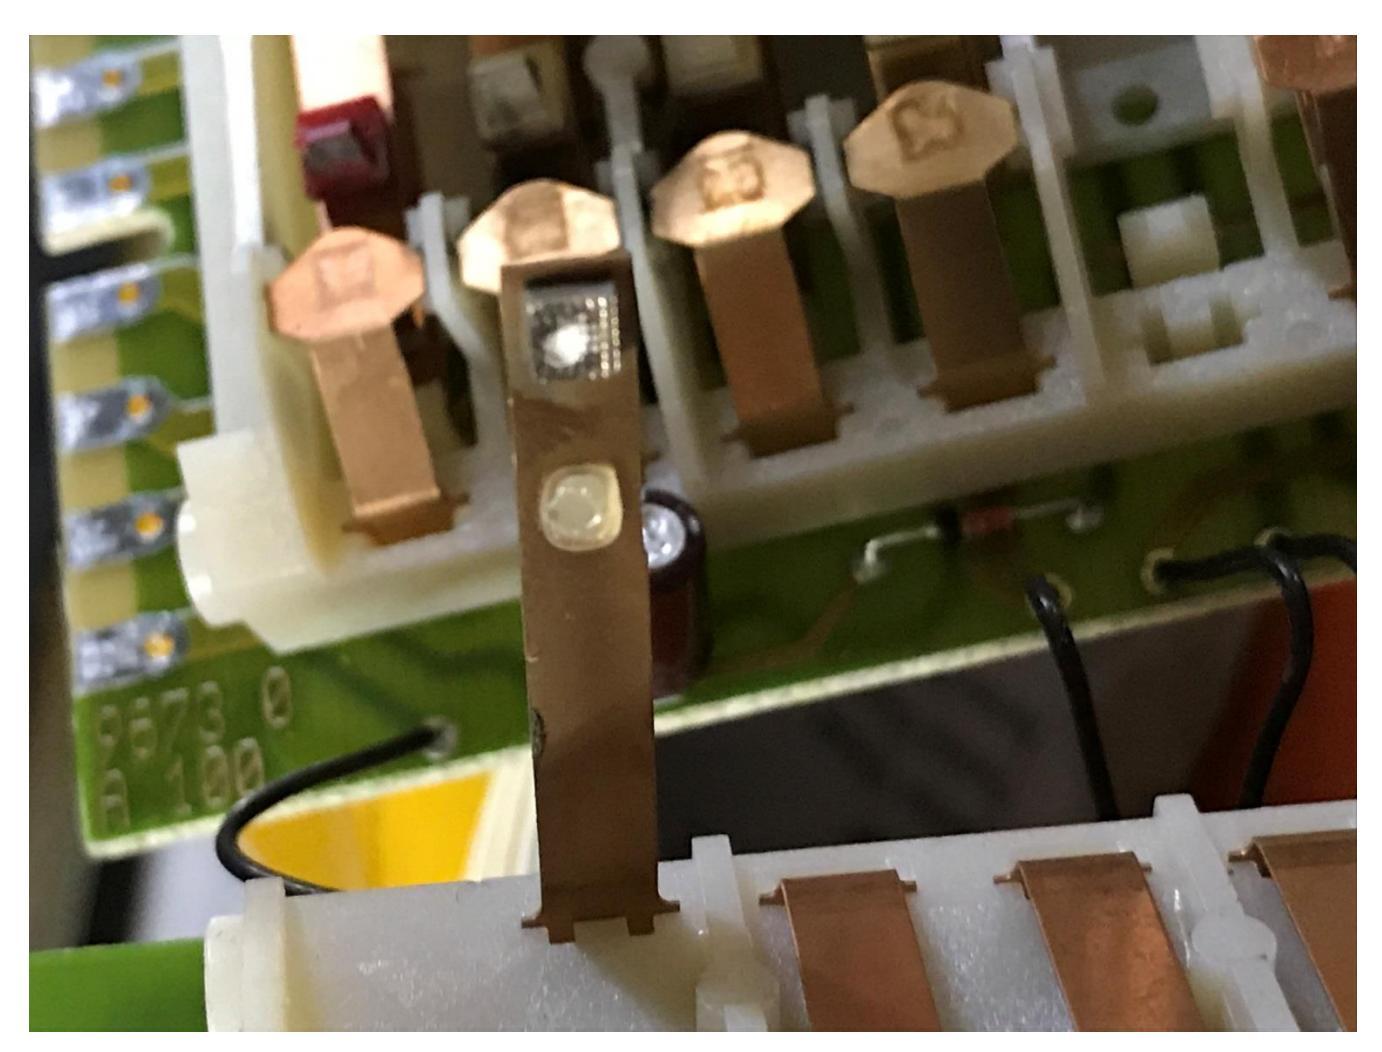
Picture of top contact for ignition output, while photo does not clearly show there is a pit on the contact where metal was removed and welded to the bottom contact. This enforces the possibility that perhaps a fault in the flame safeguard caused the failure.

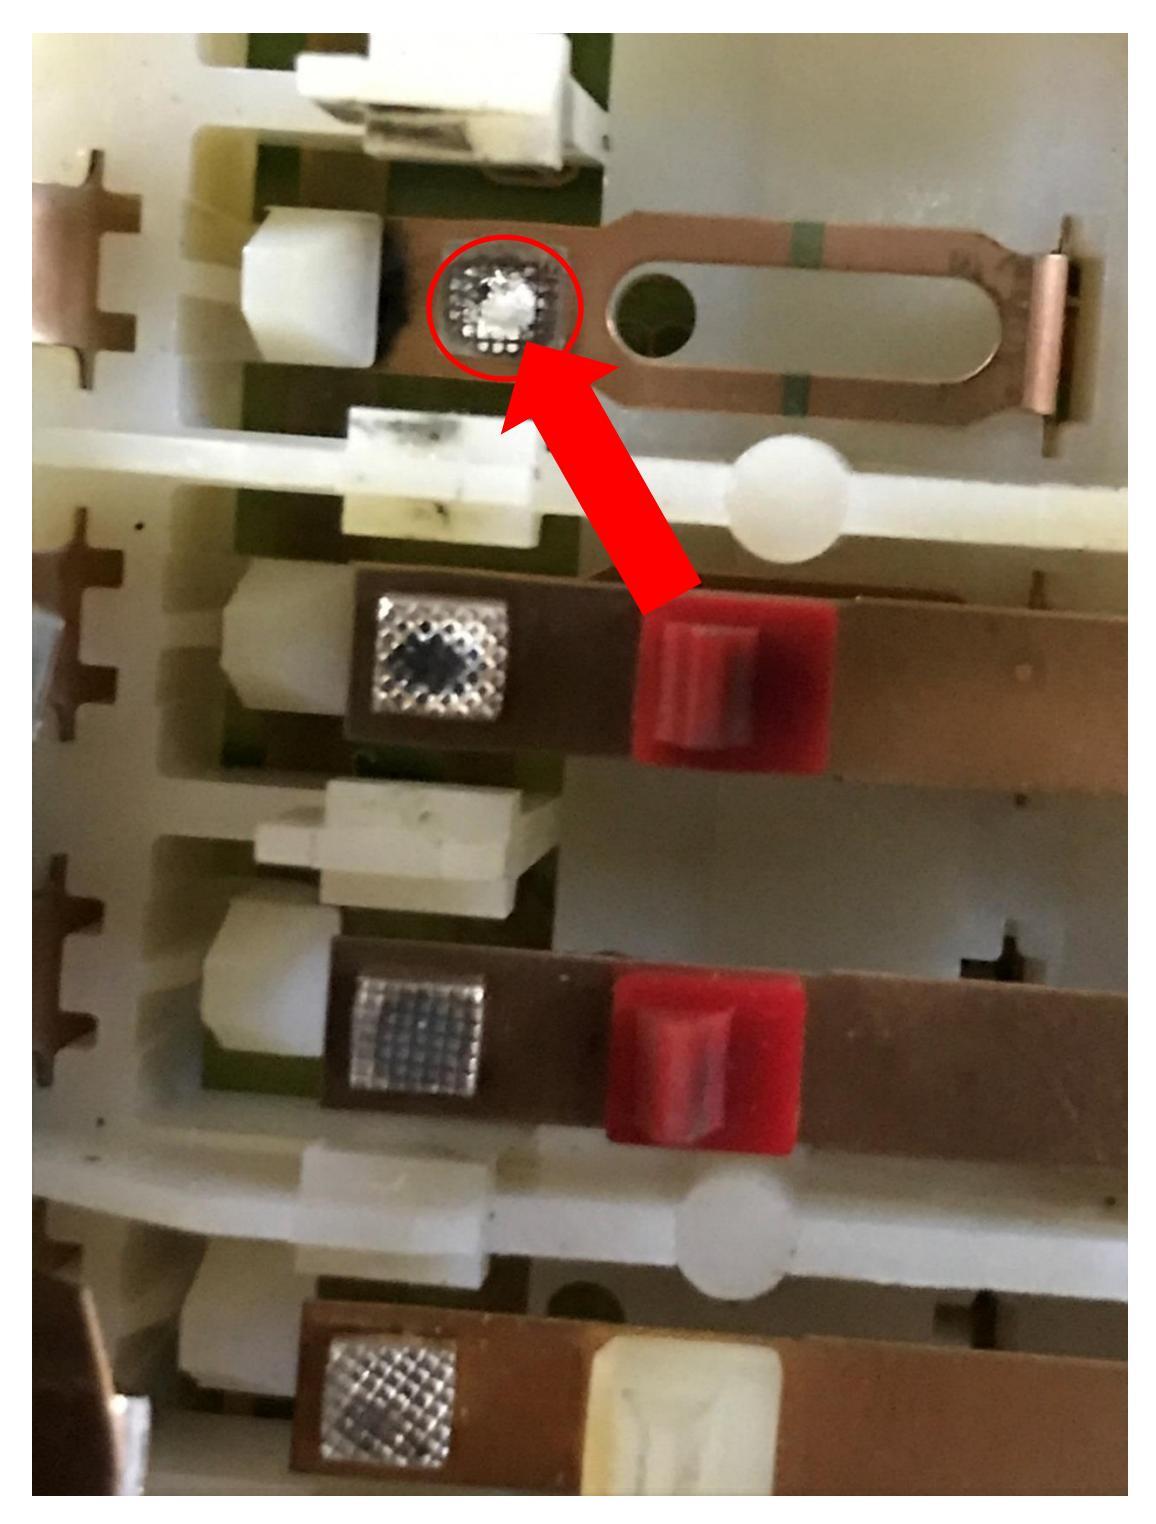
Photo of bottom ignition contact, while it is difficult to see there is a small raised piece of metal on the contact.

The red circle shows the surface area of the ignition contact, and the red arrow shows the raised piece of metal on the contact surface.

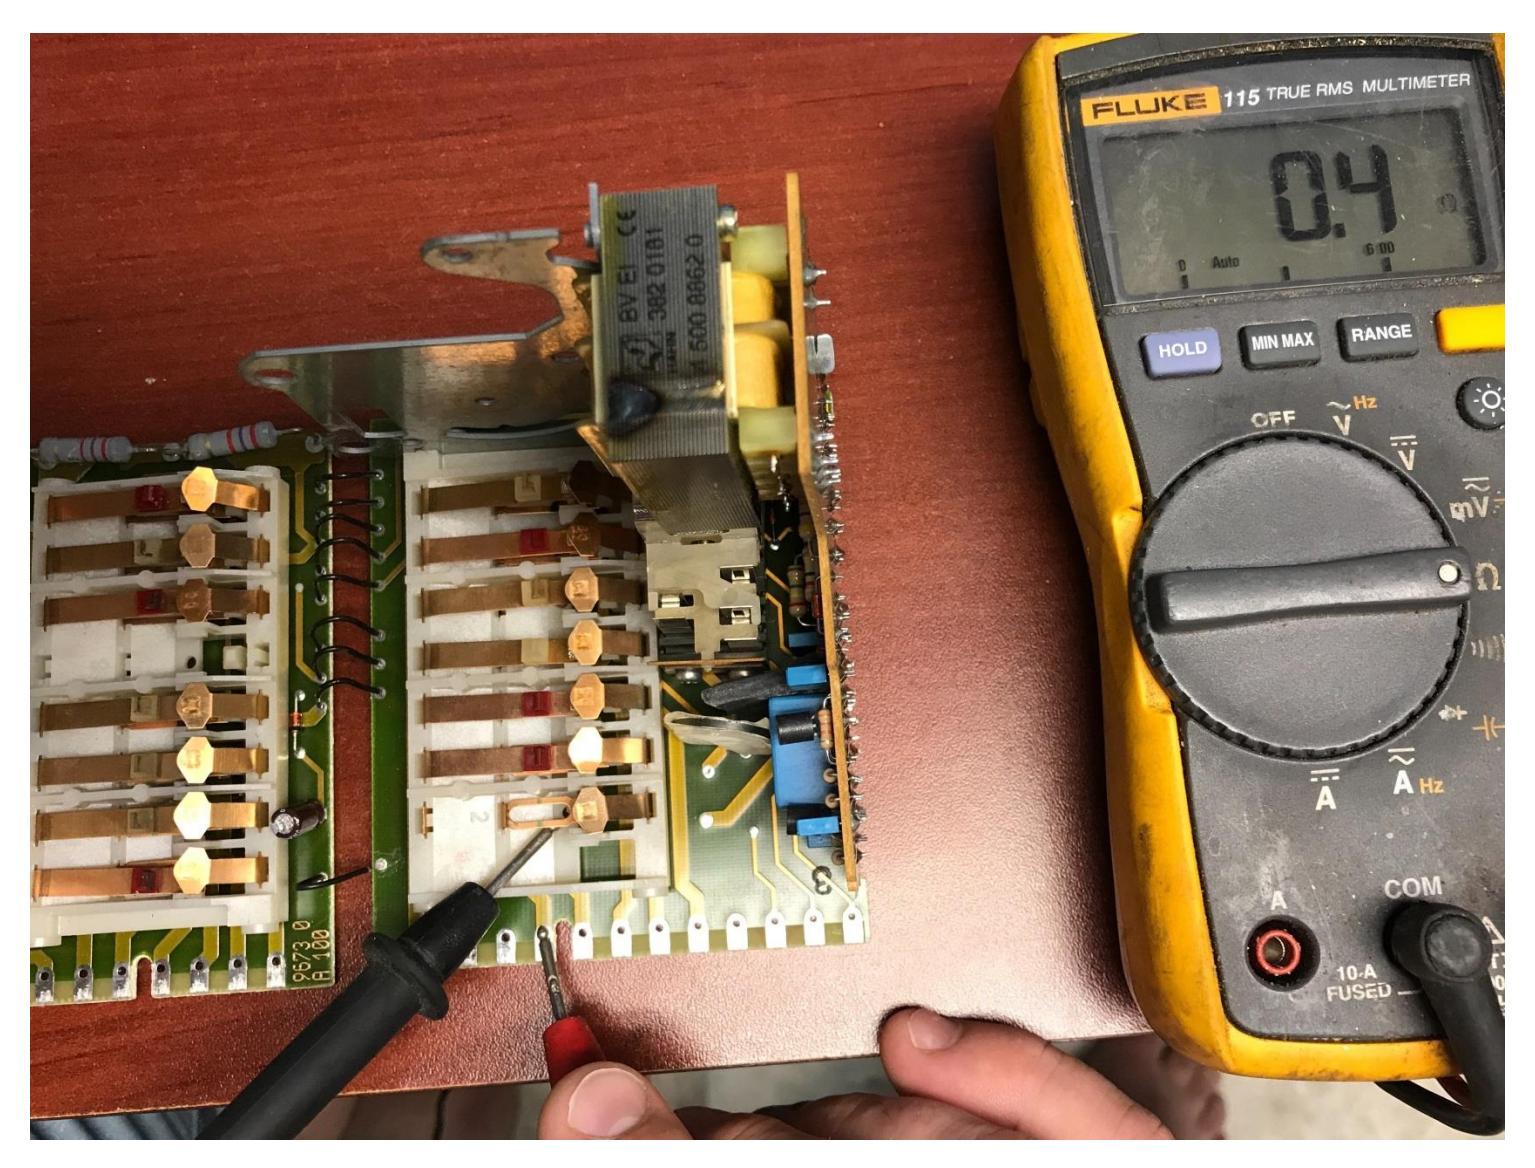
A continuity test was performed to determine if the damaged contact in question served the ignition output #16 for the flame safeguard. This test determined that the lower contact with the welded piece of metal did in fact serve the ignition output for the flame safeguard. However further tests determined that this contact did not also energize the safety shut off valves for the appliance, reducing the possibility that a fault in the flame safeguard was the cause.
