SR22® PISTOL PRODUCT SAFETY BULLETIN

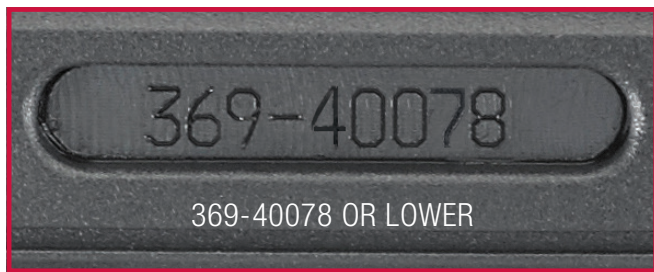
Any SR22 with serial number **369-40078** or lower (including those with a “SS” serial number prefix) is subject to this Safety Bulletin, **IF** it has either: (1) exhibited (or exhibits in the future) a slack single-action trigger; or (2) discharged upon decocking. If you have ever experienced either of these conditions with your SR22 pistol, you should stop using your pistol and **sign up** for the Safety Retrofit.

STEP 1: If you meet the criteria above, **sign up** for the retrofit at Ruger.com/SR22Retrofit or contact Ruger Customer Service at **336-949-5200**.
