Incident Summary #II-744934-2018 (#8435) (FINAL)

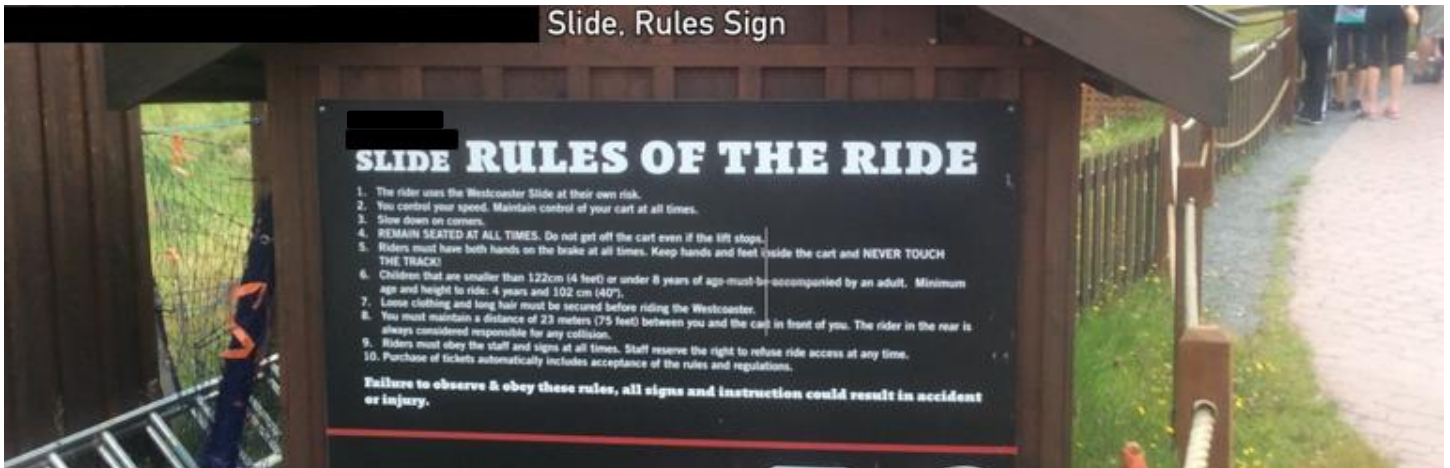
Failure scenario(s)	Rider's hand was caught between the cart they were riding and the track (flume) system.	
	Facts and evidence	<p>Statements provided by the operator indicate that:</p> <ul style="list-style-type: none"> An adult rider arrived at the bottom station and got off of the cart they were riding. A few moments later the spouse of the rider informed the attendant on duty at the bottom station that the rider seemed to have fractured their hand. The spouse indicated that the rider had caught their hand between the cart and track. The first aid attendant providing care indicated that the "patient" was in a lot of pain and was unable to elaborate on the cause of the injury. The first aid attendant agreed that the spouses statement aligned with the injury of the "patient". (The exact location on the track was not determined). <p>Signage at the ride start indicates that, "Riders must have both hands on the brake at all times. Keep hands and feet inside the cart and Never Touch the Track". (See photo 1)</p>

Figure 1, Instructional Signage at the Ride Start, See Rule Number 5.

Causes and contributing factors	It is not possible that the riders hand would have been caught between the cart and the track if both hands had been on the brake. It is likely that instructional signage related to riders keeping both hands on the brake and riders not touching the track were not being followed.

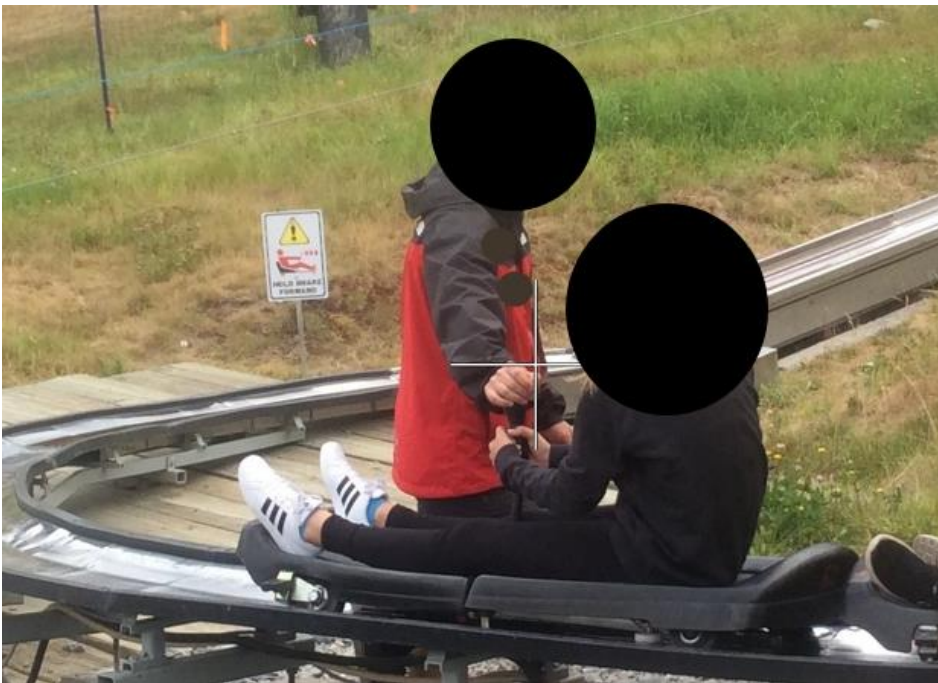
Figure 2, Rider on a cart with the attendant, Rider has both hands on brake
