Incident Summary (#5612964)

SUPPORTING INFORMATION	Incident Date		March 9, 2017	
	Location		Abbotsford	
	Regulated industry sector		Electrical – Low Voltage Electrical System (30-750V)	
	Impact	Injury	Qty injuries	0
			Injury description	N/A
			Injury rating	None
	Damage	Damage description	Revenue meter in the electrical room of an industrial building failed causing a fire. The meter was heavily damaged, the meter base and the fused switch protecting it were damaged. Damage to a small section of conductors for the tenant space.	
			Damage rating	Minor
	Incident rating		Minor	
Incident overview		Tenants noticed lights flickering and when one of the tenants opened the electrical room door on the exterior of the building they noticed smoke and flame. A tenant extinguished the fire and the fire department was notified. The fire was contained within the electrical room.		
INVESTIGATION CONCLUSIONS	Site, system and components		The local power utility company meter, installed in a meter base. It was used for revenue metering.

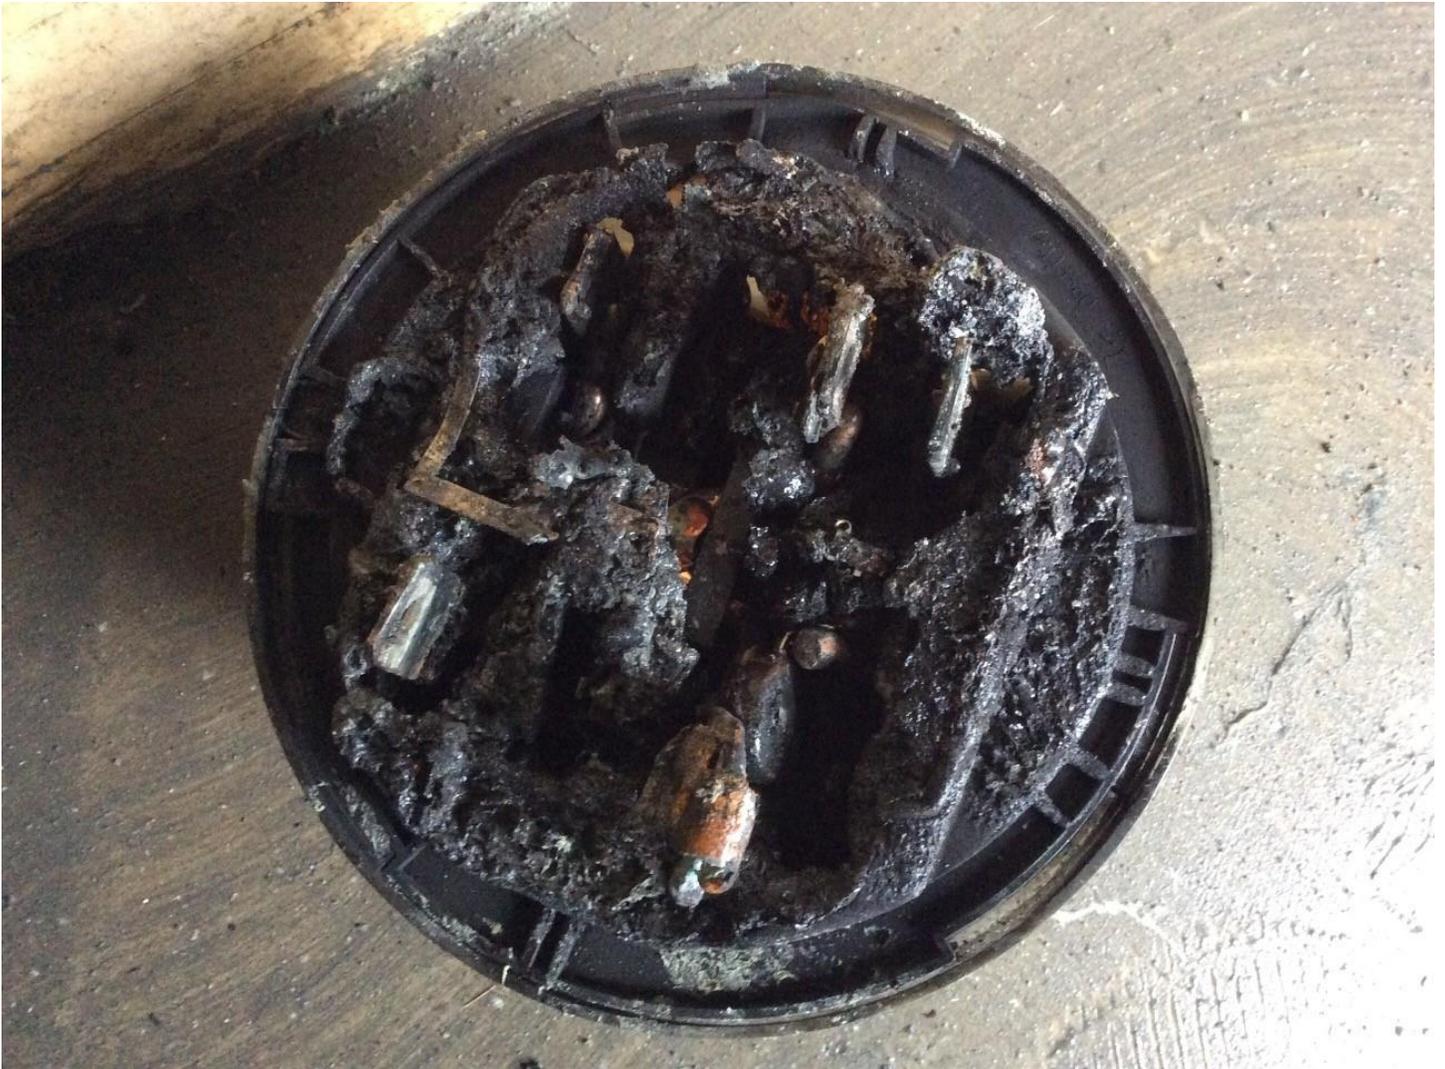
Causes and contributing factors		The revenue meter had the most severe damage inside the meter base in the centre of the meter. Heat and fire radiated out from there. A failure in the meter base is the probable cause.

Rear of revenue meter showing damage radiating out from centre.

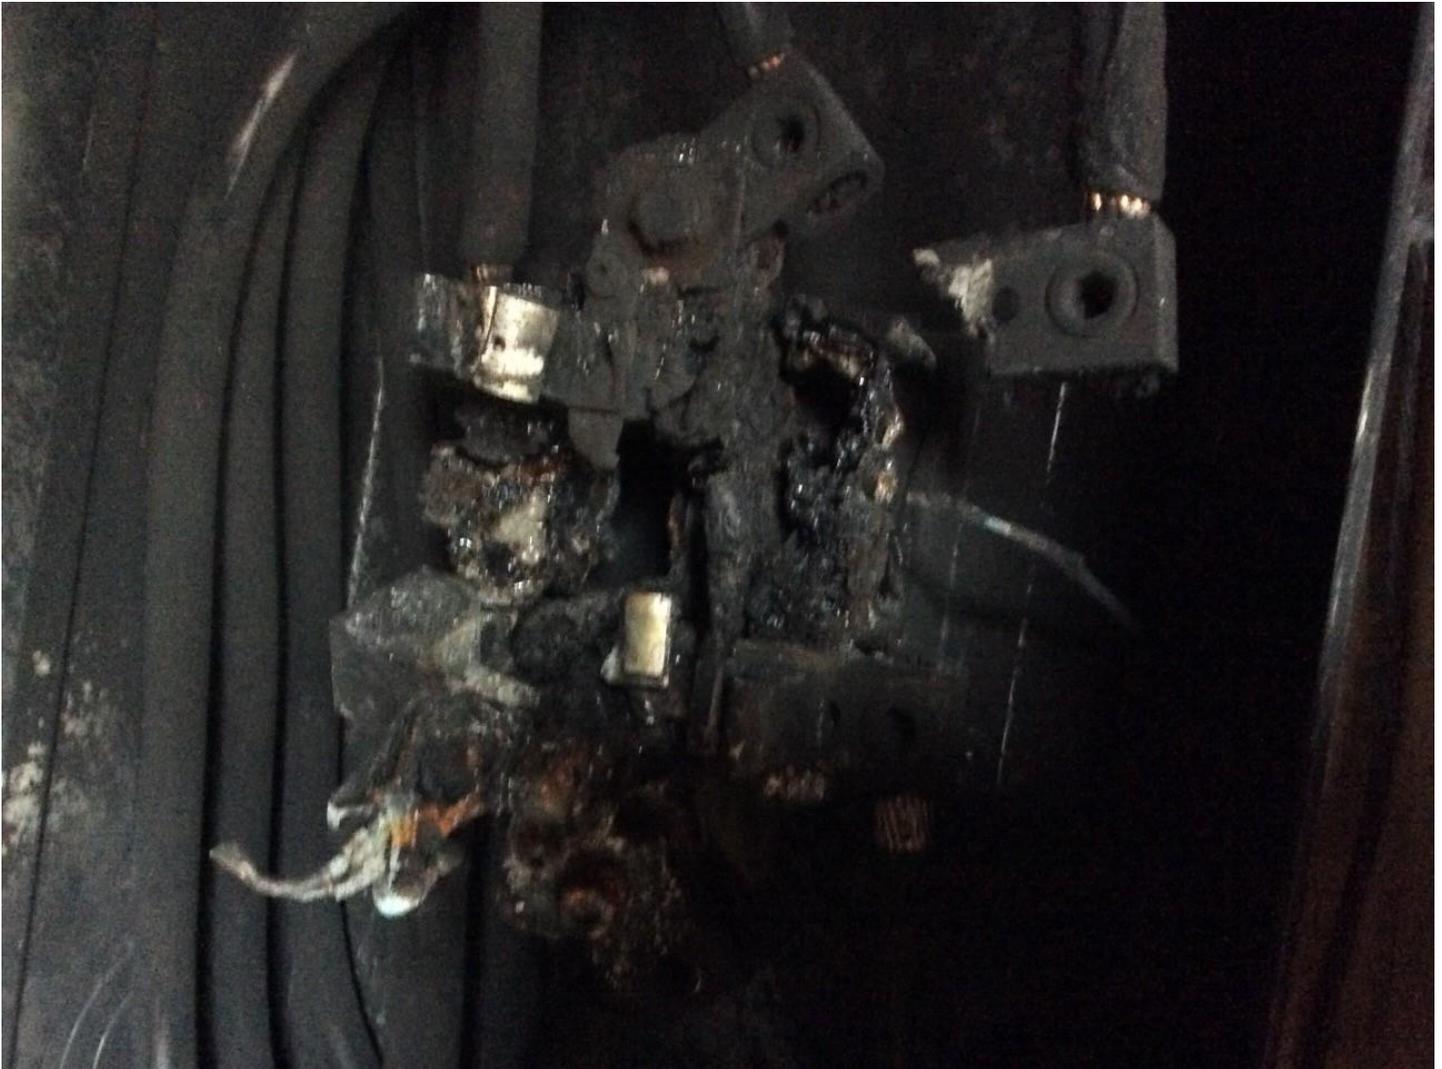
Failure scenario(s)		The revenue meter should have failed safe inside the metal meter base. However, the original electrical installer for the service and metering equipment failed to isolate the neutral conductor inside the meter bases. Therefore, when the fault occurred the overcurrent devices could not function and a fire resulted.	
	Facts and evidence		A tenant noticed flickering lights and upon investigating its cause found smoke and flames in the electrical room. The revenue meter was badly damaged and there was smoke and heat damage to the meter base, the fused switch, and cable damage for one tenant space. The majority of damage was in the meter base which was located above the fused switch. Fire burned up to damage a small section of the cable and down into the fused switch. The meter was damaged where it connects to the meter base. All components in the meter base were showing damage and the majority of it was in the centre of the meter base.

Inside of meter base. Showing damage radiating out from centre.
