## Incident Summary Report II-690797-2018 (7294) (Final)

SUPPORTING INFORMATION	Incident Date	May 19, 2018	
	Location	Kelowna	
	Regulated industry sector	Amusement Devices – Amusement ride	
	Impact	Qty injuries	None – 1
		Injury description	Traumatized
		Injury rating	Insignificant
	Damage	Damage description	None
		Damage rating	None
	Incident rating	Insignificant	
	Incident overview	31 passengers were on a ride that only has capacity for 30 people, therefore one passenger was without a position on the ride. Operator then started ride. Passengers informed operator immediately, that a passenger on the ride did not have a position and not secured by safety restraint. Ride was immediately stopped.	
Site, system and components	Succeeding the loading of no more than 30 new passengers, the operator must ensure all riders have a position (cell) and each individuals safety restraint is secure. Once operator has verified everyone on ride is correctly positioned they may begin ride operation.

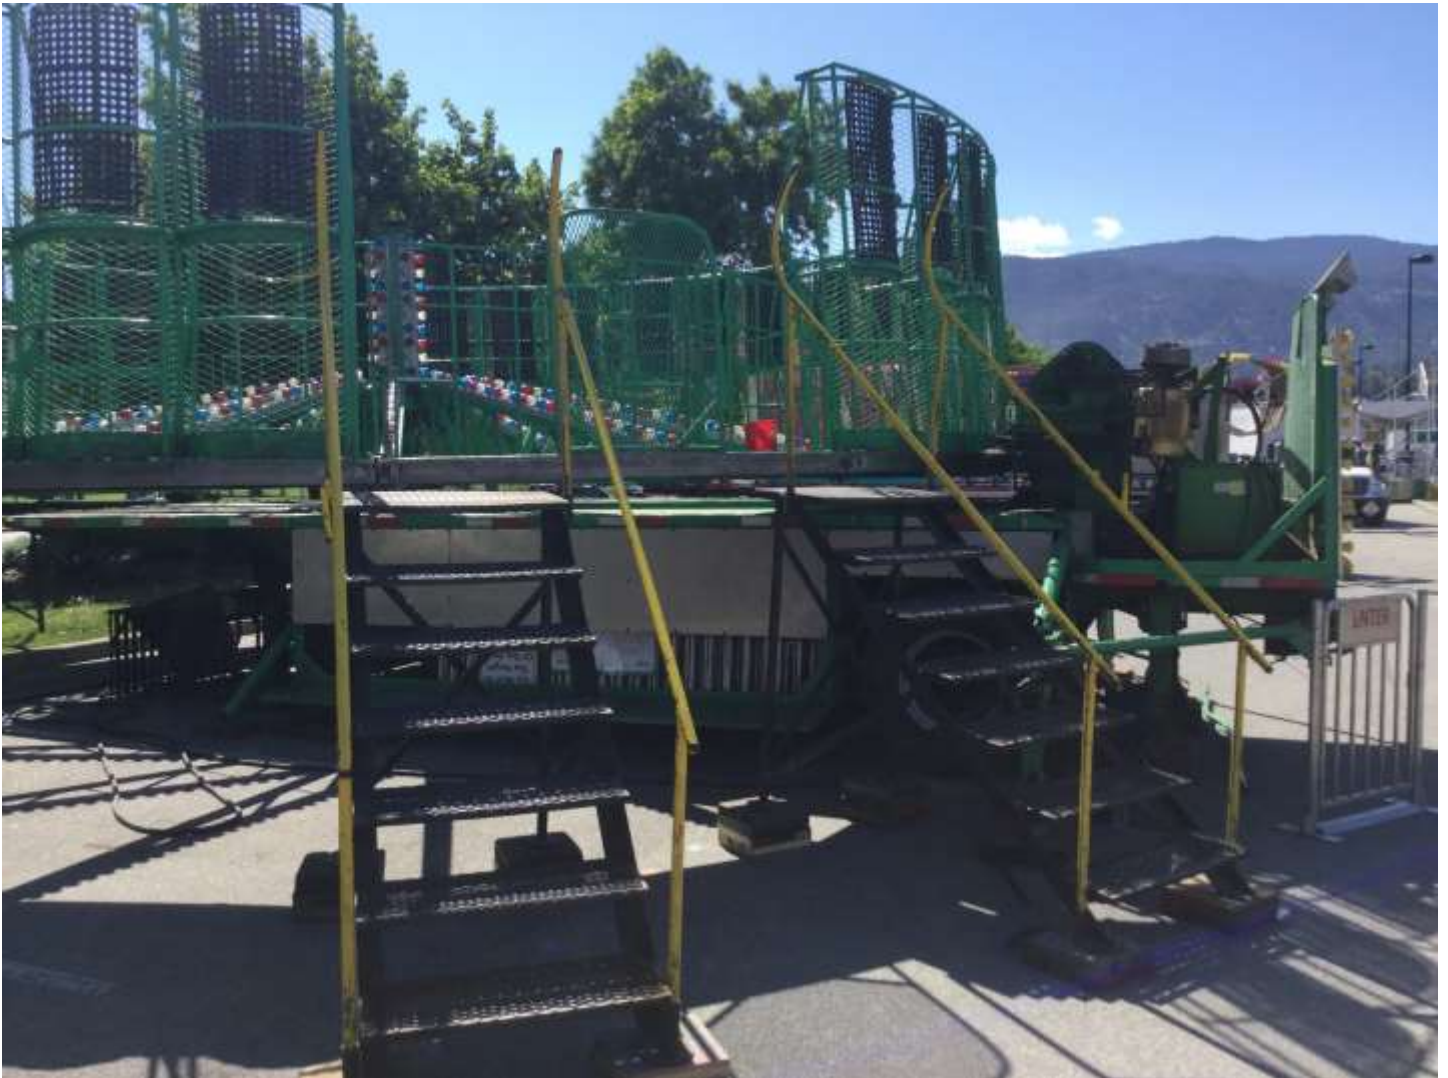
Loading and unloading area

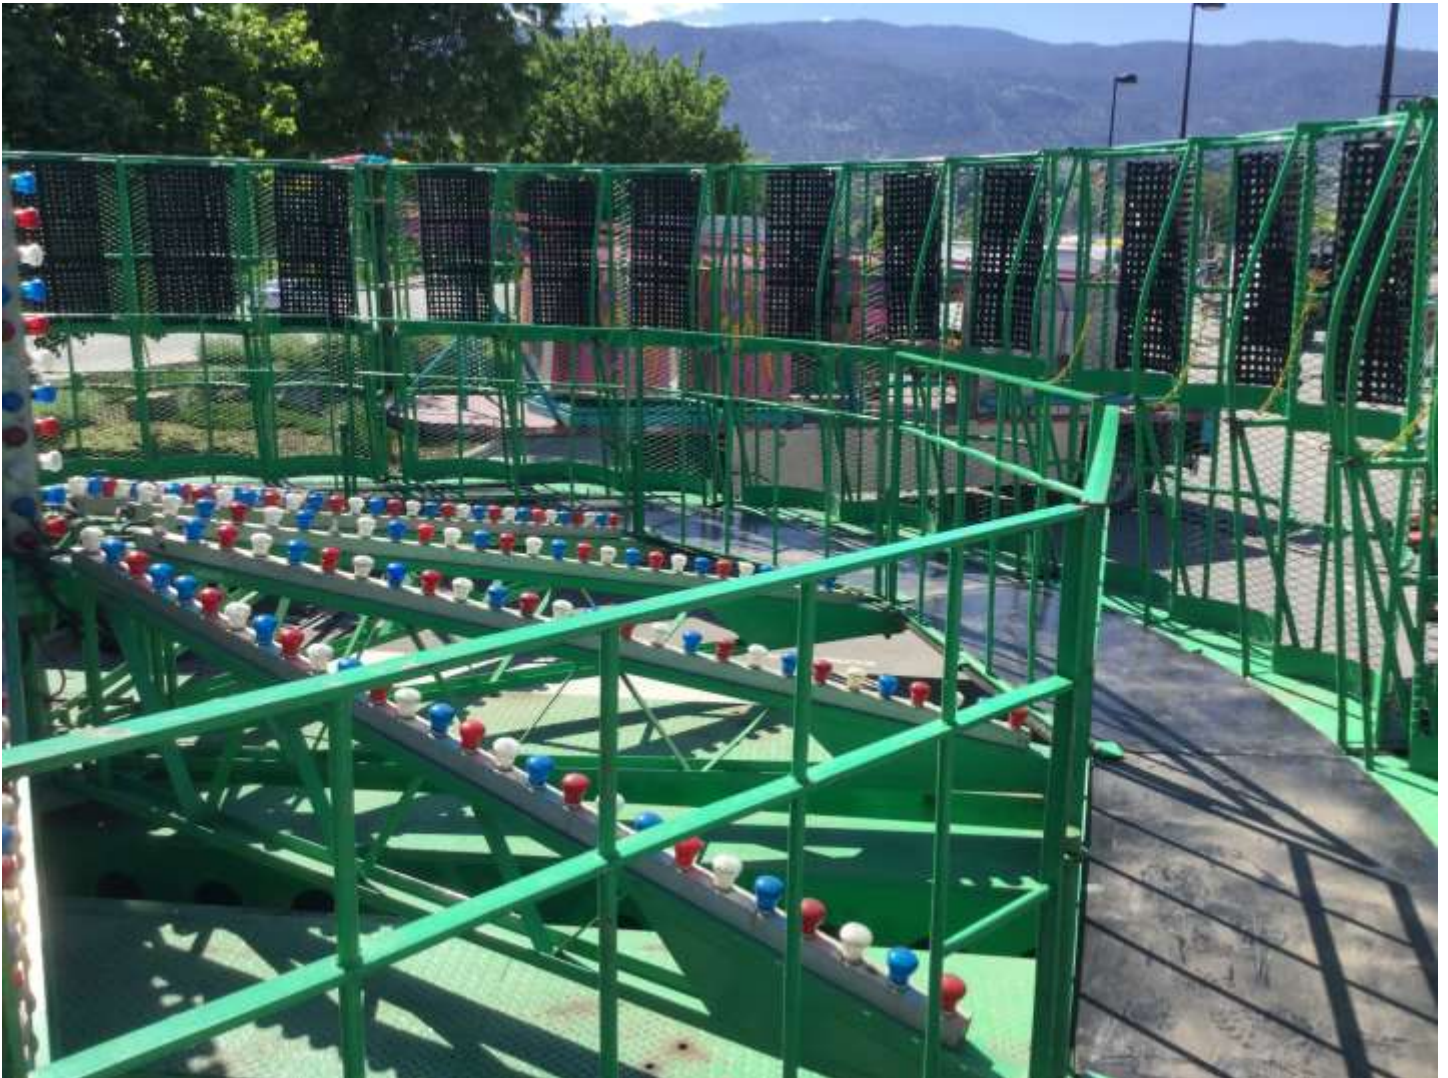
Rider "Cells" and inner walkway
