Incident Summary (Reference # II-694077-2018)

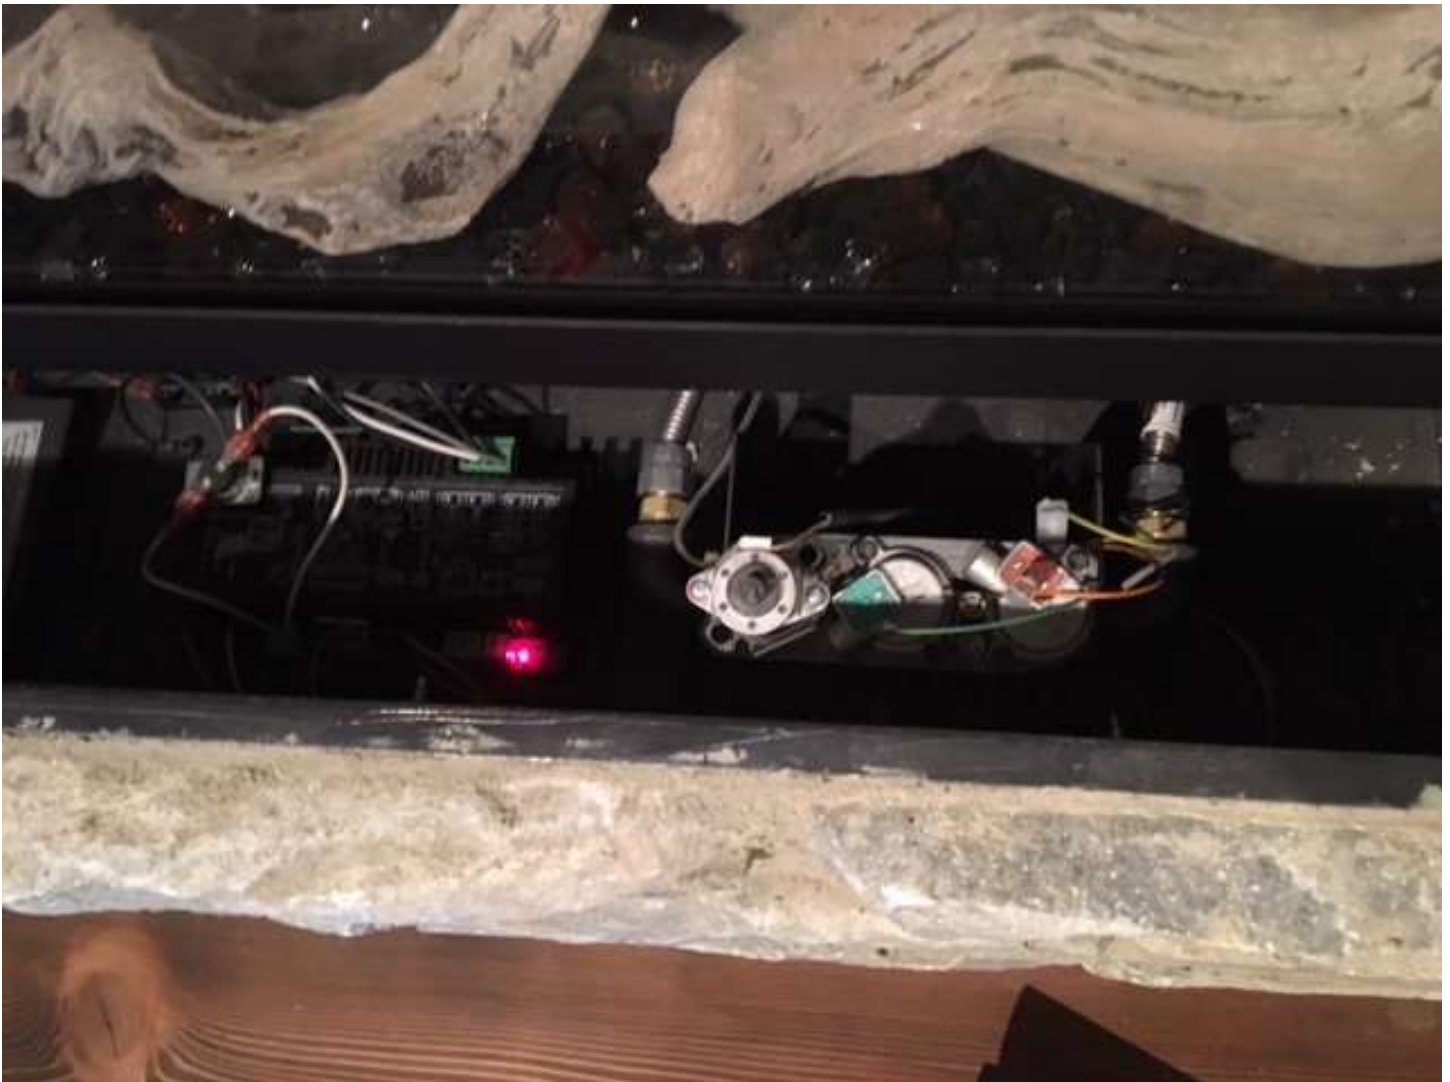
This is a picture of the gas safety valve that failed
