Investigation Report

Lakeland Mills Ltd. – Explosion and Fire – April 23, 2012

BC Safety Authority – Incident Investigation – Jurisdiction and Role

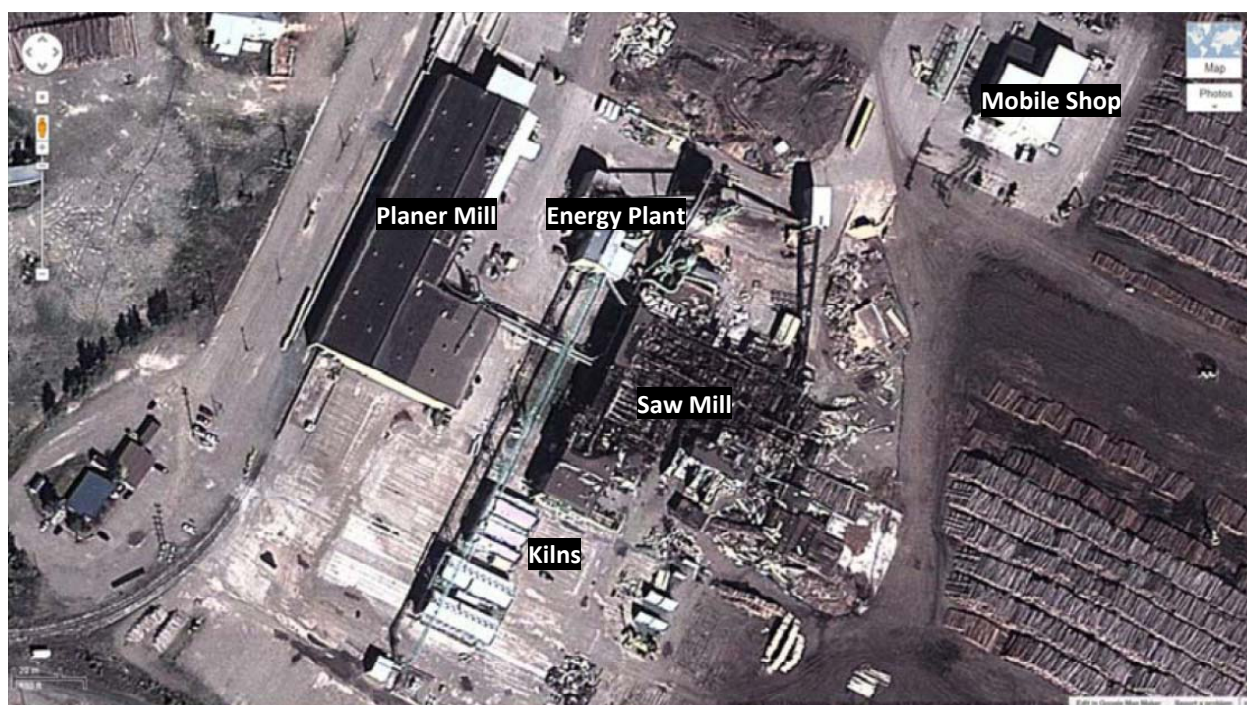
Photograph 1: Google satellite view of the Lakeland Mills Ltd. site after the explosion and fire.

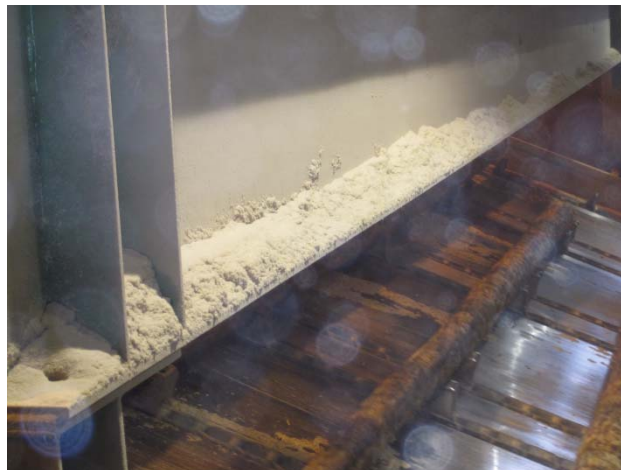
Photograph 4: Combustible dust accumulations around stairwell horizontal surfaces.

Given the above statements, photographs 2 through 5 may not reflect the condition of combustible dust accumulation at the mill just prior to the incident however do reflect conditions that were previously permitted to exist. During interviews, employees stated having initiated a mill clean-up following the January incidents and management statements indicate efforts were being oriented towards improving dust clean-up; however, a hazardous accumulation of combustible wood dust was concluded to have existed in the mill on April 23, 2012.

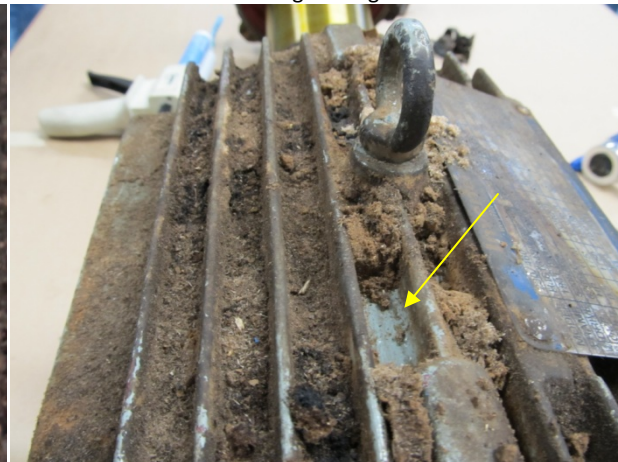
Hazardous accumulations of wood dust were found packed within the junction box and cooling fins of the motor as shown in Photographs 6 through 11. Although this contamination presents ignition hazards and would have impeded proper cooling of the motor, there were no signs of the motor having ignited the packed dust or having overheated during operation. It is therefore considered unlikely that failure or overheating of the motor during operation provided the ignition source for the incident.

Photograph 11: P6 motor – top view showing depth of cooling fin contamination on scraped portion.

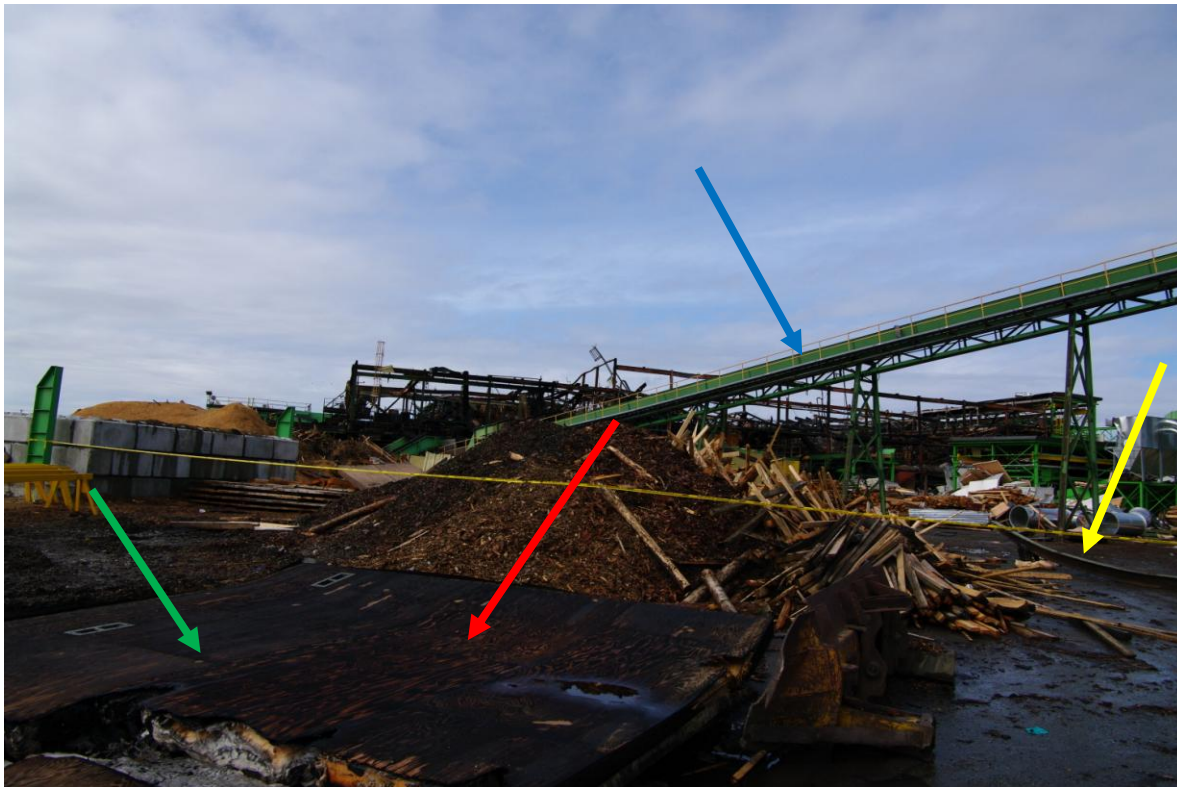
Photograph 1

Facing southwest looking at the door (green arrow) and steel track (yellow arrow) from north side of the operating floor.

Note: the explosion carried the door up and over the conveyor (blue arrow).

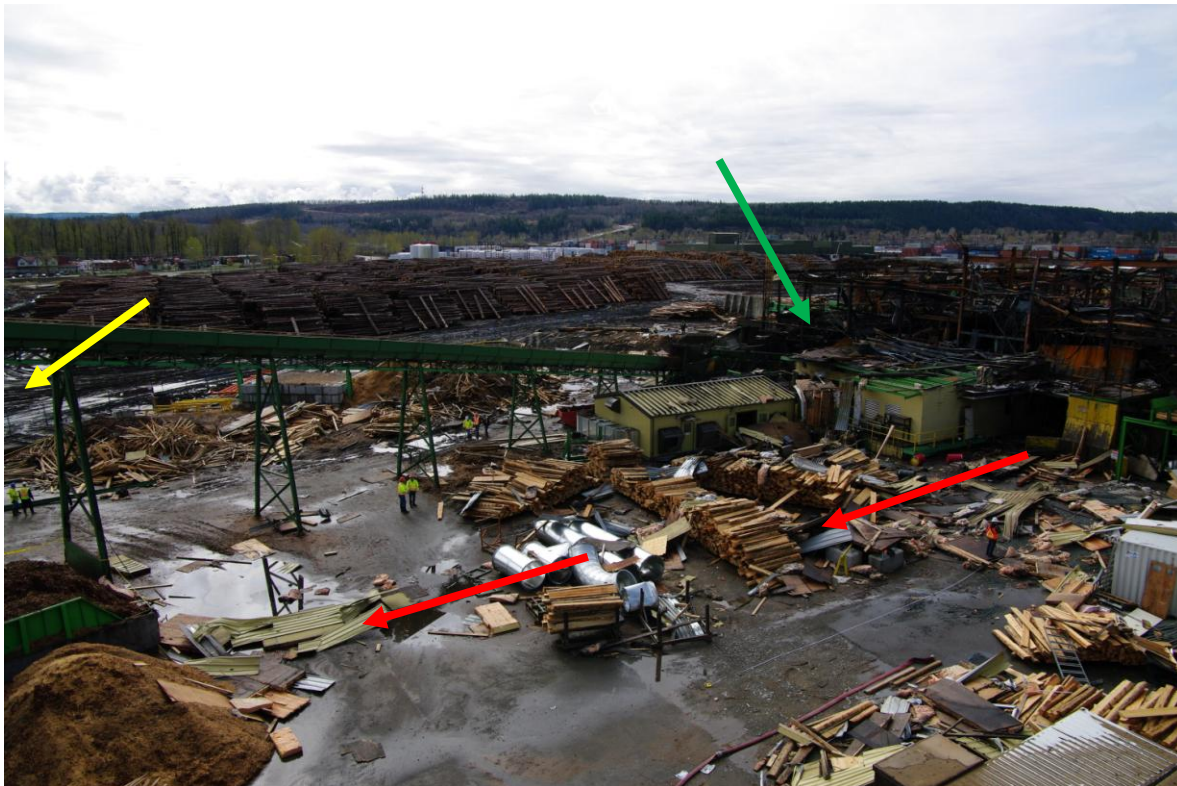
Photograph 2

Blast debris on the north side of the mill.

Note: the origin of door (green arrow) and final location (yellow arrow).

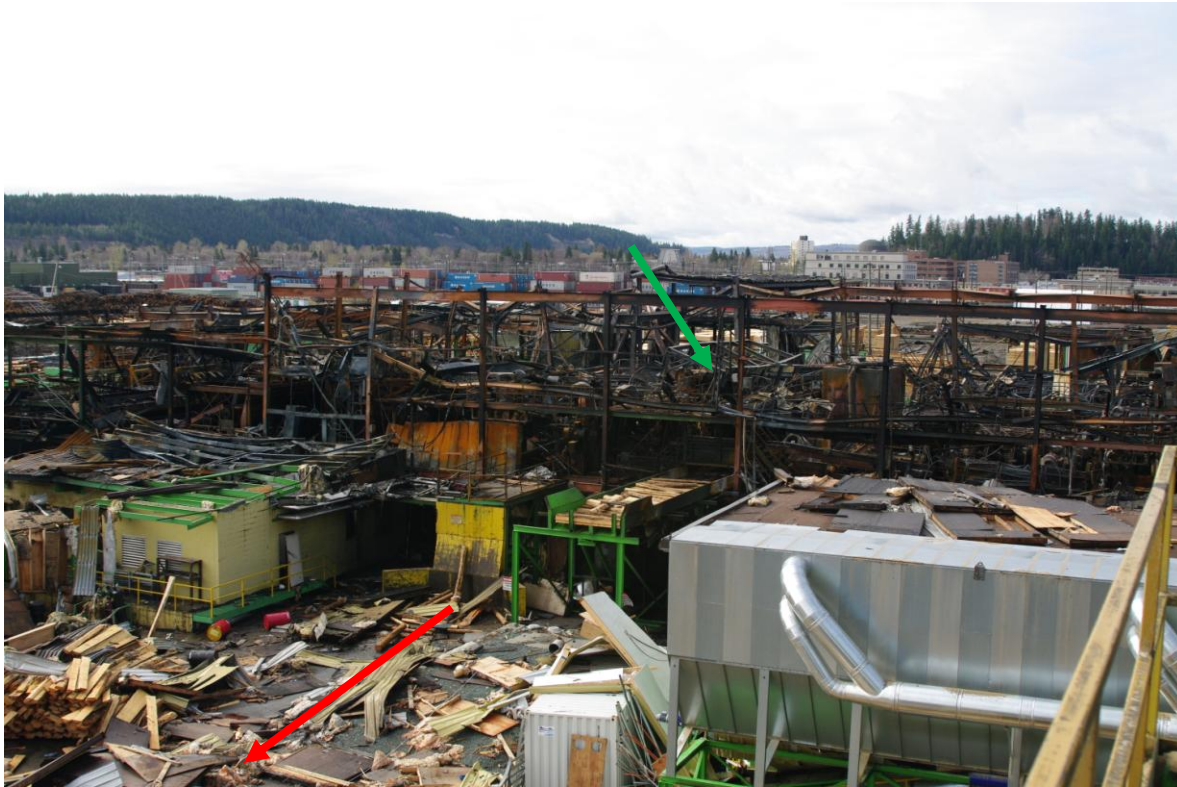
Photograph 3

Blast debris north side.

Note: the location of the large head rig (green arrow).

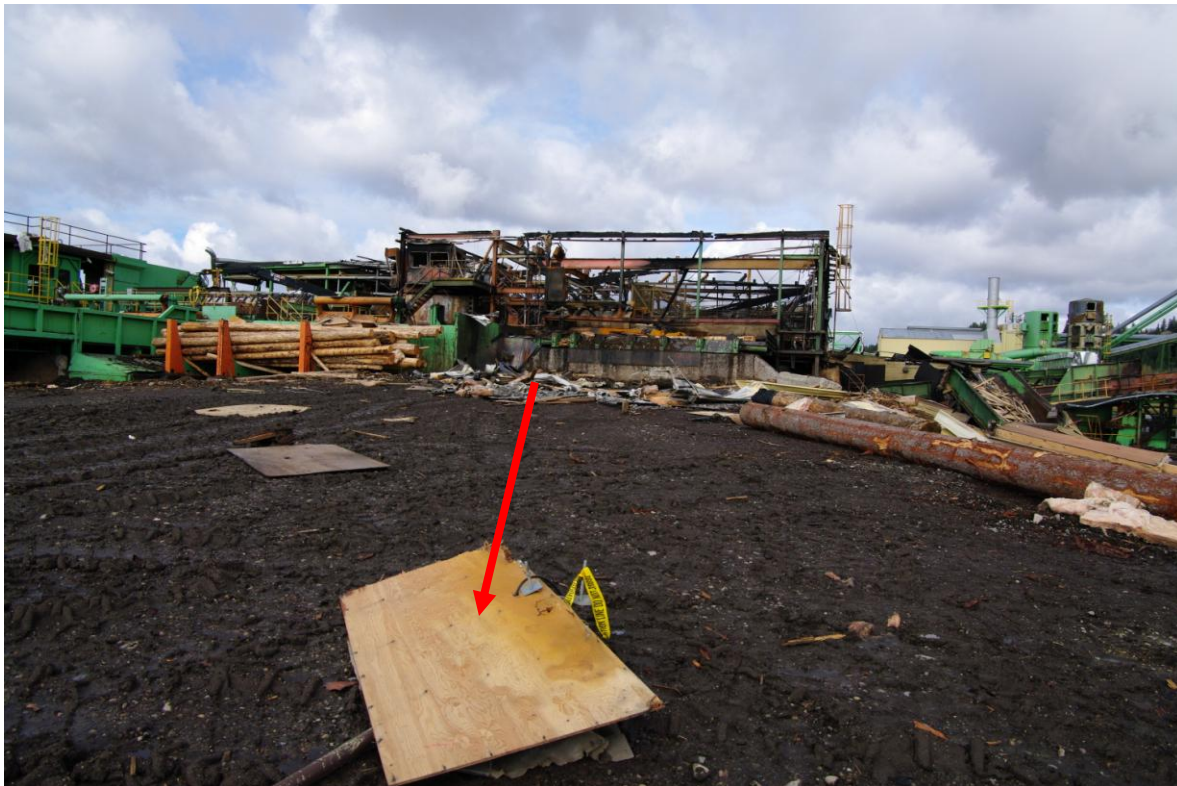
Photograph 4

Blast debris east side.

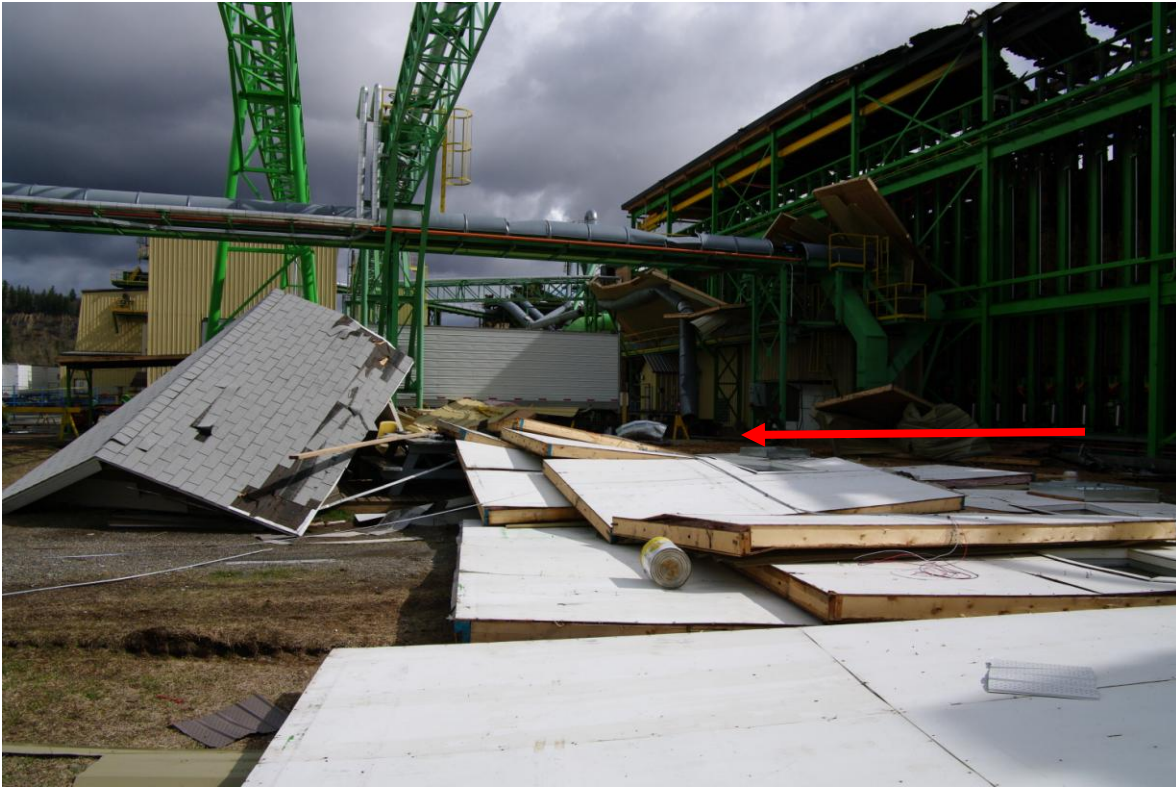
Photograph 5

Blast debris west side.

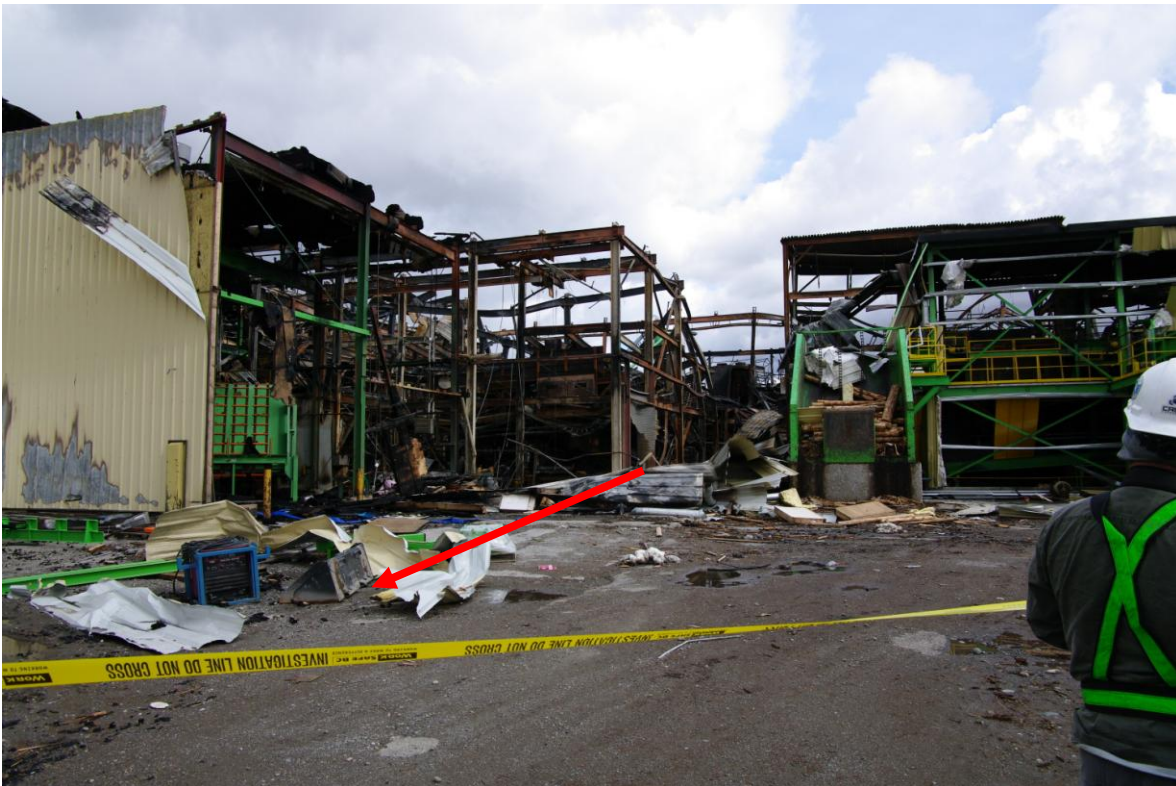
Photograph 6

Blast debris south side.

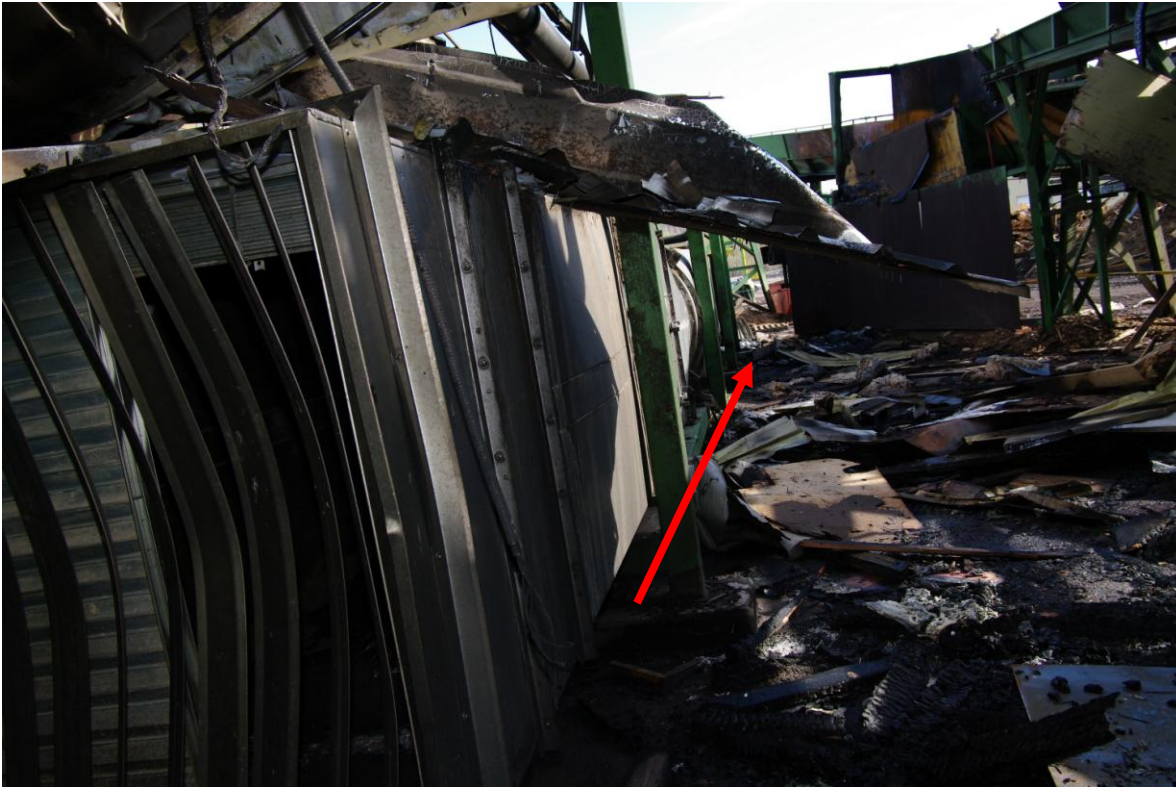
Photograph 15

Facing north at vent trunking grid L-24/25.

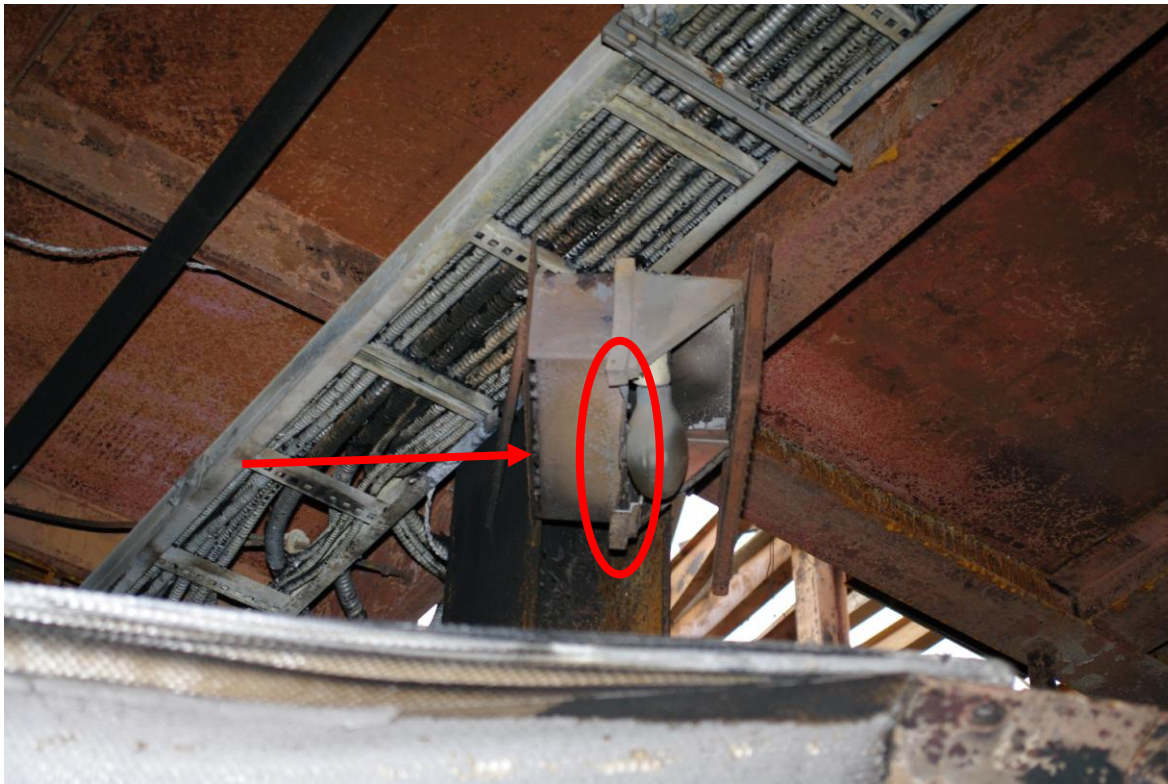
Photograph 20

Light fixture over conveyor 12P grid G-24.

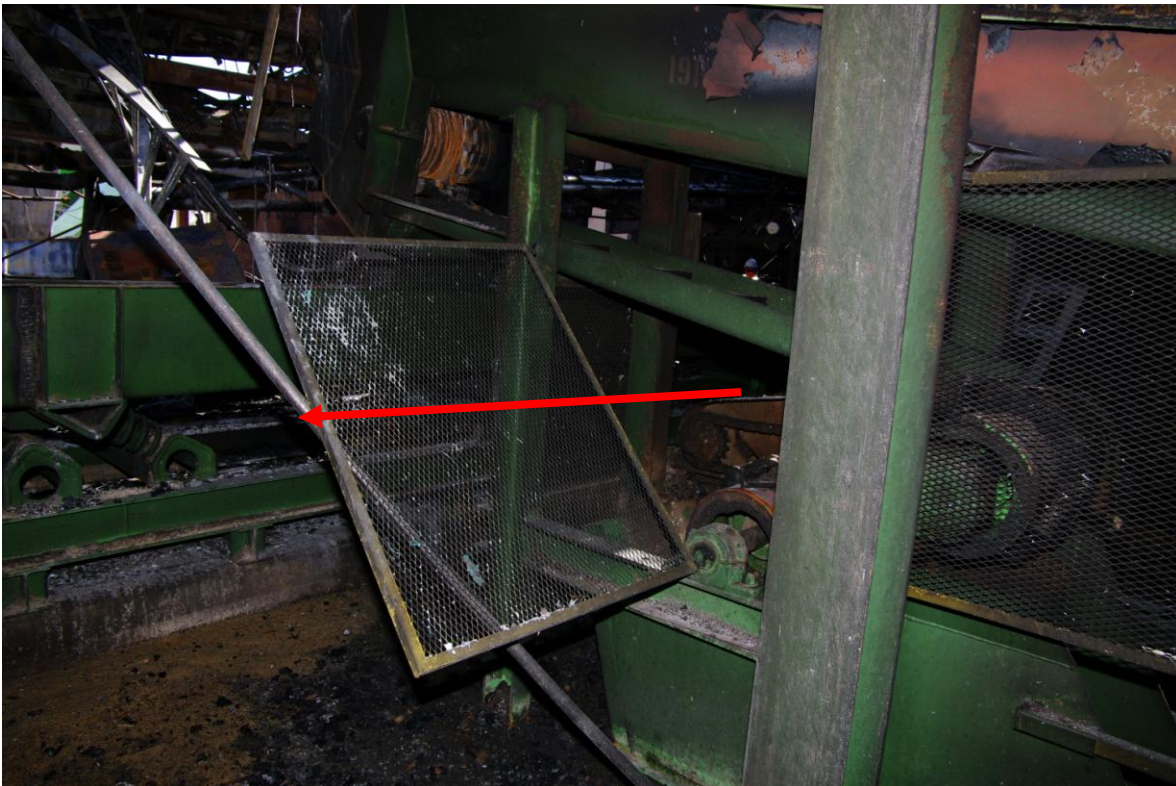
Photograph 22

Facing east looking at a protective screen displaced out to the west, grid J - 17.

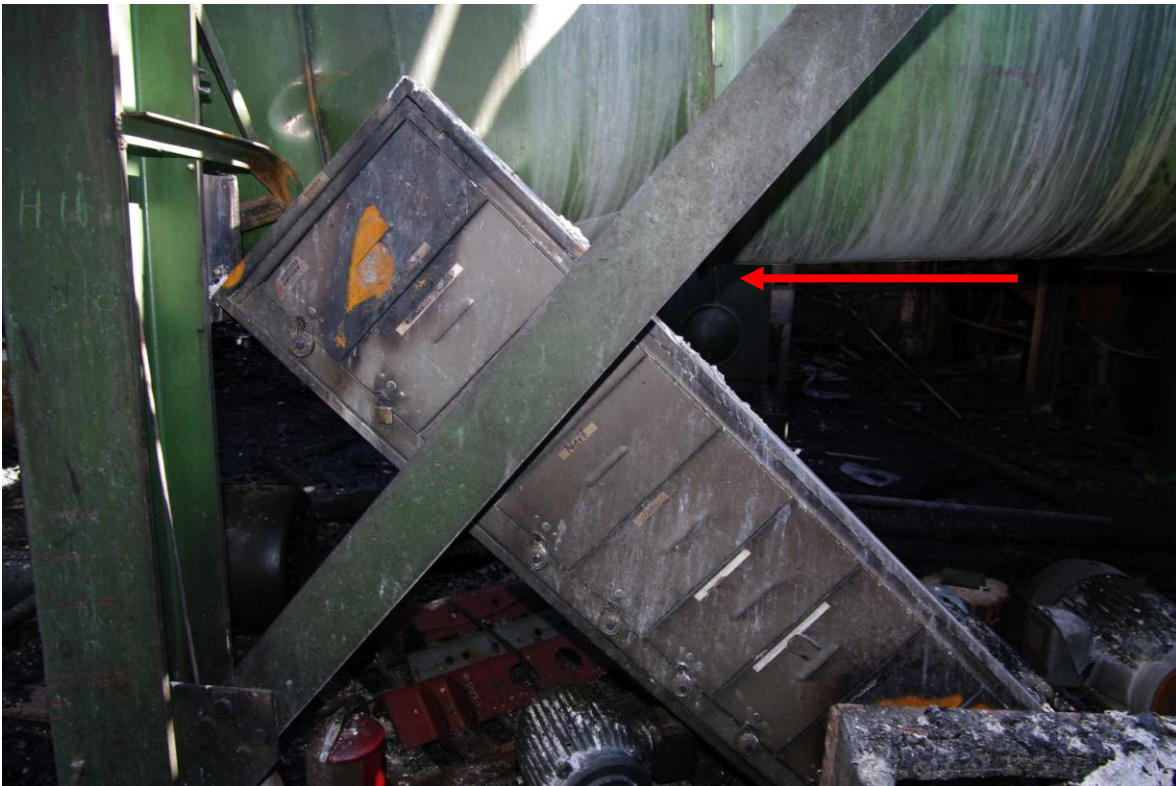
Photograph 24

Facing north looking at a filing cabinet displaced to east to west, grid H-15.

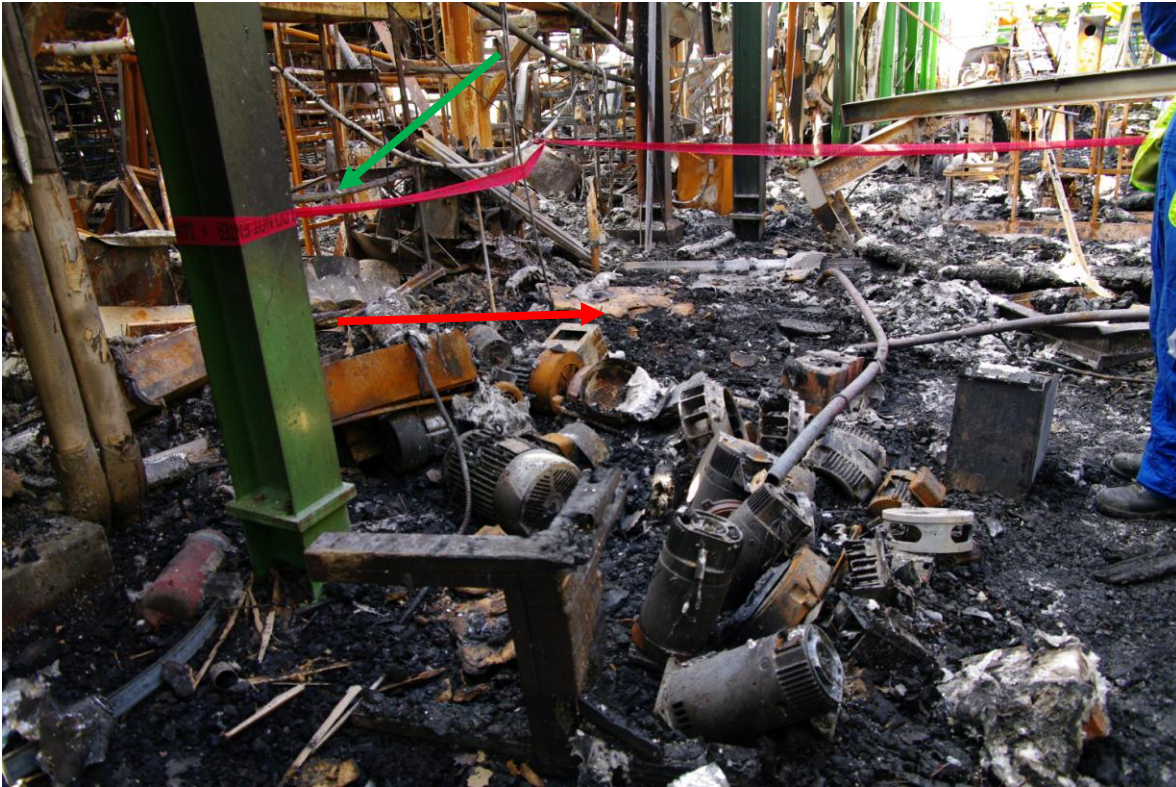
Photograph 25

Facing south looking at the contents of a store room (green arrow) displaced east to west, grid E/F-15/16.

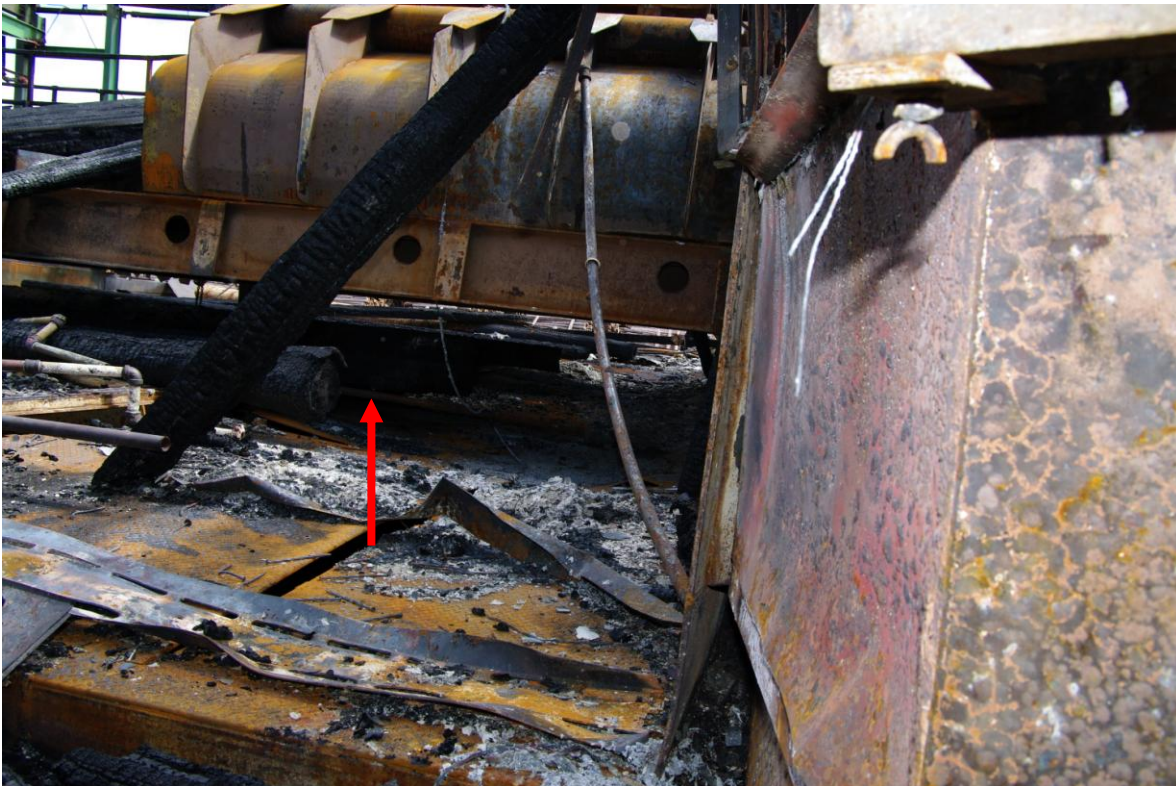
Photograph 28

Facing east looking at the decking in front of the small head-rig operators booth, grid J-22.

Note: the deck plates are separated and bowed upwards (arrow).

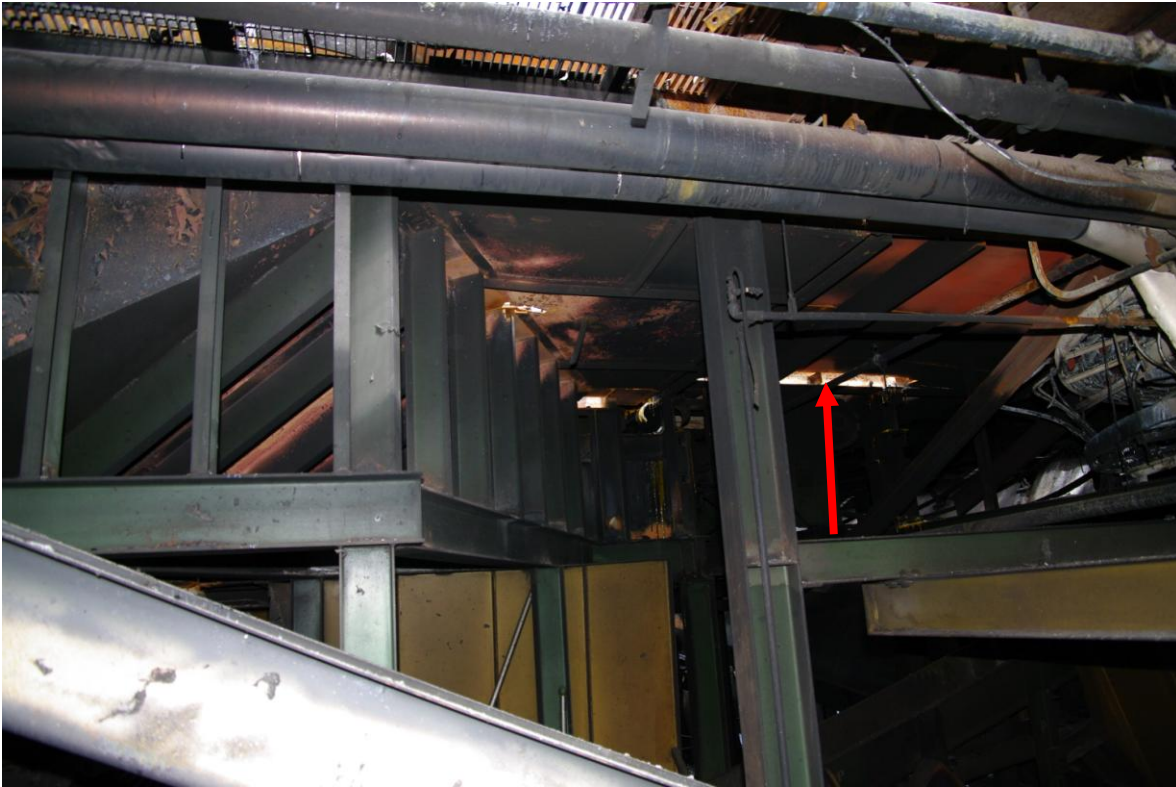
Photograph 29

Facing north looking at the underside of the decking in front of the small head-rig operators booth shown in photograph 28, grid J-22.

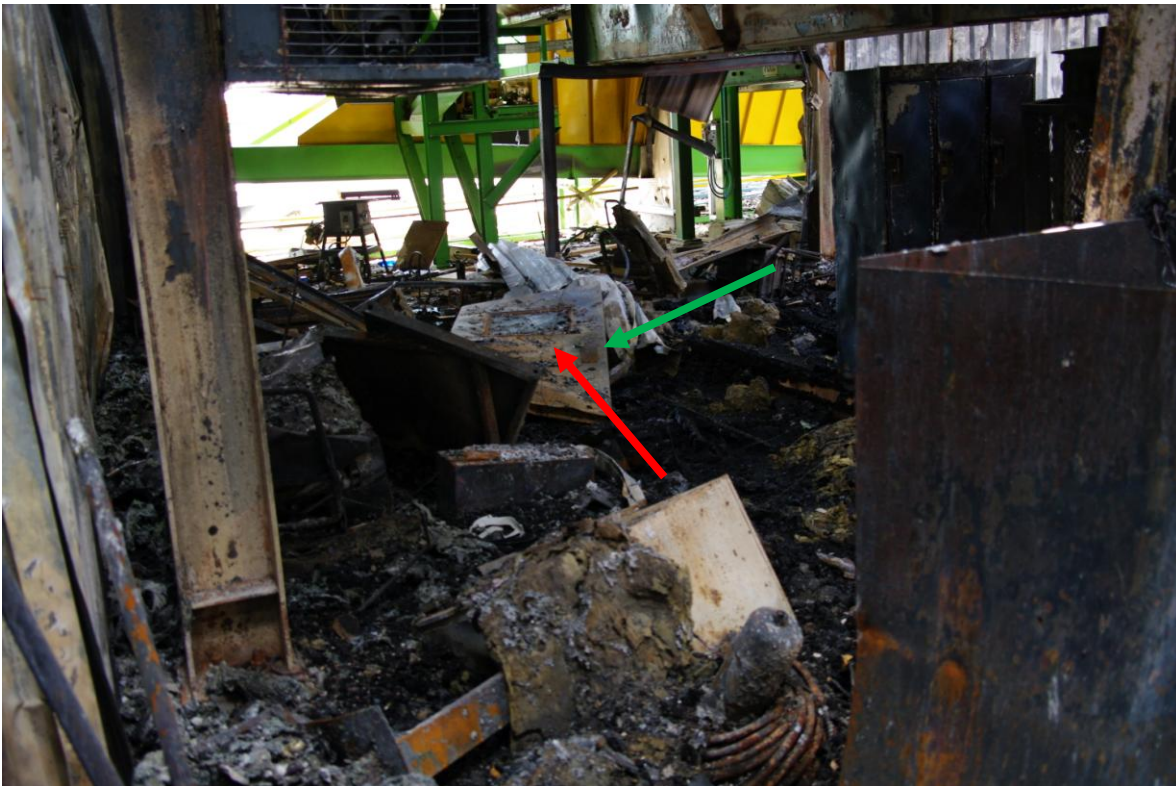
Photograph 30

Facing south looking at the door of the maintenance lunch room (green arrow) displaced north to south, grid F-21/22

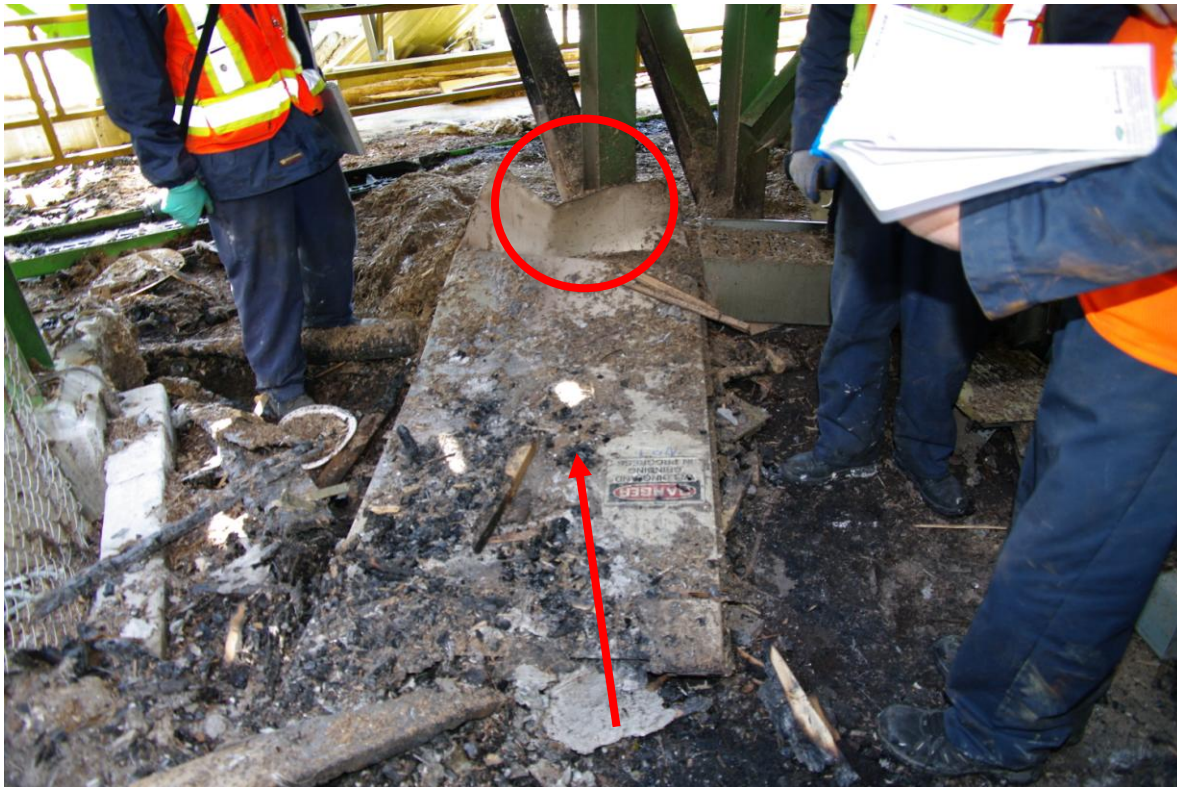
Photograph 31

Facing south looking at the outside door to the parts storage room, displaced north to south, grid D-22/23.

Note: the impact damage to the bottom of the door (circle).

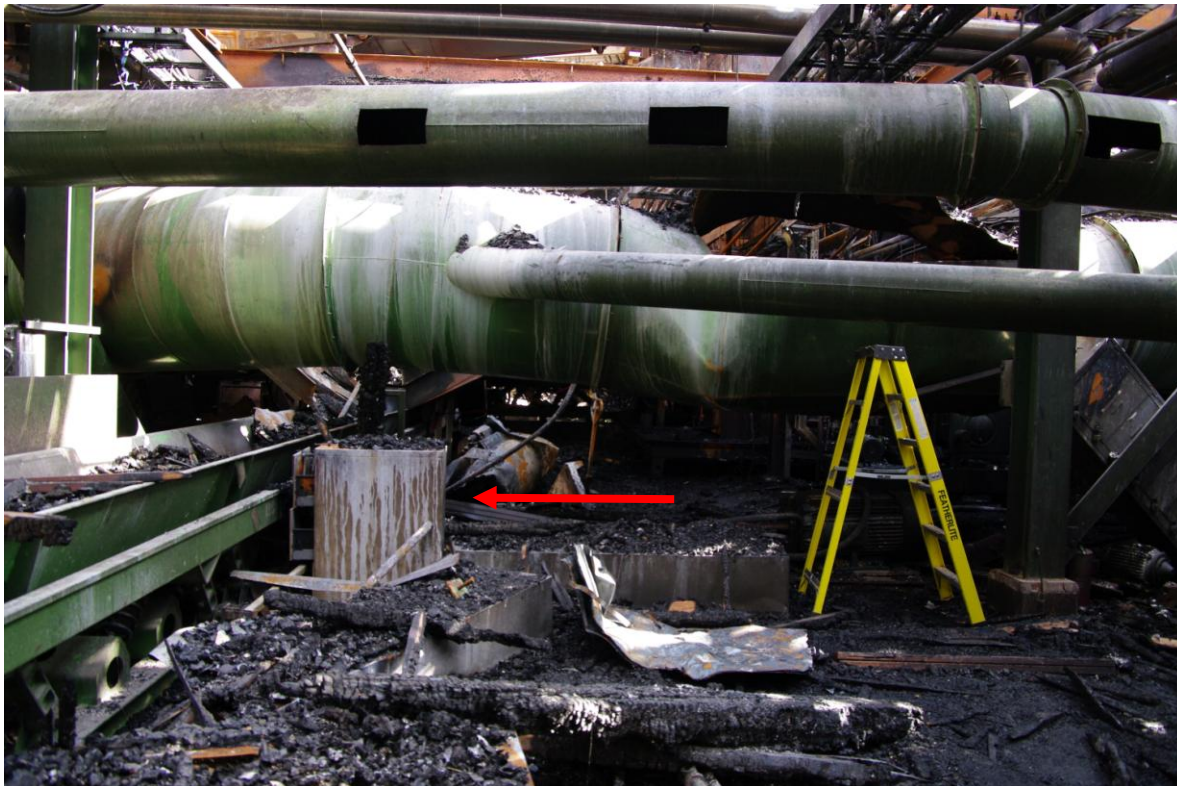
Photograph 32

Facing north looking at a filing cabinet displaced east to west, grid H-15.

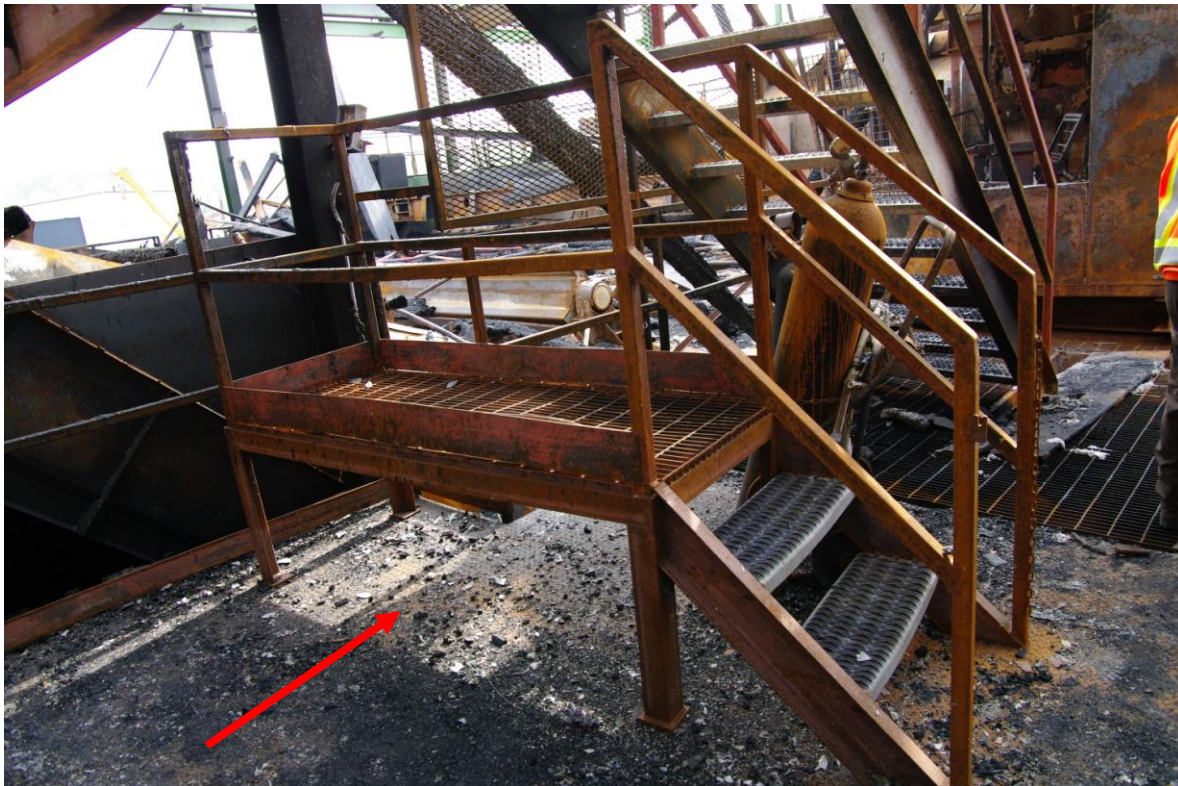
Photograph 34

Facing east looking at a steel stand on the operating floor, displaced approximately 2.5m east of its original position, grid J-22/23.

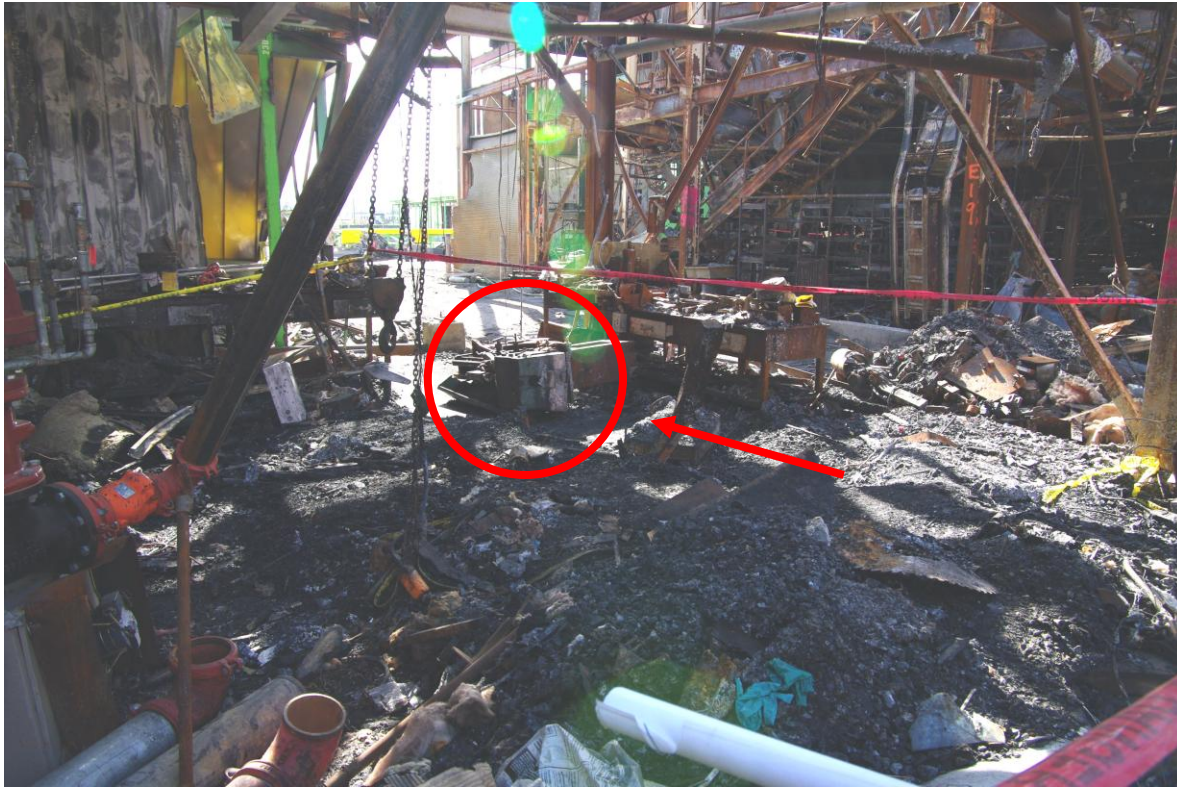
Photograph 35

Facing south looking at the maintenance shop.

Note: the lathe (circle) was displaced north to south and tipped on its side, grid E-20.

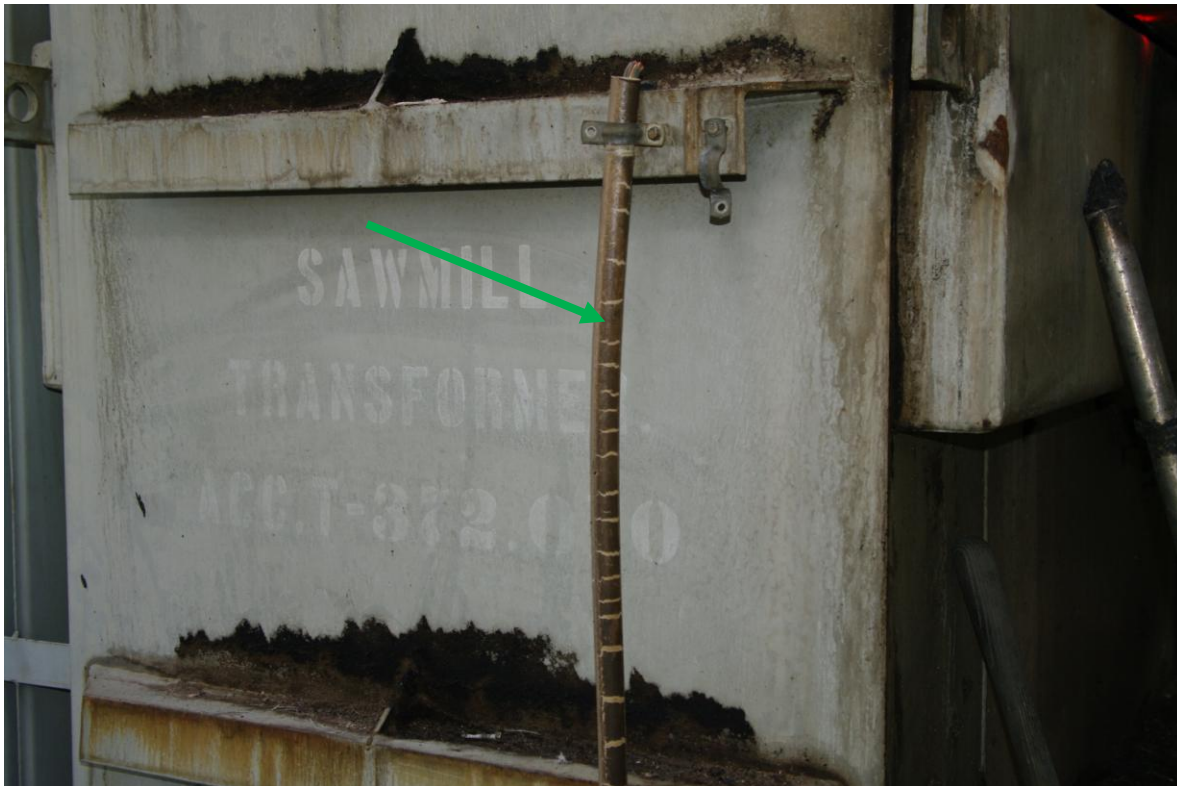
Photograph 36

Looking at the sawmill transformer. Grid D-23.

Note: the ground wire (green arrow) was found arced and separated.

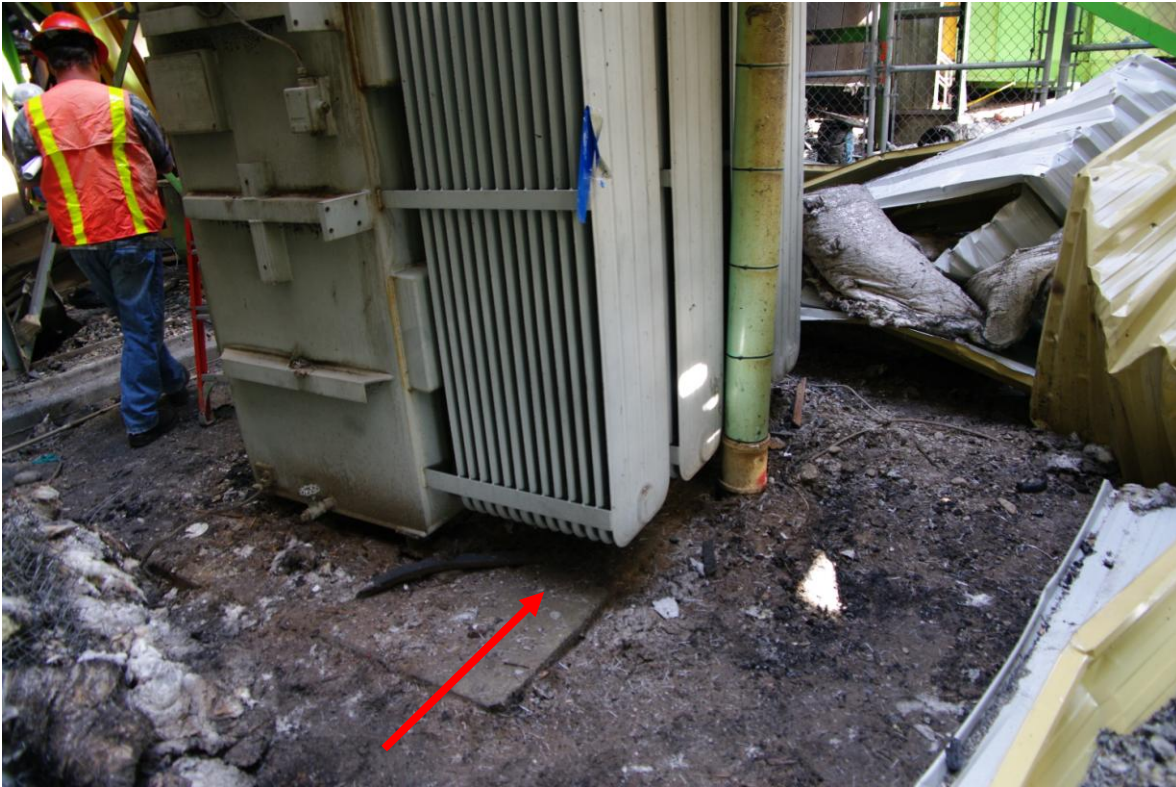
Photograph 37

Looking at the log handling transformer.

Note: the right side of the transformer was shifted approximately 10cm to the south, grid D-23.

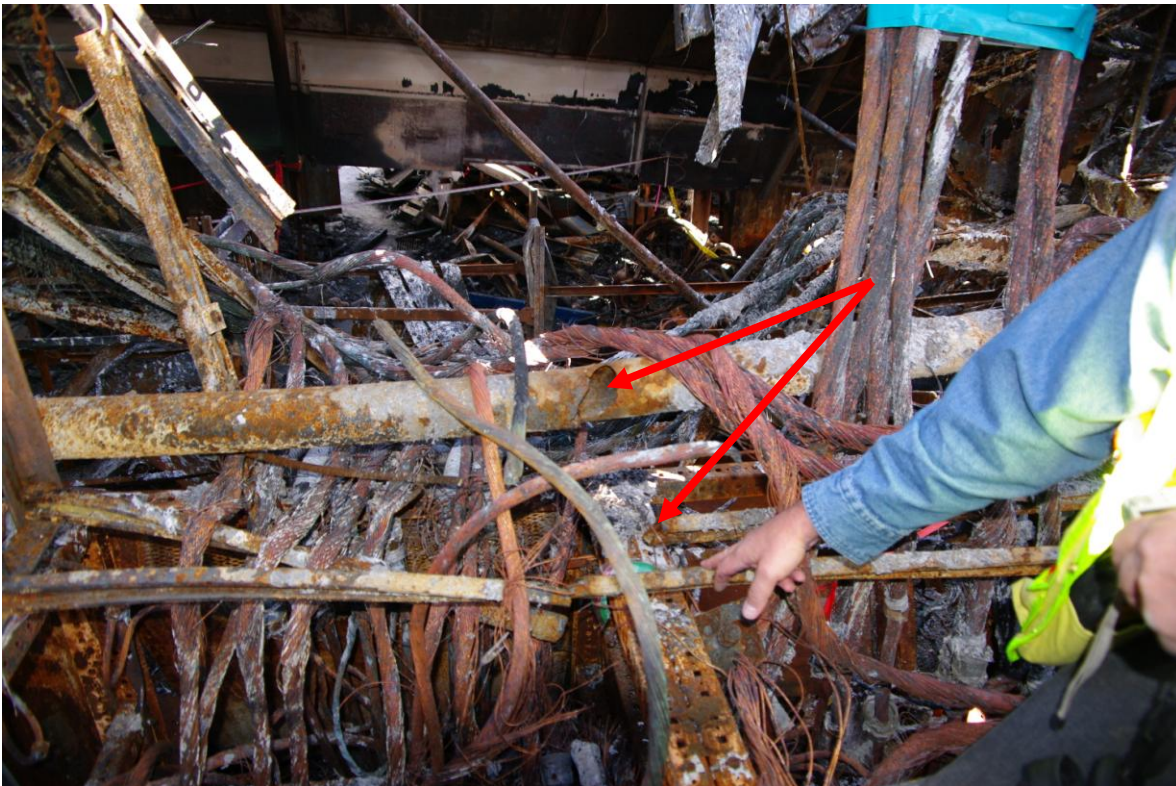
Photograph 40

Looking at a hole burned through a sprinkler pipe and cable tray (arrows) above the PDC, grid G-23.

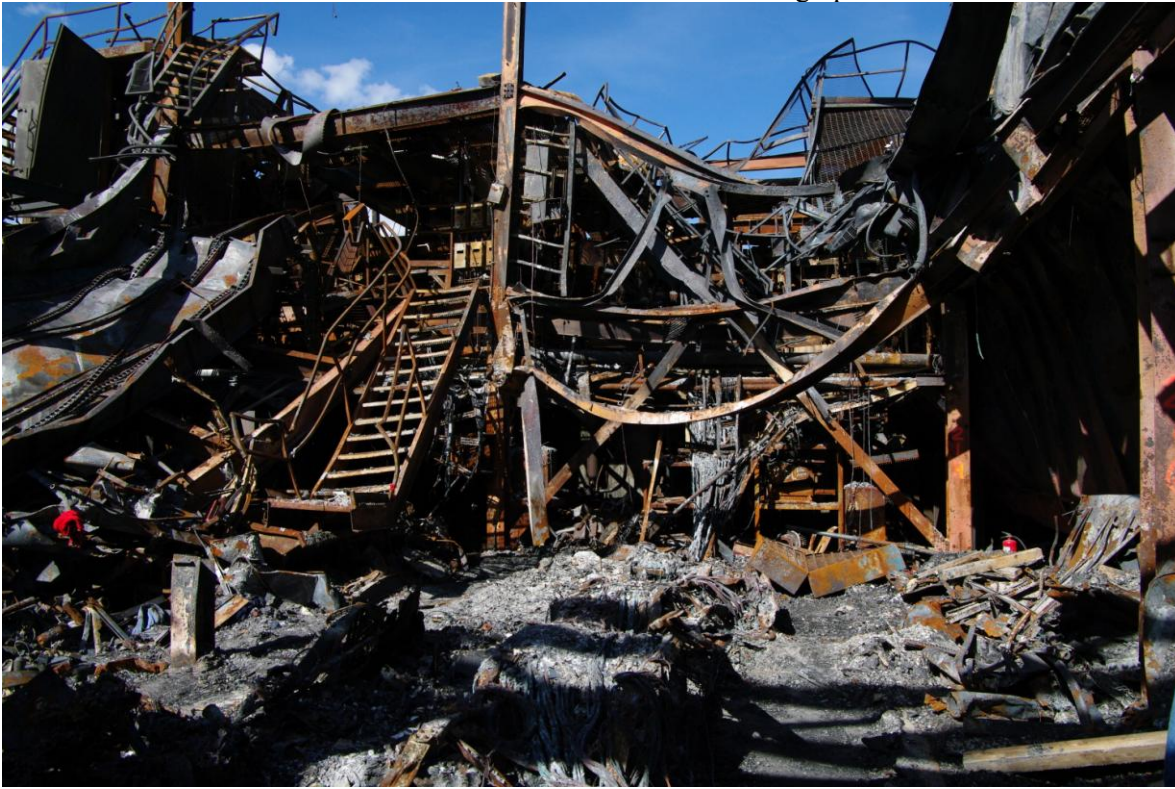
Photograph 41

Facing north looking at the south side of the major collapse shown in Photographs 17 and 21, grid G-20.
