Investigation Report

Lakeland Mills Ltd. – Explosion and Fire – April 23, 2012

BC Safety Authority – Incident Investigation – Jurisdiction and Role

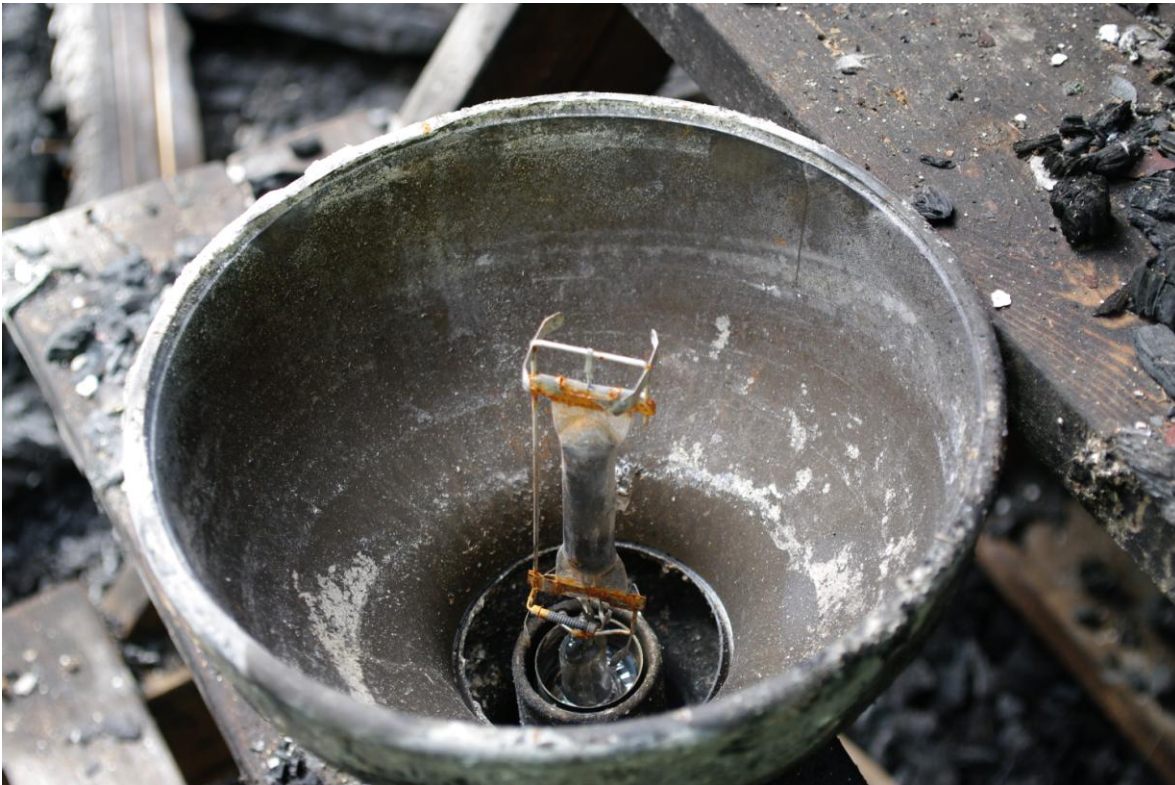
Photograph 42

Looking at examples of unprotected lighting in the west side of mill (this and 6 following photographs).

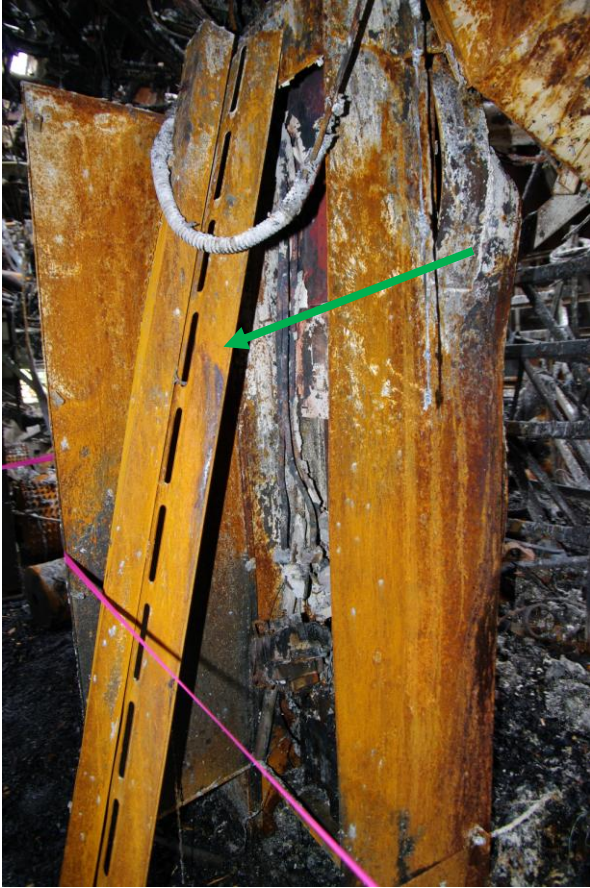
Photograph 45

Photograph 44
Looking at examples of unprotected fluorescent lighting (arrow) (this and following photograph), grid J-23.

Grid J-22.

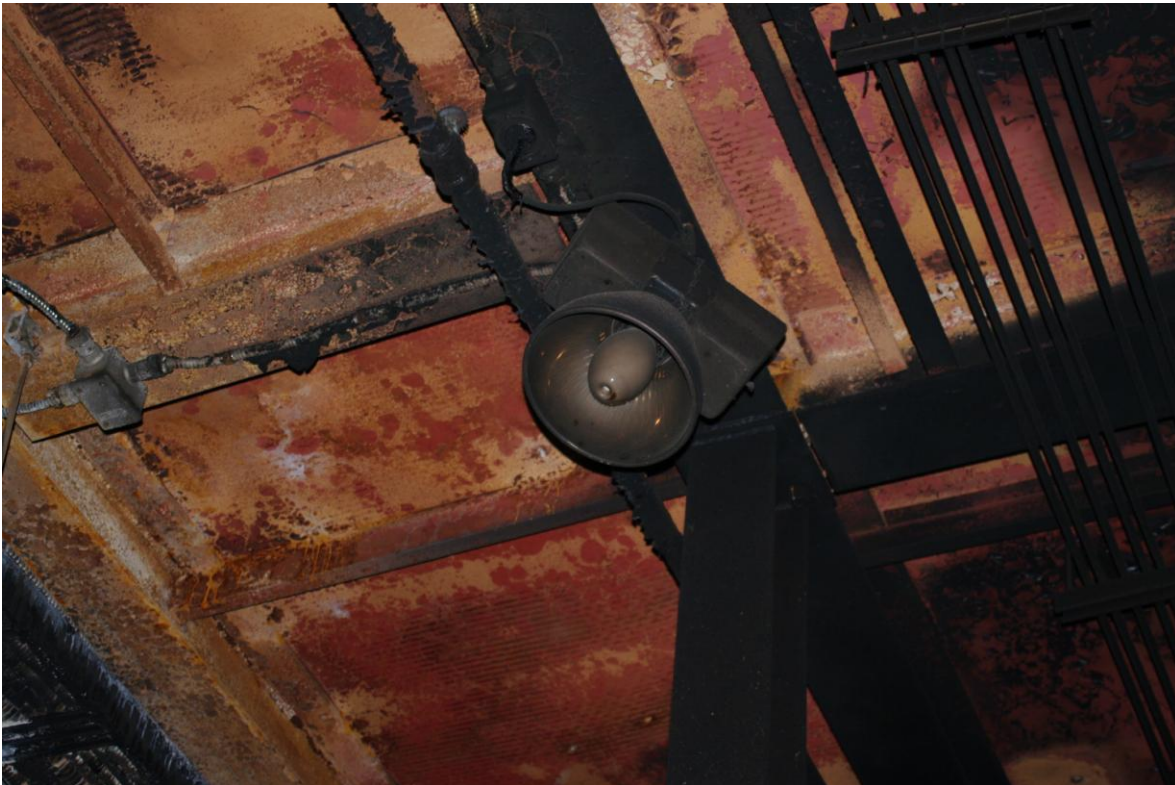
Photograph 46

Looking at an example of unprotected lighting in the east side of mill.

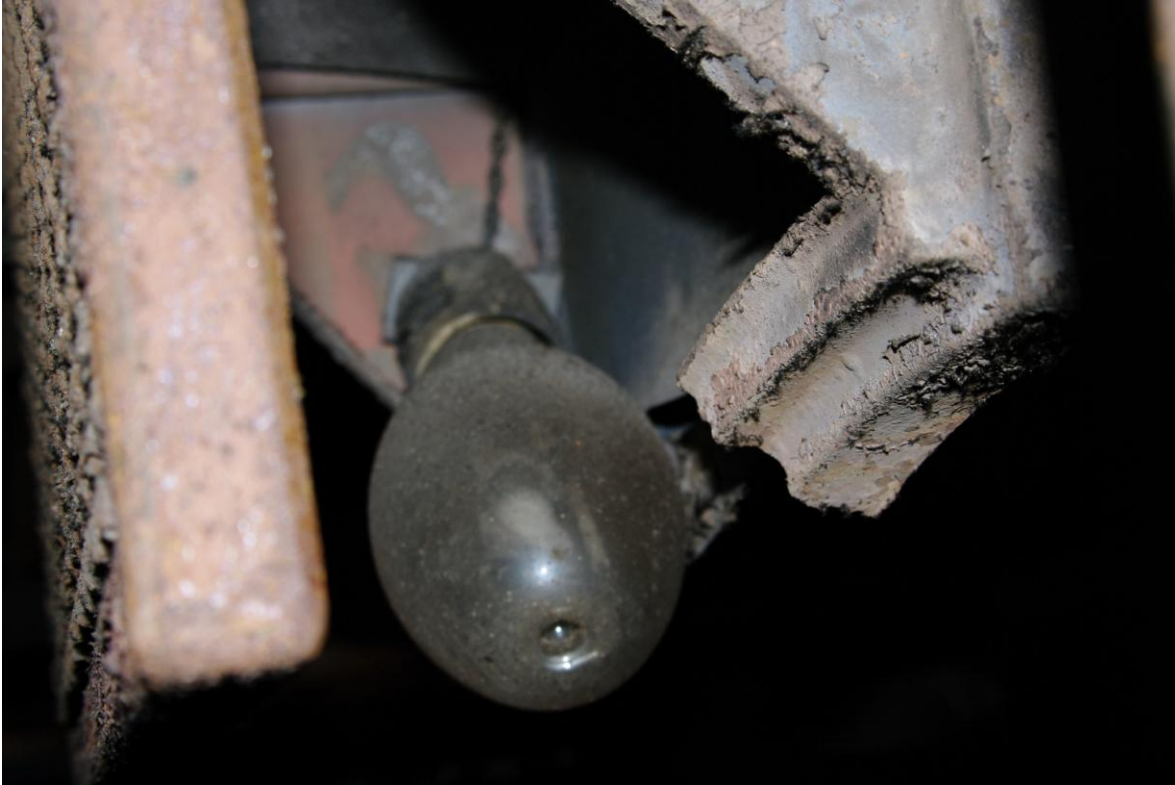
Photograph 47

Southeast area of mill.

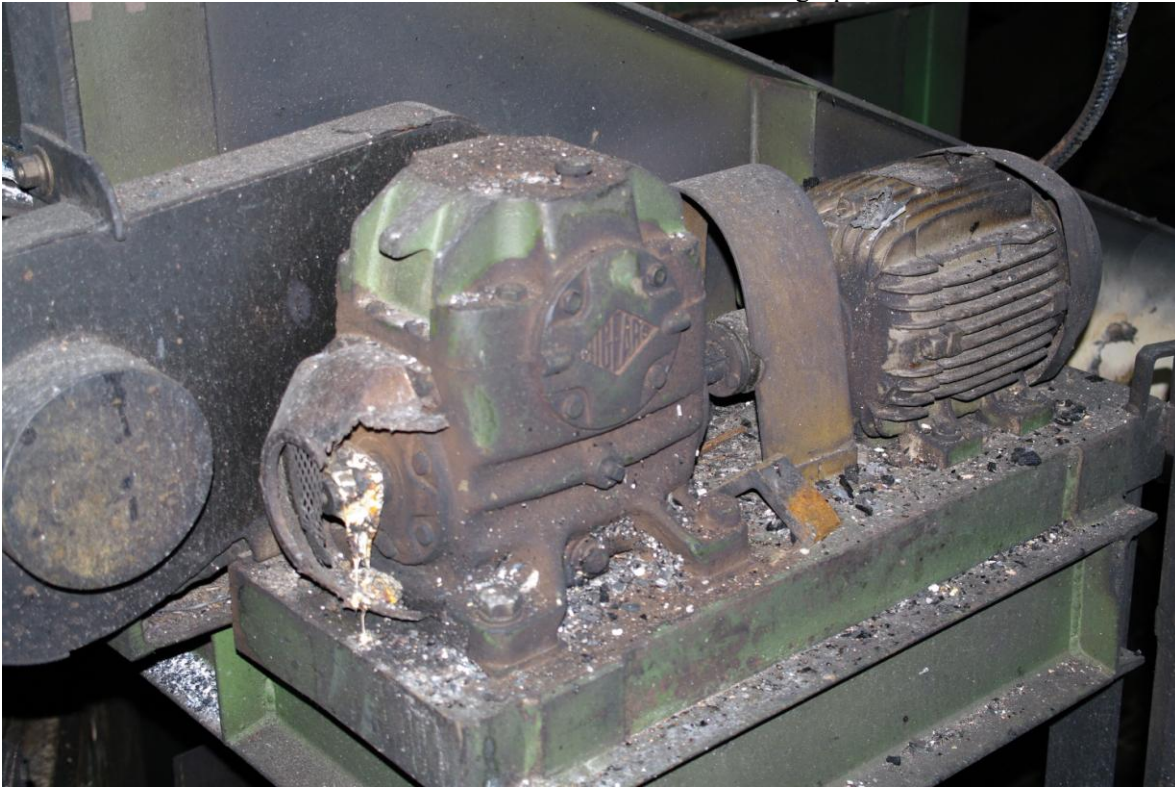
Photograph 49

Motor 14P

Note: similar directional damage as motor 6P (Photograph 16).
